2019 Annual Inspection Report

Gerald Gentleman Station Ash Disposal Facility

Nebraska Public Power District

19128371-0001-2-R-0

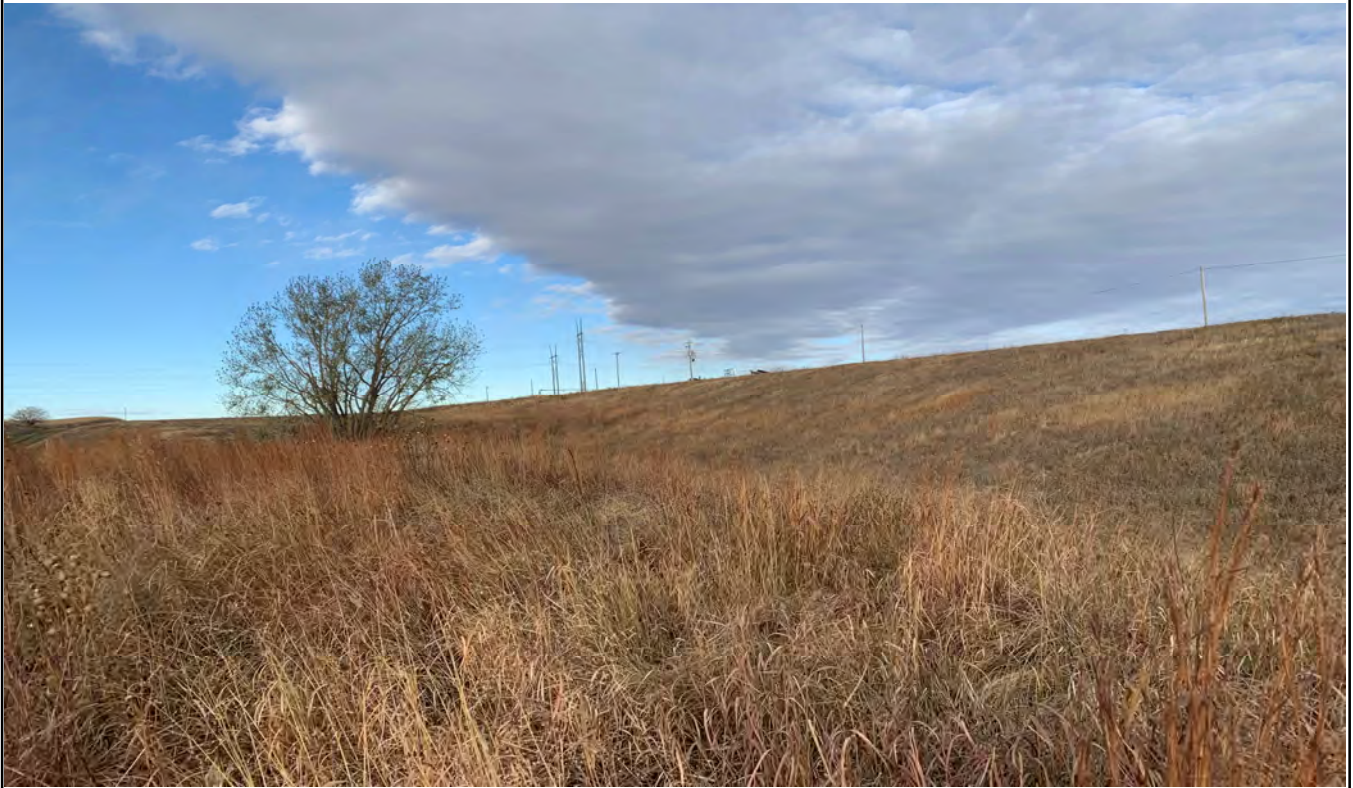
Photograph 1
Vegetation on exterior slope of ash landfill No. 3. (IMG_2082.JPG)

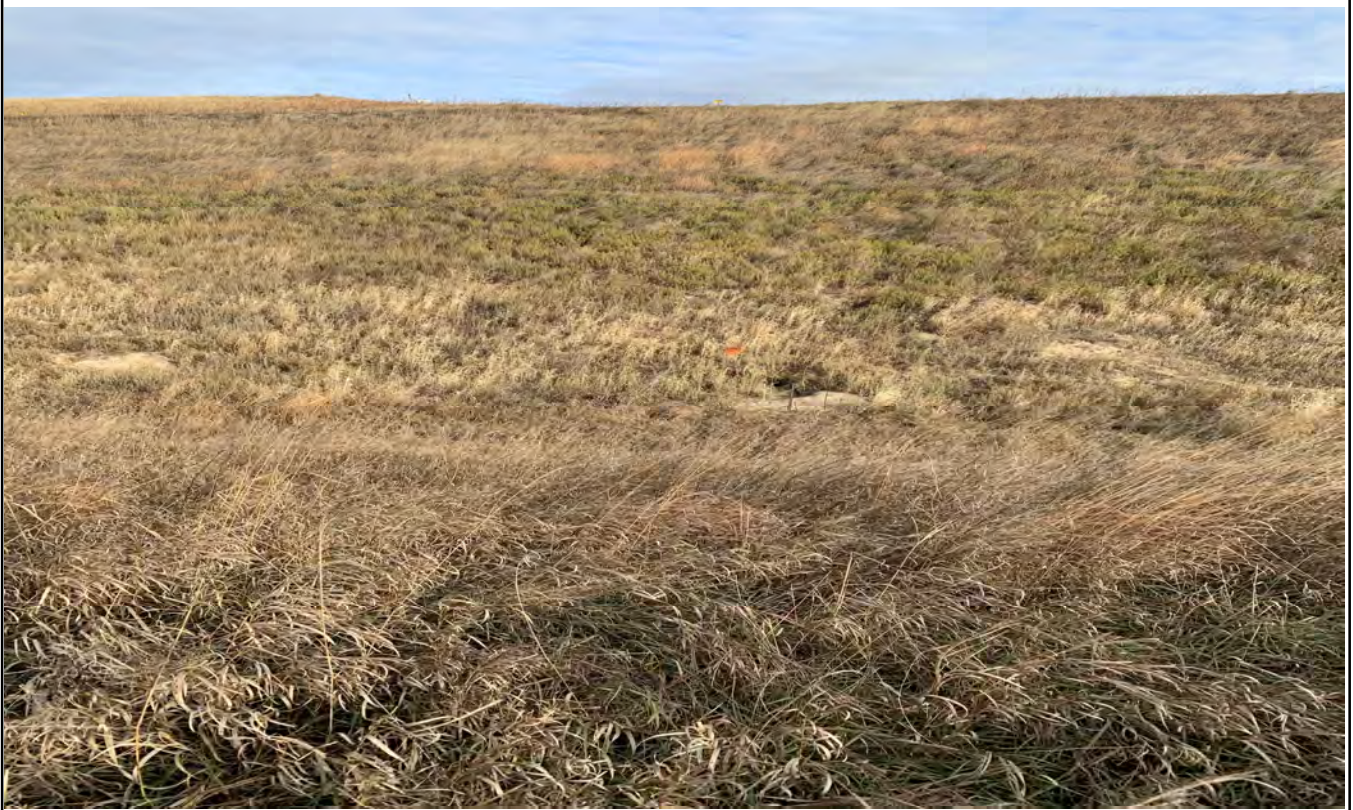
Photograph 2
Exterior slope vegetation. (IMG_2085.JPG)

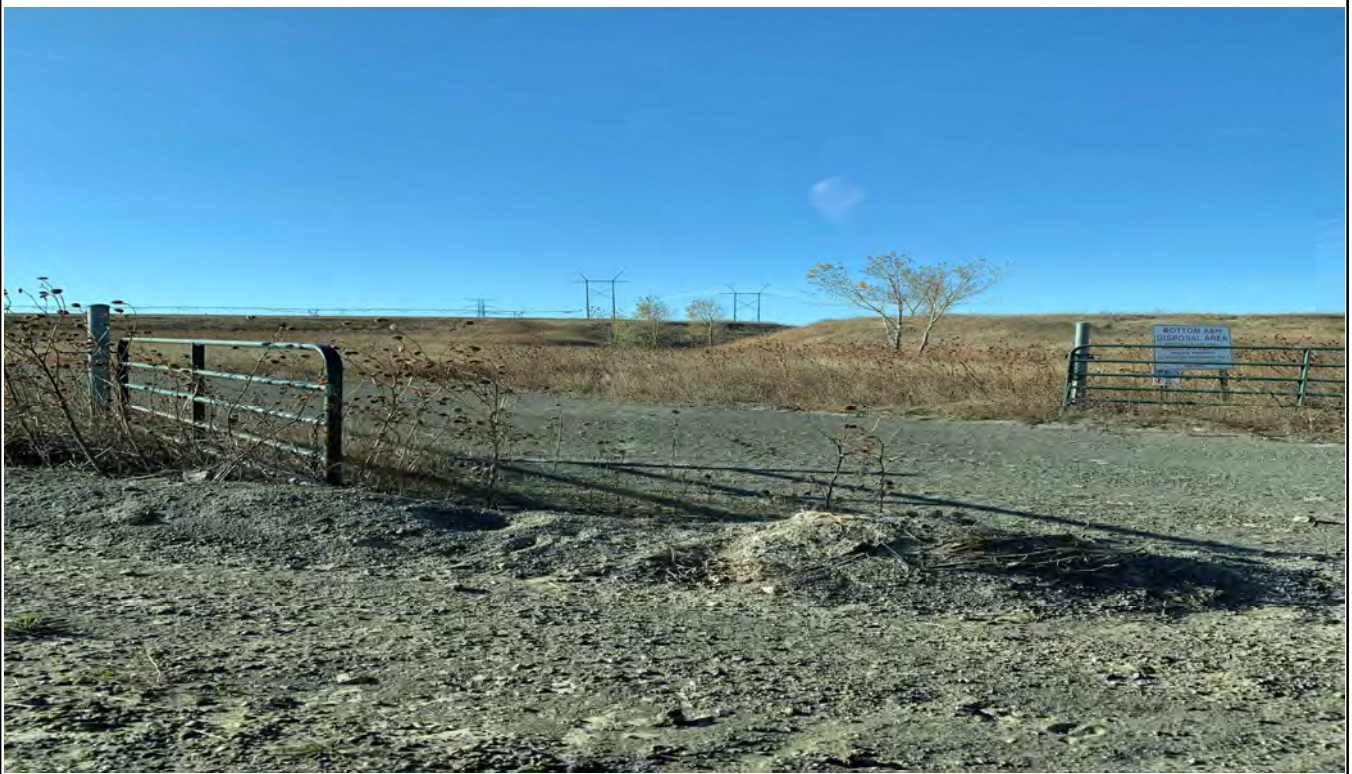
Photograph 3
Security gate & entrance to closed Bottom Ash Disposal Area. (IMG_2087.JPG)

Do all entrances have signs detailing entrance authorization and allowed disposal material?	<u>Y</u>	N	NI	NA	RA	Recommend removal of sign in front of closed bottom ash facility
Are the roads to the site in good repair?	<u>Y</u>	N	NI	NA	RA	
How is access controlled to the site (fencing, locked gate, etc.)?	Fence around perimeter, access is restricted by site security					
Are the facility boundaries clearly marked?	<u>Y</u>	N	NI	NA	RA	
Are there signs of unauthorized access to the site such as trails or gaps in the fencing?	Y	<u>N</u>	NI	NA	RA	
Is there any evidence of any unauthorized disposal (other than CCPs or construction/demolition debris)?	Y	<u>N</u>	NI	NA	RA

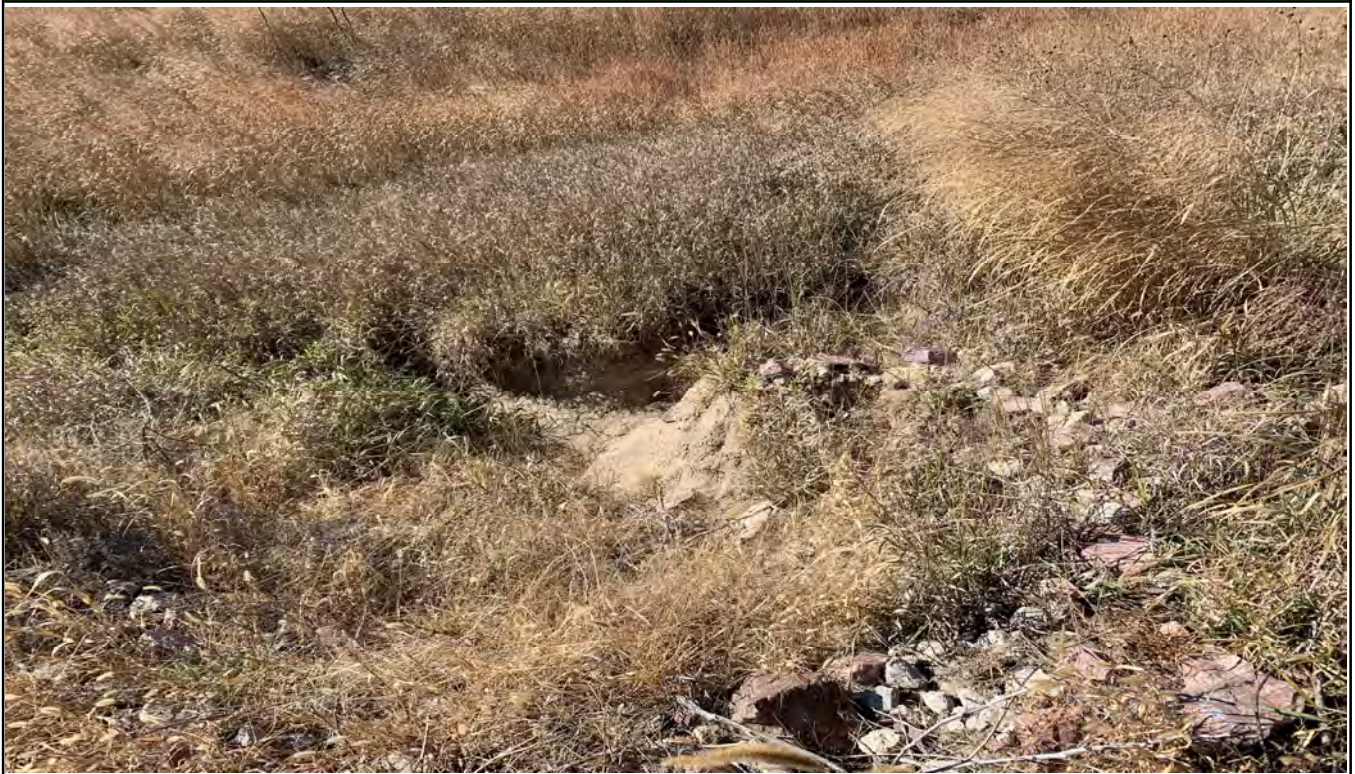
Some evidence of burrowing animals was observed along the west outer slopes of Ash Landfill No. 3 (likely badger holes). The number of animal burrows observed was slightly higher compared with the previous inspection. NPPD inspects the embankments weekly, and signs of burrowing animals are documented. Animal burrows on the embankment slopes should continue to be addressed and repaired, as necessary. Animal burrowing does not currently pose a threat to the structural stability of the facility at this time.

Photograph 7
Animal Activity and erosion west exterior slope. (IMG_2110.JPG)

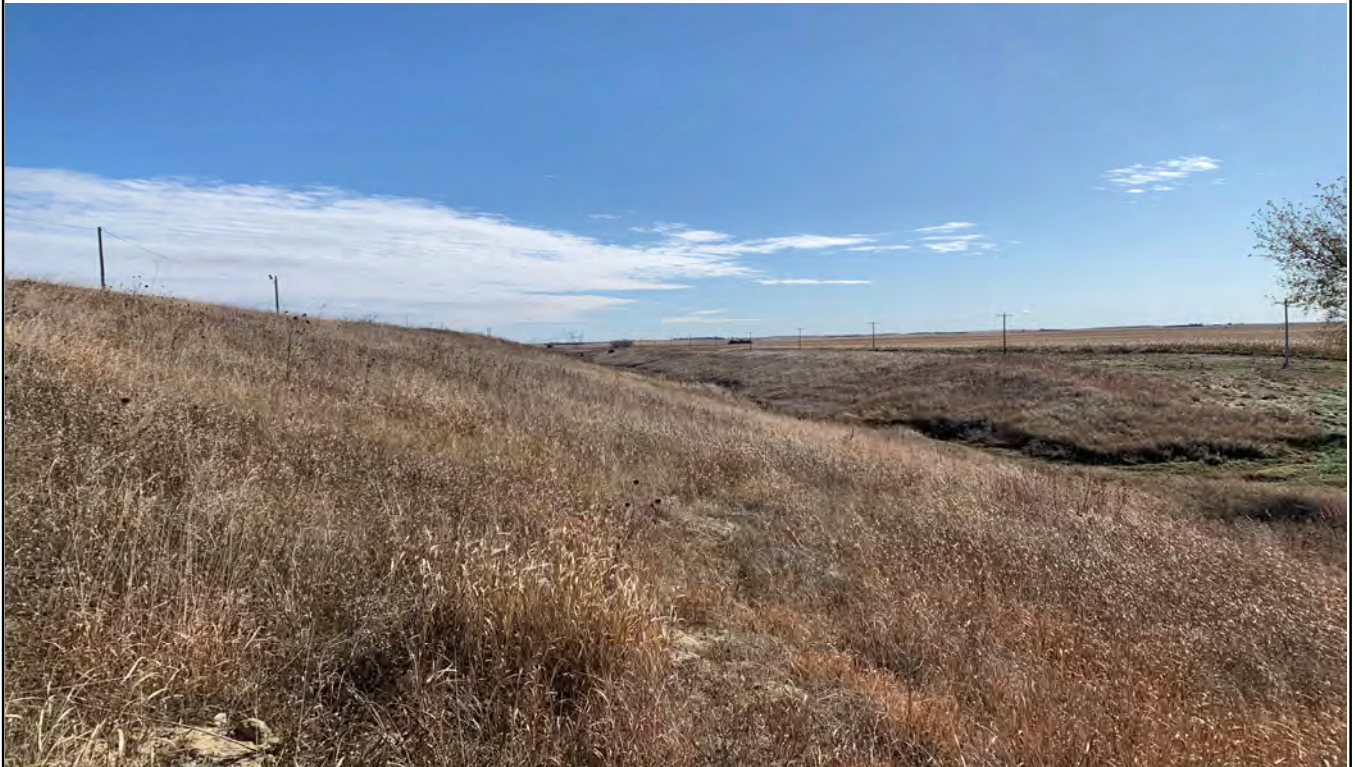
Photograph 8
Vegetation in south side of Ash Landfill No. 4. (IMG_2115.JPG)

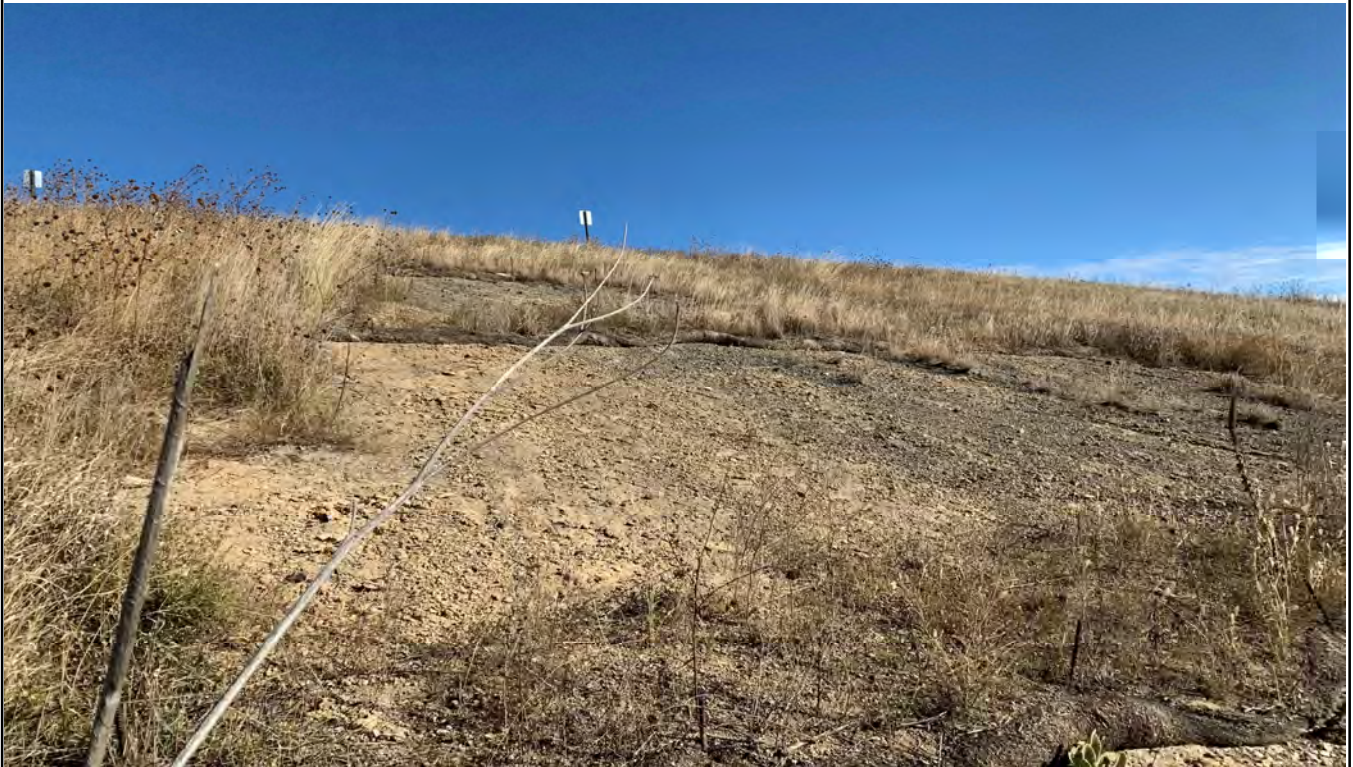
Photograph 10
Area without vegetation on south side of Ash Landfill No. 4. (IMG_2122.JPG)

Are there signs of erosion in the disposal area such as gullies, dirt flows, etc.?	<u>Y</u>	N	NI	NA	RA	Erosion rills/gullies were observed on the exterior slope on the west side of AP3 and on the south side of the west cell of AP3 just west of the riprap-lined overflow drainage
Are there signs of differential settlement in the disposal area such as cracks, sinkholes, etc.?	Y	<u>N</u>	NI	NA	RA	
Any indication of vegetative stress in or near the disposal area? Are there pockets of dead or dying vegetation in otherwise seeded areas?	<u>Y</u>	N	NI	NA	RA	There is an area on the south slope between AP3 and AP4 that should be re-vegetated (may require new topsoil).

Any housekeeping concerns about the waste placement, coverage and vegetation for visitors and neighbors?	No housekeeping issues were observed.					
Is partial closure of the facility occurring?	<u>Y</u>	N	NI	NA	RA	
Has seed and mulch been applied on the closed areas of the site?	<u>Y</u>	N	NI	NA	RA	
Any visible or exposed soil or geomembrane liner?	Y	<u>N</u>	NI	NA	RA	
Were the concerns from the last annual observation addressed and corrected?	Y	<u>N</u>	NI	NA	RA	Although no major concerns were identified during the previous observation, minor erosion and vegetation issues have not yet been addressed. Recommend NPPD develops plan for re-vegetating area south of AP3/AP4 boundary and corrects erosion on west side of AP3.

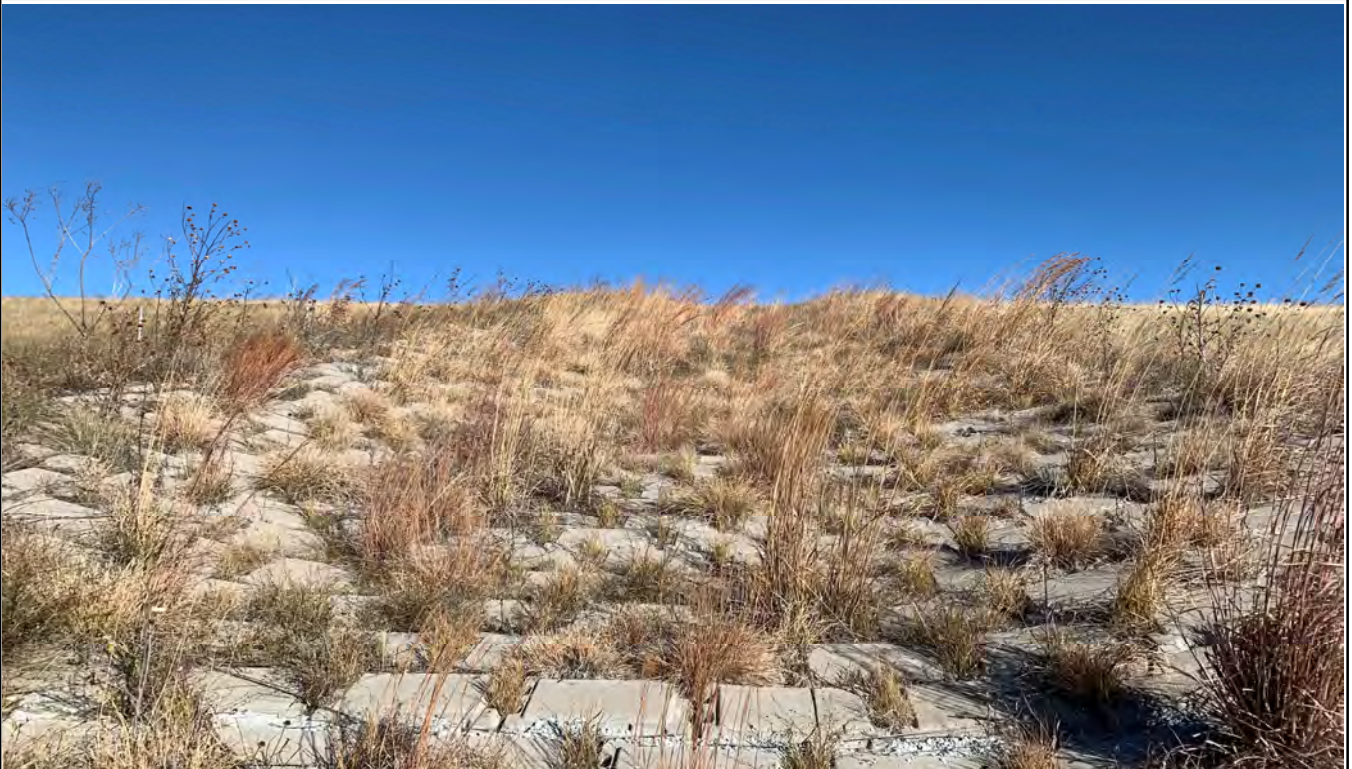
Vegetative growth on the final cover placed in 2015 has continued to improve, resulting in reduced erosion of the cover soil. The terrace channels and downchute channel on the final cover appear to be functioning as designed.

Photograph 12
Downchute channel on south side of Ash Landfill No. 4. (IMG_2128.JPG)

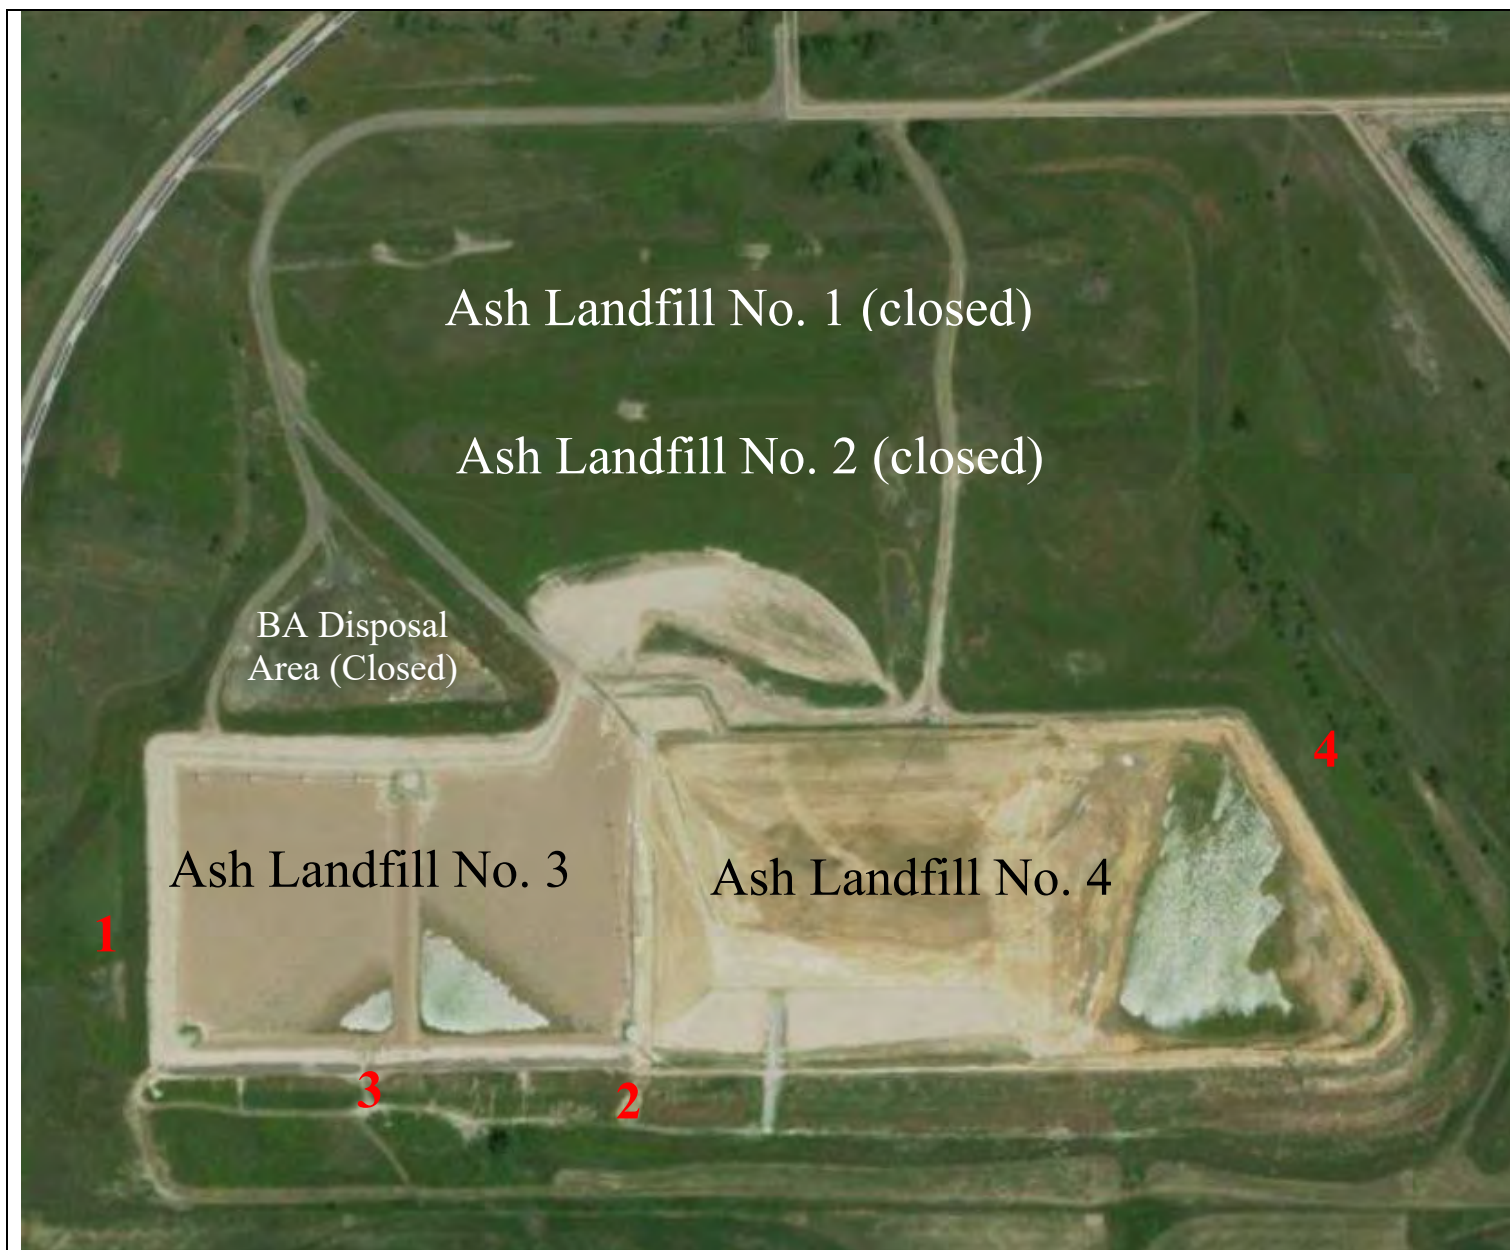
1 – Erosion rills on exterior slope

2 – Erosion west of riprap

3- Area of insufficient vegetation

4 – Small pine tree growing on exterior slope
