2019 Annual Inspection Report

Sheldon Station Ash Landfill No. 4

Nebraska Public Power District

19128355-0001-3-R-0

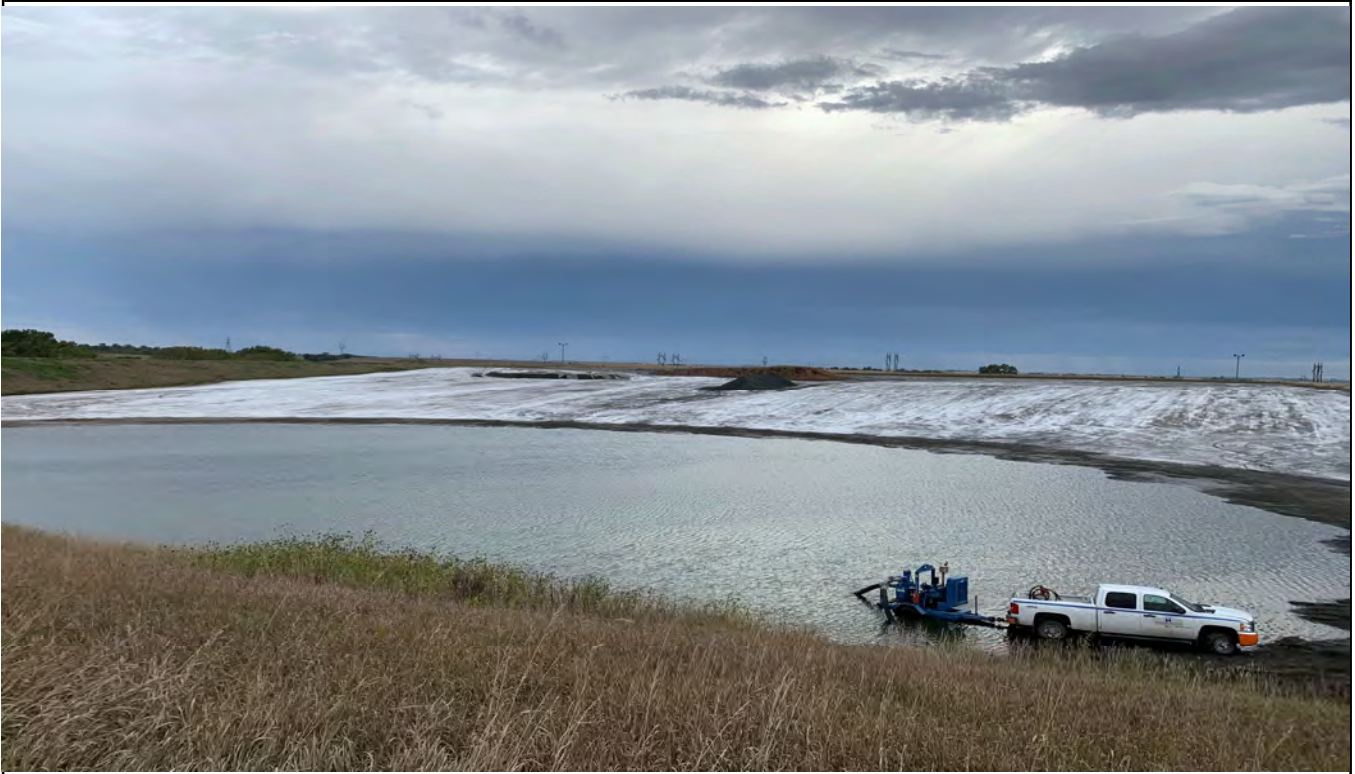
Photograph 1
Contact water pond on south side of ash disposal facility. (IMG_1977.JPG)

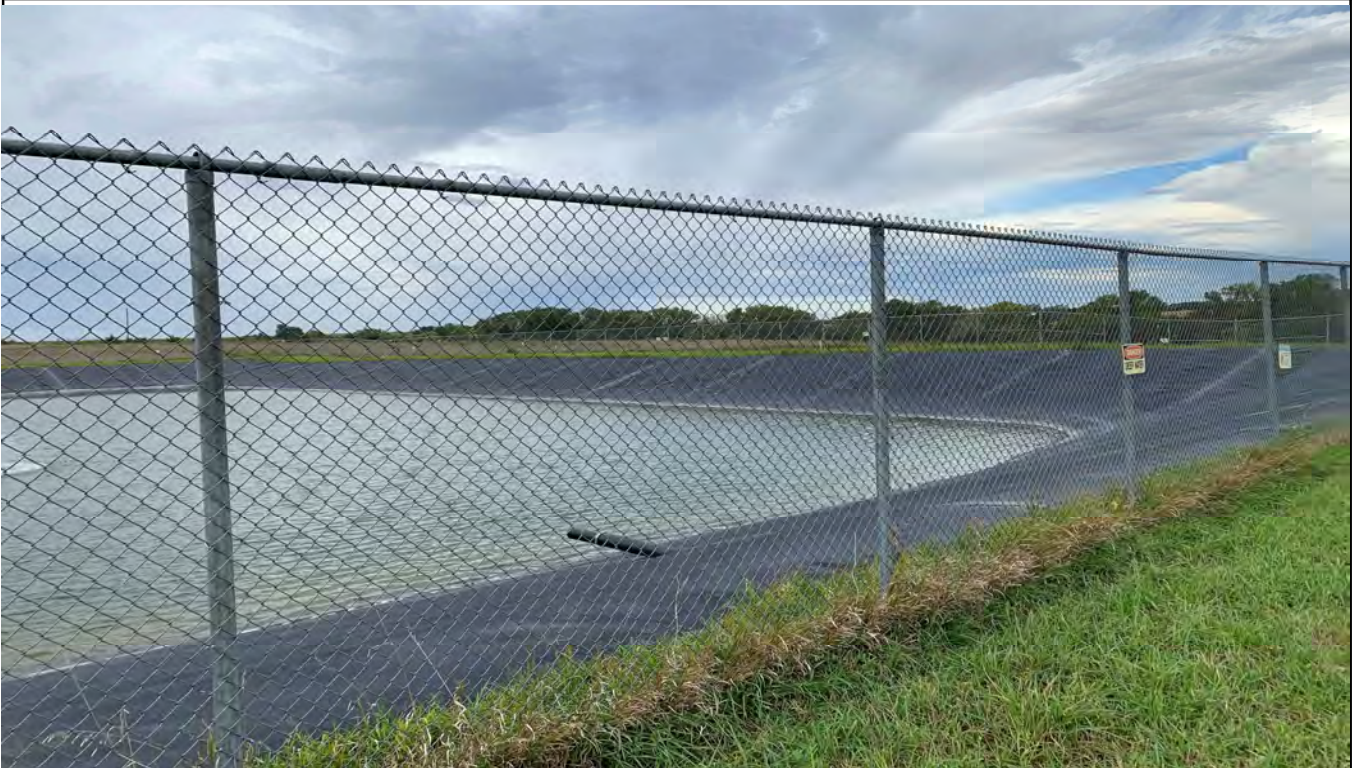
Photograph 2
Leachate evaporation pond and security fencing. (IMG_1991.JPG)

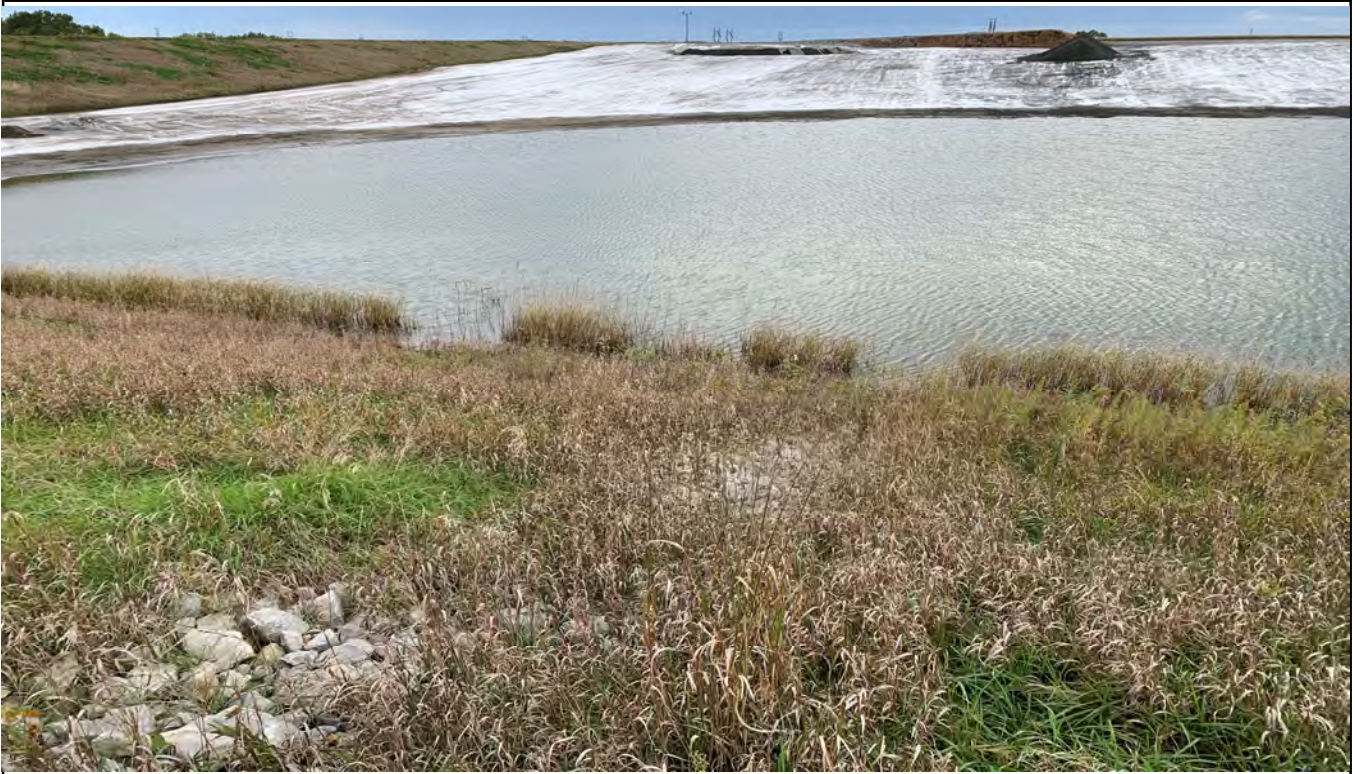
Photograph 3
Emergency overflow riprap from leachate evaporation pond to ash disposal facility. (IMG_1996.JPG)

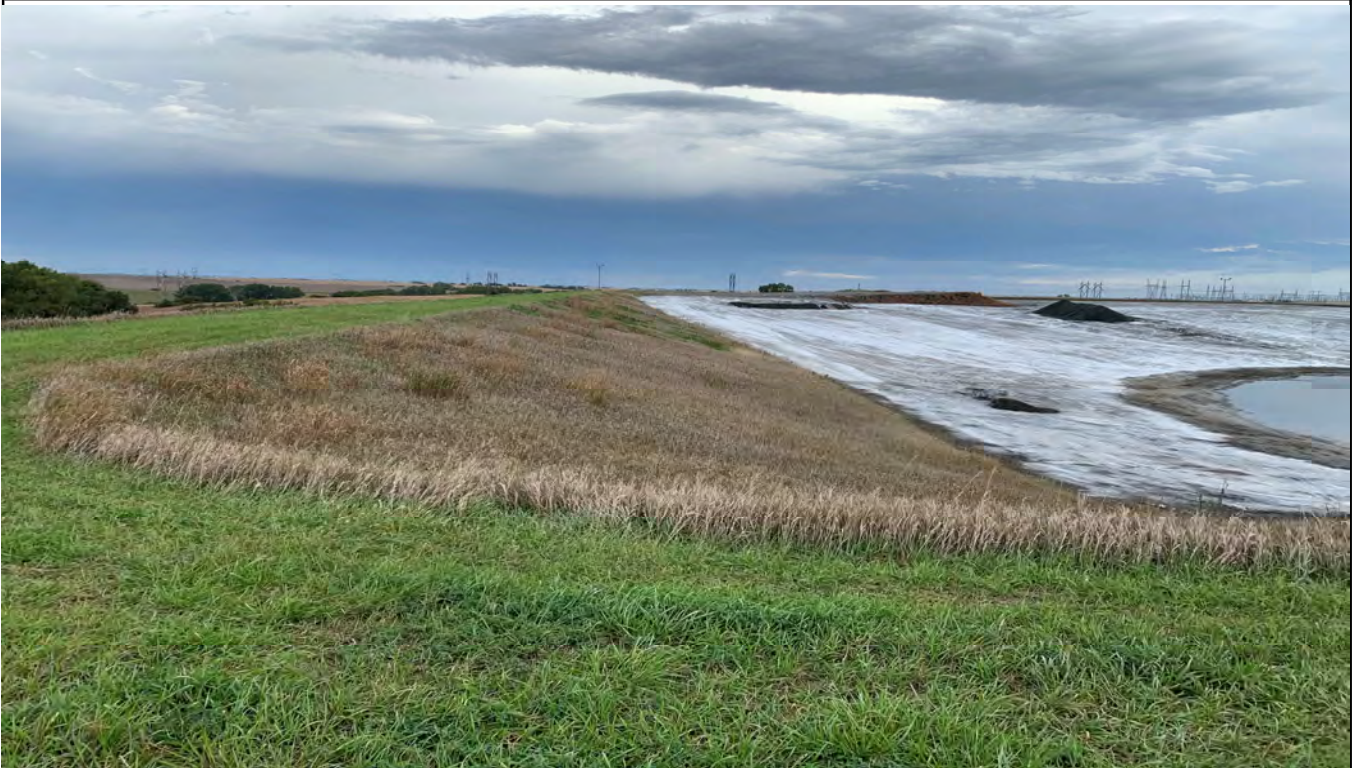
Photograph 4
Interior slope vegetation of ash disposal facility. (IMG_1999.JPG)

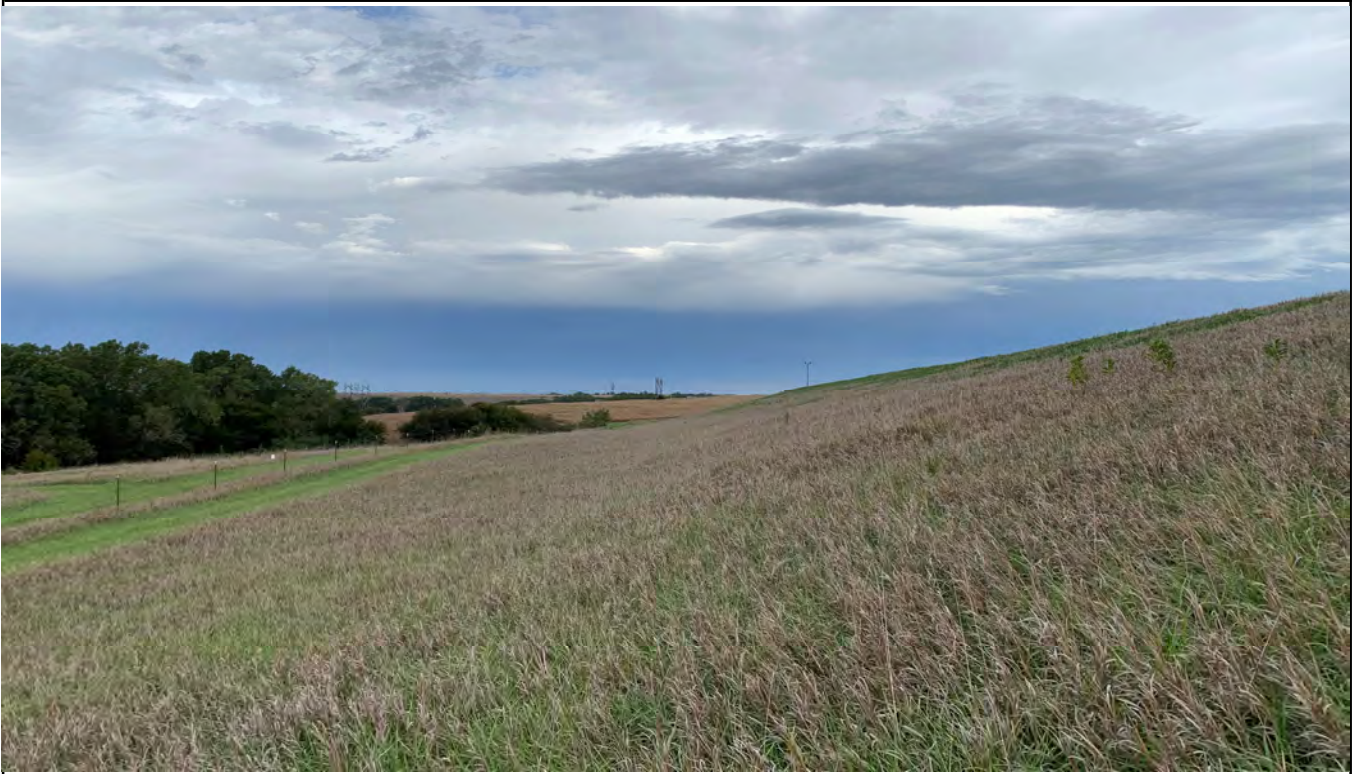
Photograph 5
Vegetation on the west exterior slope of the facility. (IMG_2003.JPG)

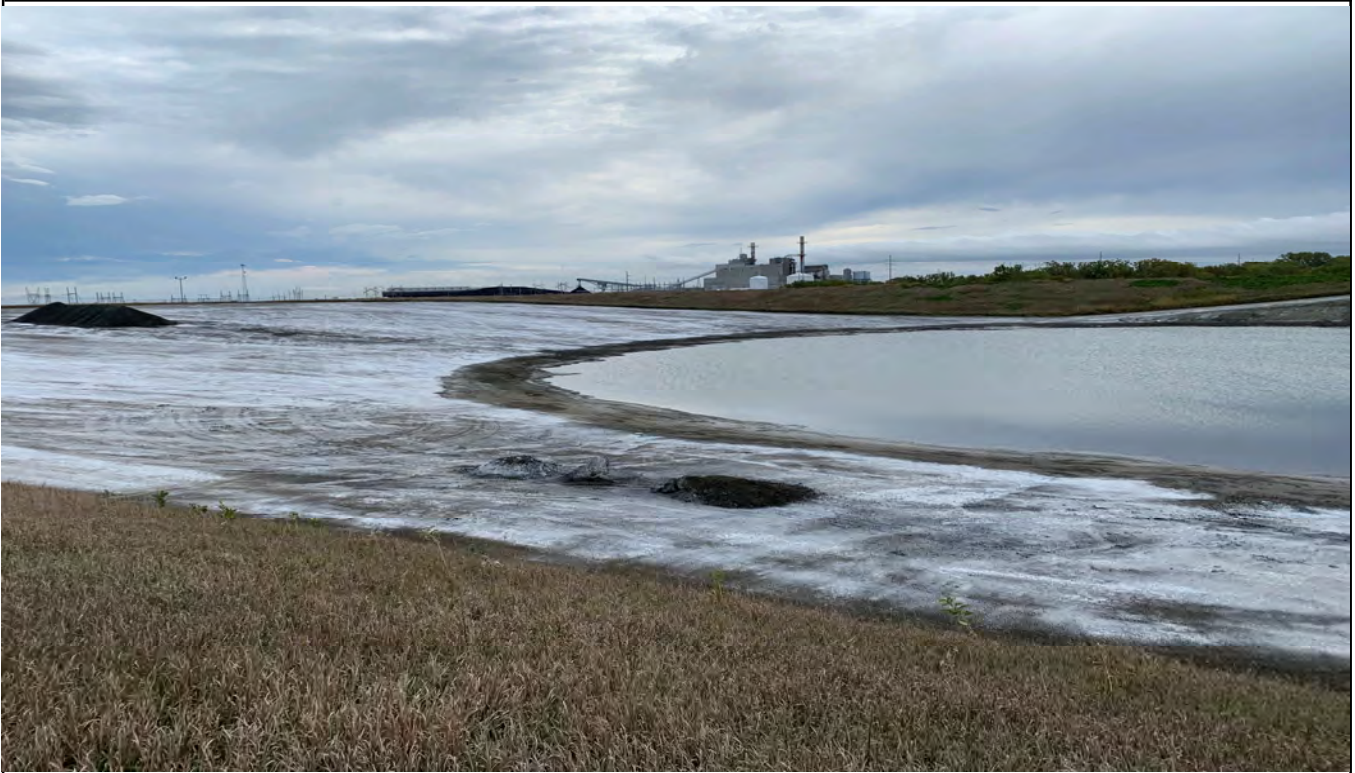
Photograph 6
Bottom ash stockpile within the facility. (IMG_2007.JPG)

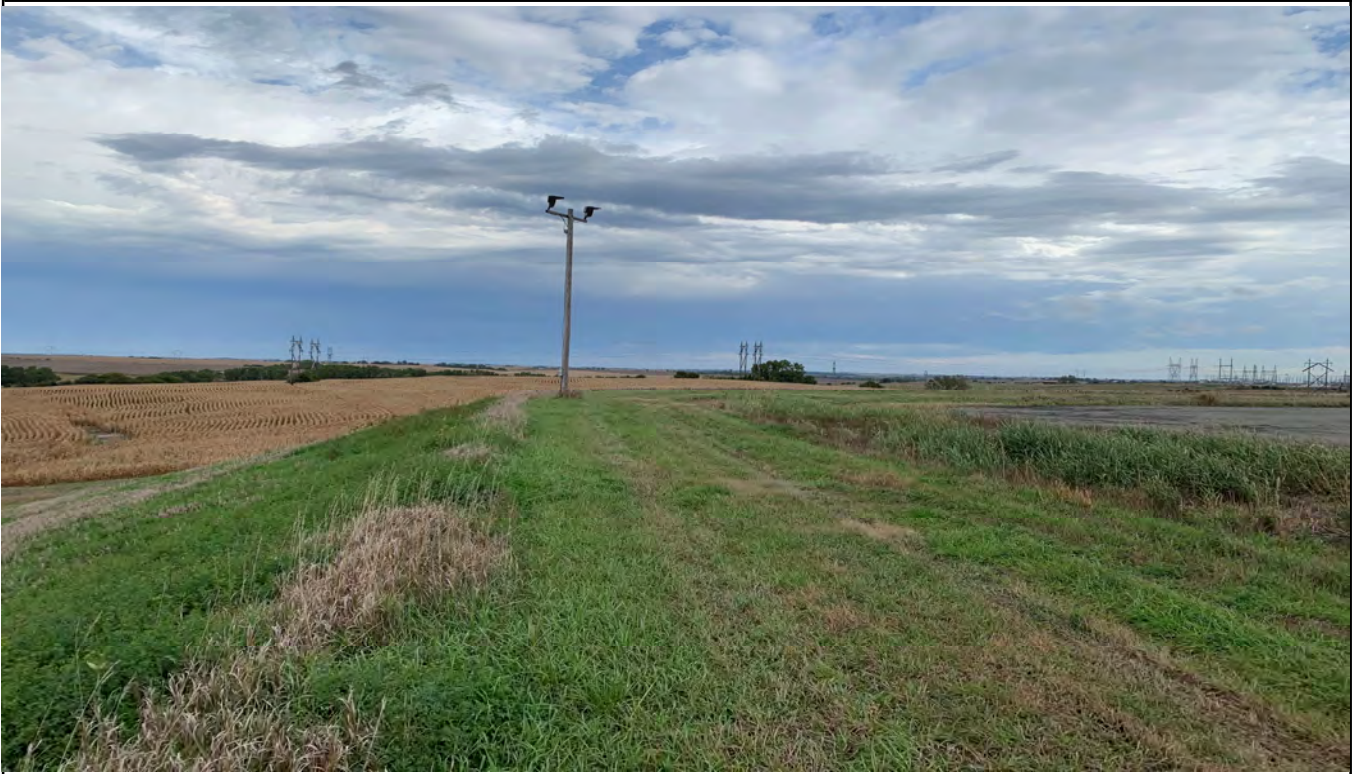
- Minor erosion was observed on the perimeter access road on the north side of the facility in July. Eroded areas were filled with aggregate and the perimeter road is in good condition.

Photograph 7
Perimeter road on facility embankment crest. (IMG_2014.JPG)

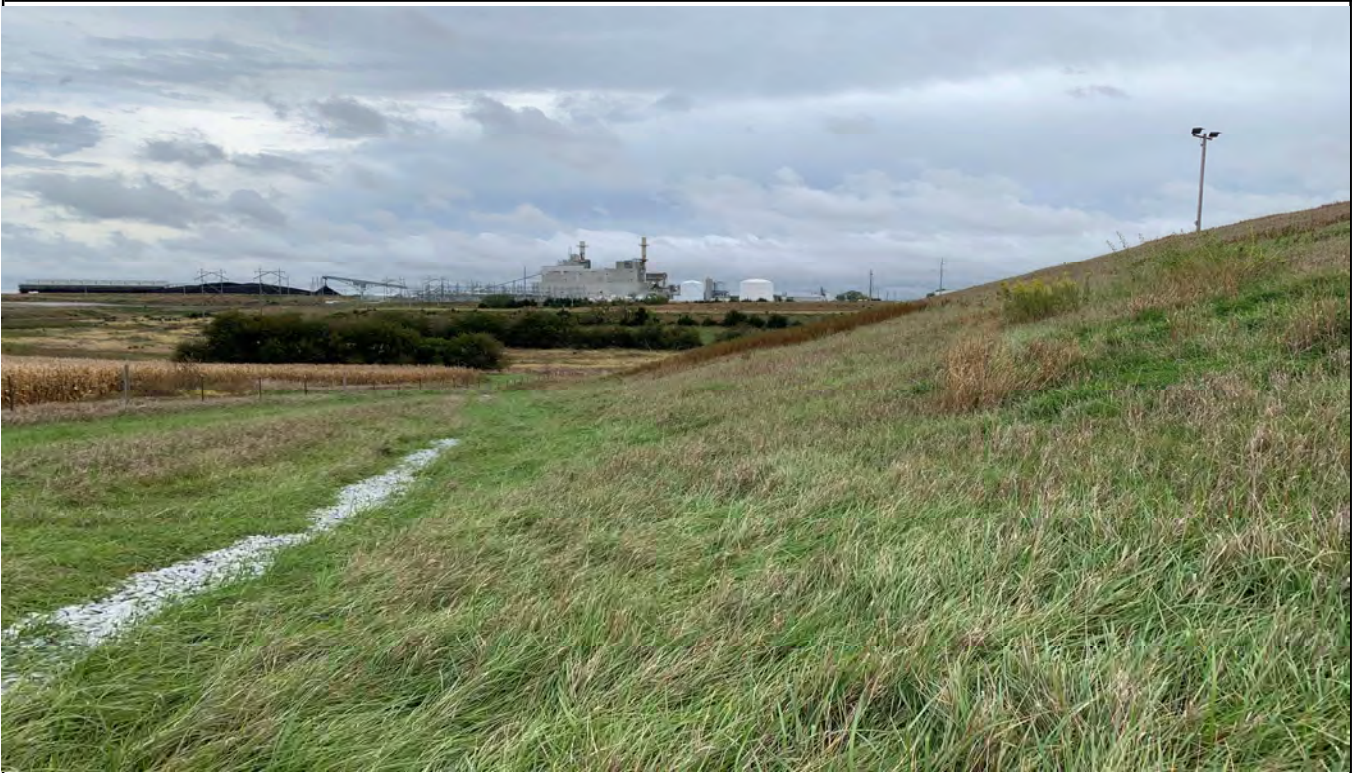
Minor erosional rills have been observed near the toe of the exterior slopes in the northeast corner and north side of the facility during previous inspections. NPPD has repaired these areas and backfilled the erosion rills with crushed rock. Vegetation has generally been established in the repaired areas, and significant erosion was not observed on the exterior slopes. NPPD should continue to monitor the exterior slopes and perimeter roads of the disposal facility for erosion, both during weekly inspections and after large rain events, making repairs as necessary.

Photograph 8
Vegetation on northern exterior slope with riprap in high traffic areas. (IMG_2019.JPG)

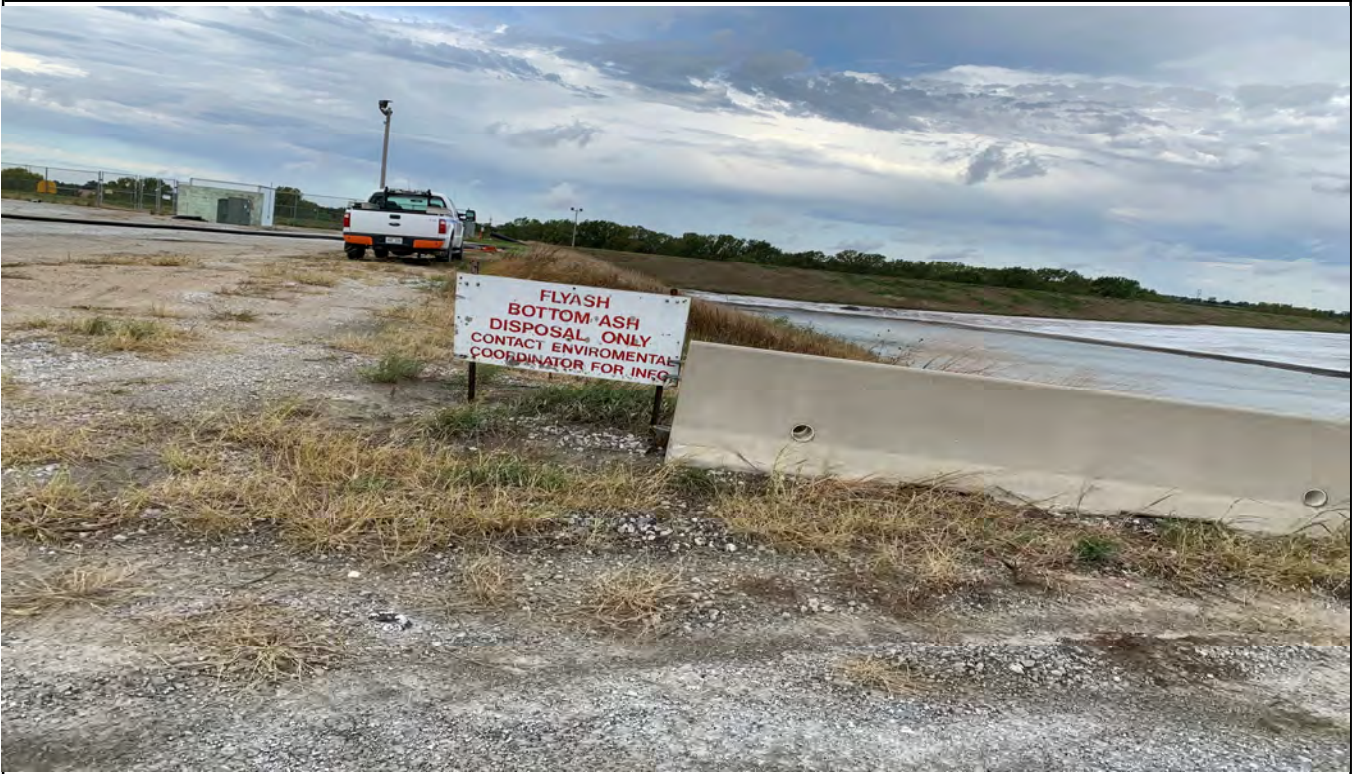
Photograph 9
Signage at entrance to ash disposal facility. (IMG_2027.JPG)

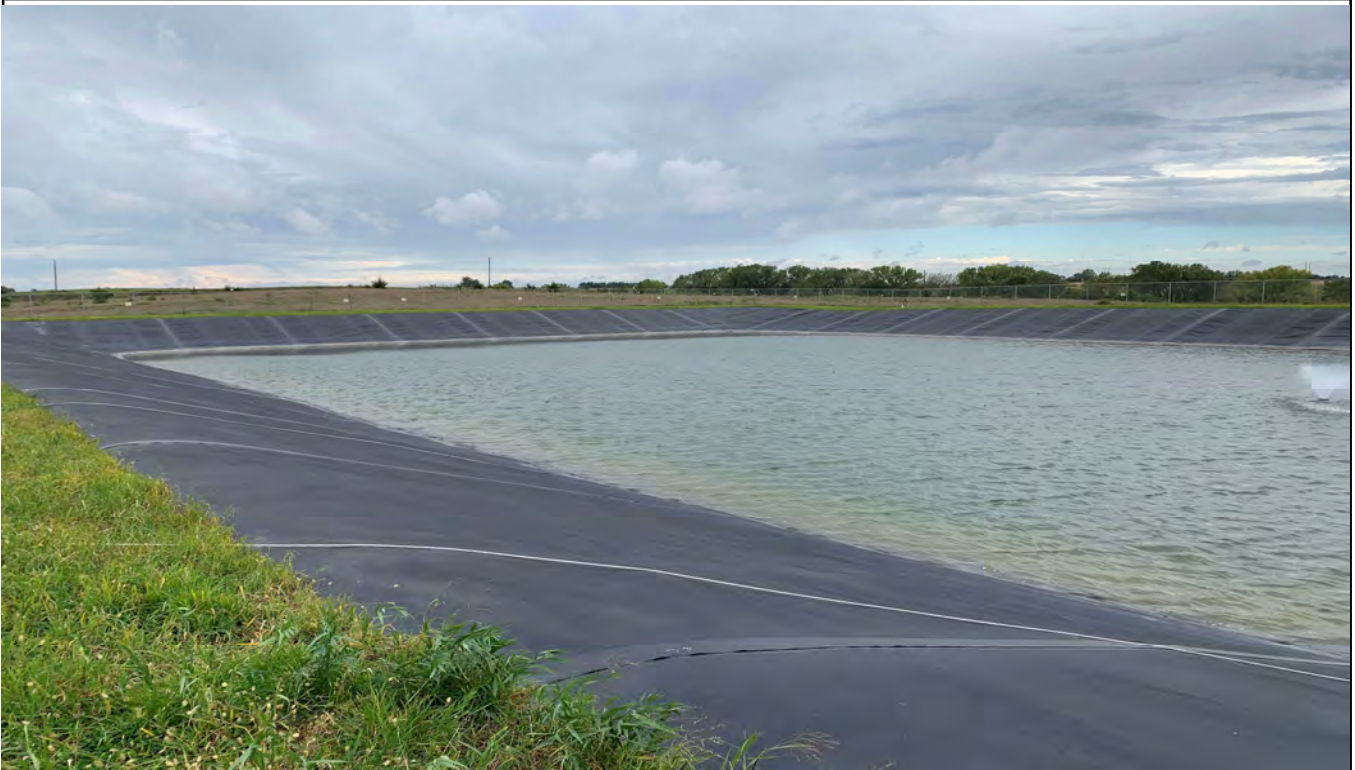
Photograph 10
Leachate evaporation pond. (IMG_2030.JPG)

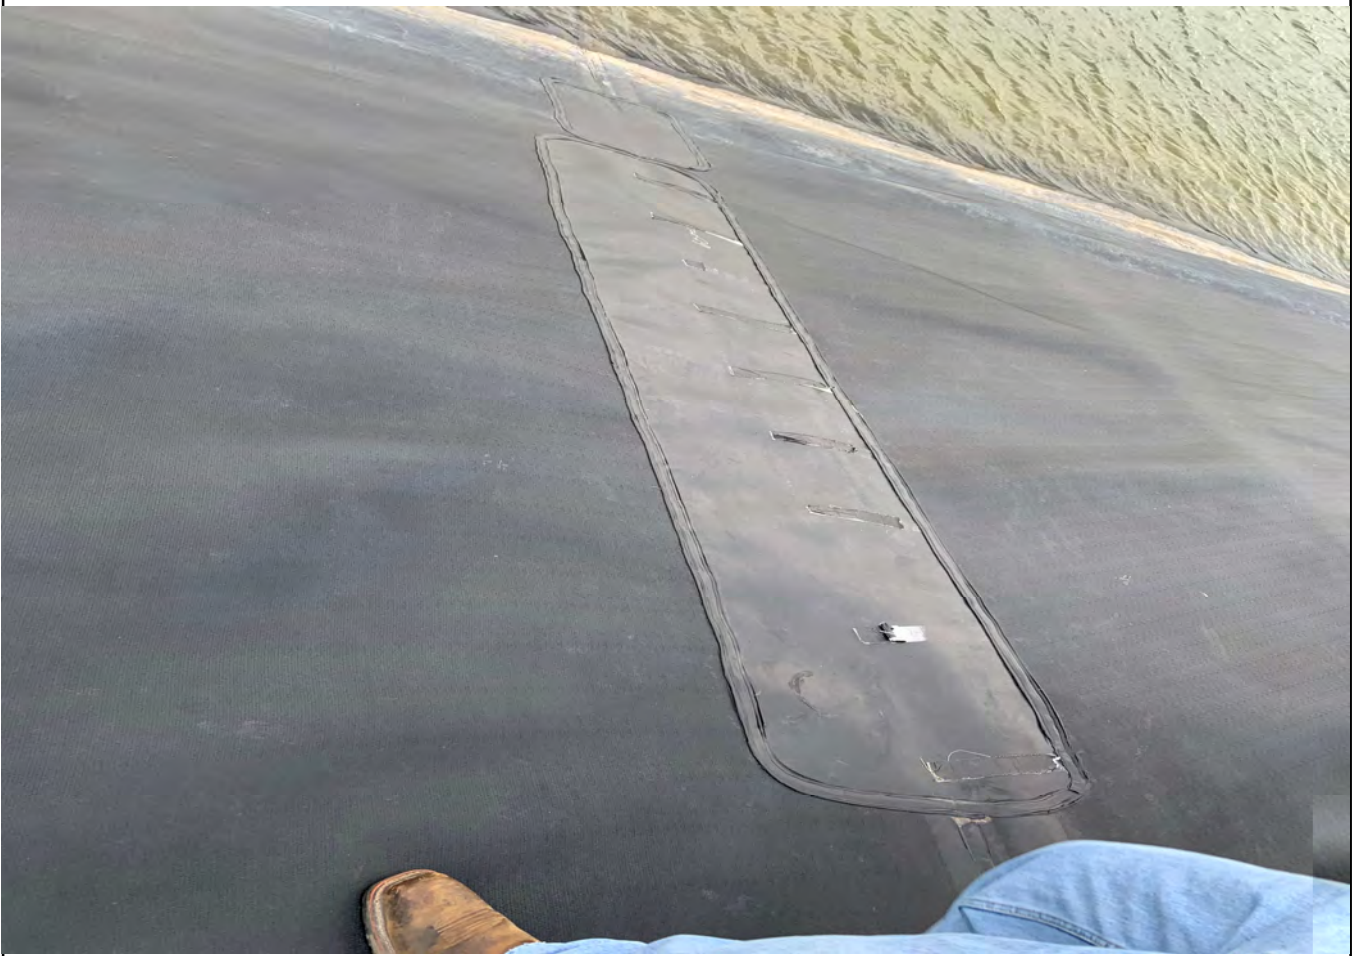
- Simbeck and Associates performed repairs on the geomembrane liner at the leachate evaporation pond on January 8, 2019. The repairs included fixing an approximately 10-foot-long tear in the geomembrane along a seam above the normal water operating level on the west side of the pond. The damage to the seam was first observed on January 2, 2019.

Photograph 11
Liner repair performed on leachate evaporation pond in 2019. (IMG_2034.JPG)
