2020 Annual Inspection Report

Gerald Gentleman Station Ash Disposal Facility

Nebraska Public Power District

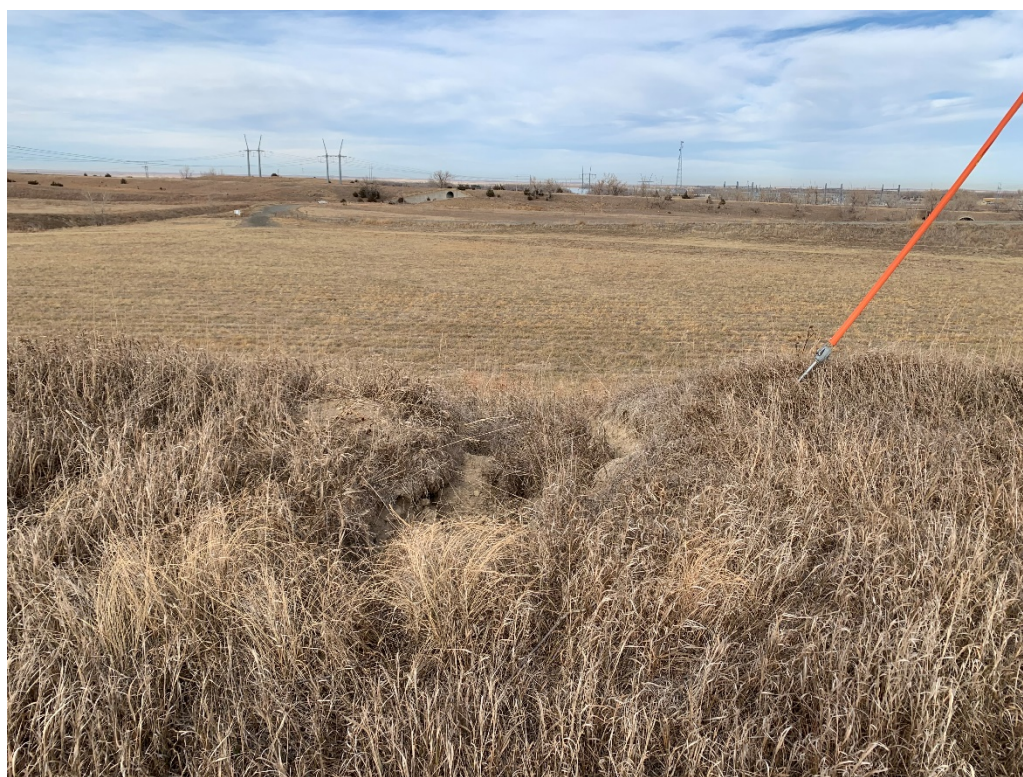
**PHOTO 2**

Minor erosion on crest of slope near southeast corner of closed Bottom Ash Landfill

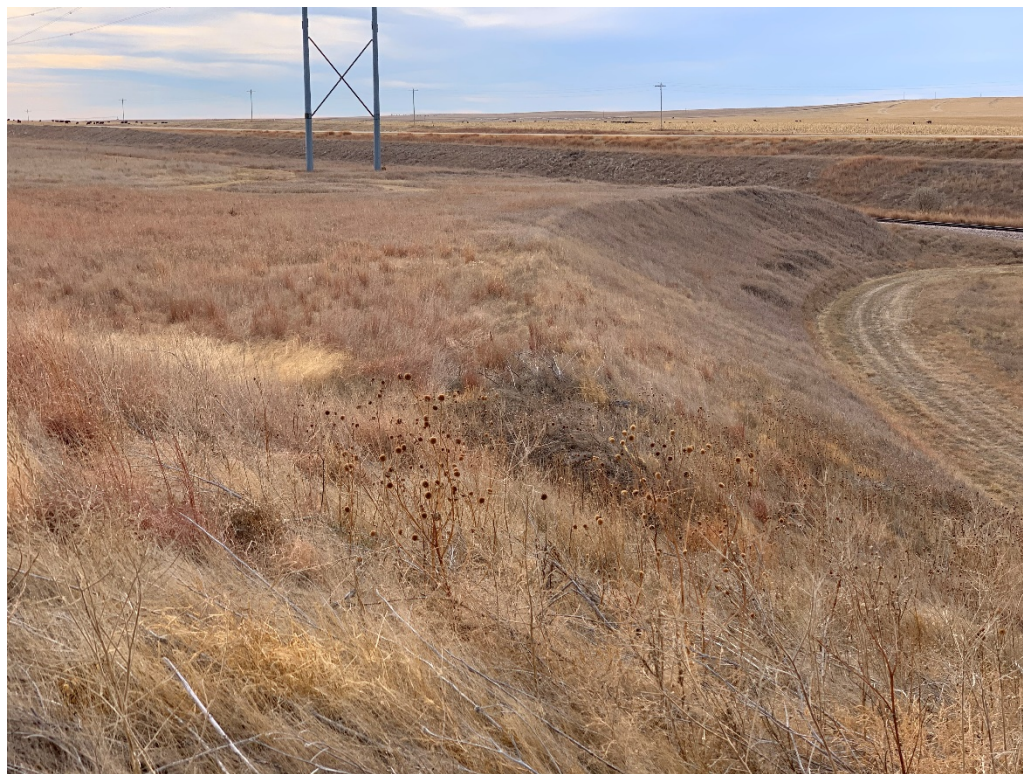
Ash Disposal Facility Annual Inspection, Gerald Gentleman Station**PHOTO 3**

Vegetative growth on the exterior slopes and final cover placed in 2015 appears to have struggled with the warm and dry weather in 2020. NPPD may consider irrigation of the exterior slopes if the vegetation does not rebound in 2021 to maintain vegetation capable of protecting the slopes from erosion.

Vegetation on west exterior slope of Ash Landfill No. 3.

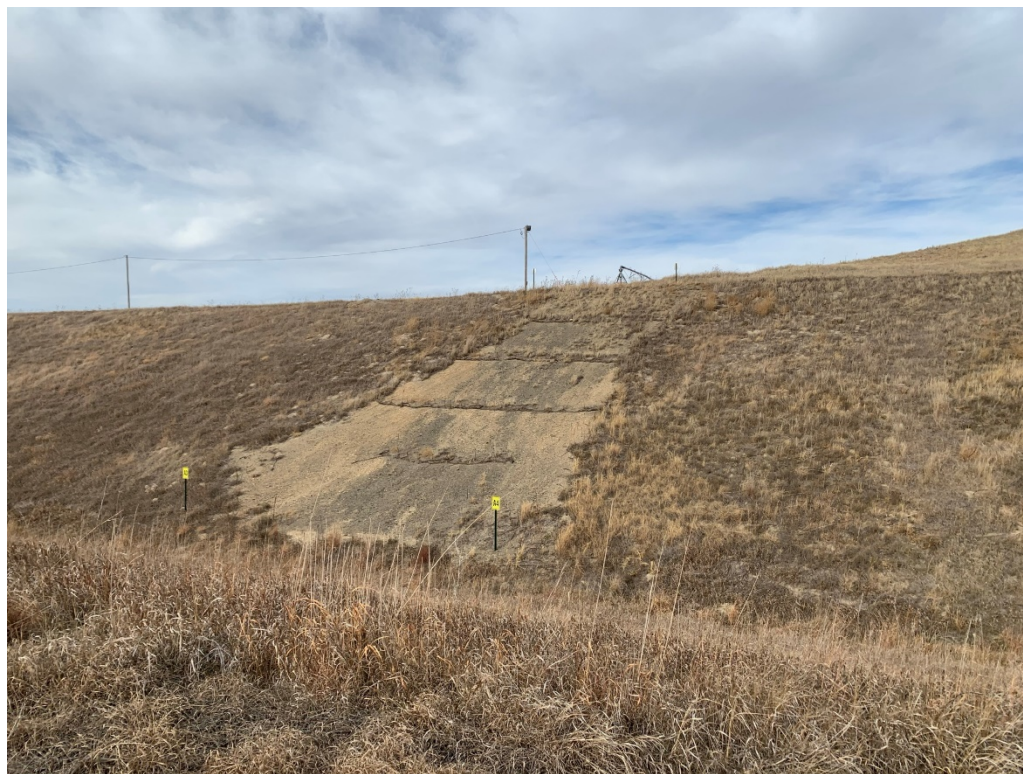
Ash Disposal Facility Annual Inspection, Gerald Gentleman Station**PHOTO 5**

Area of historical erosion needing revegetation

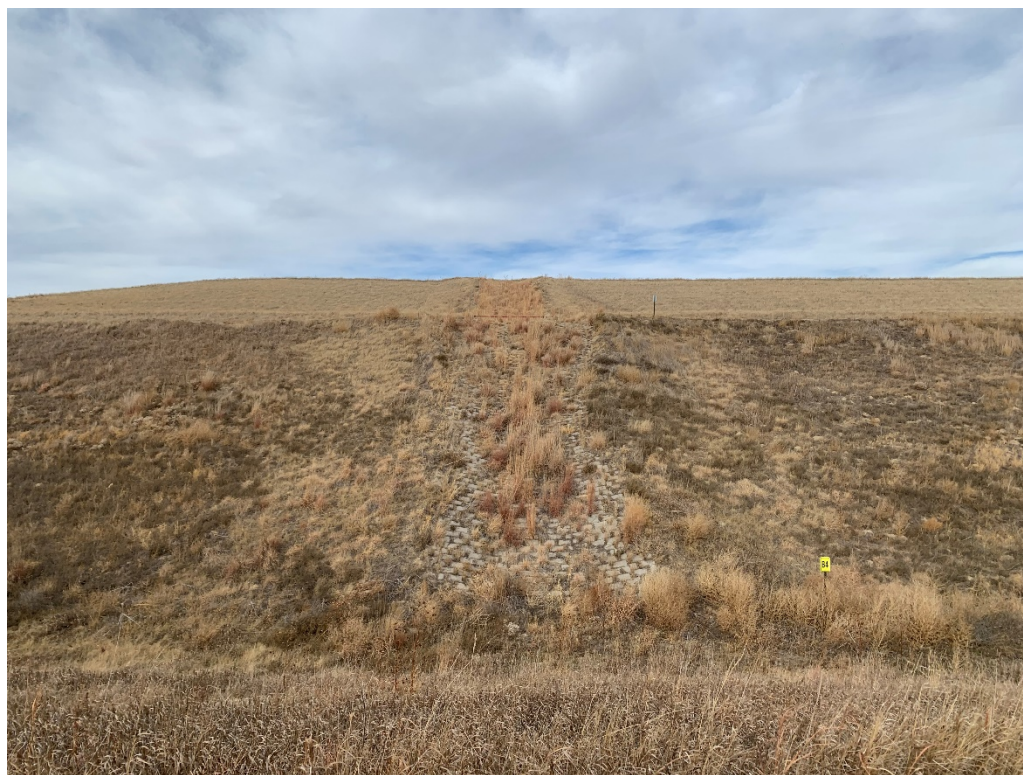
**PHOTO 6**

The terrace channels and downchute channel on the final cover appear to be functioning as designed.

Downchute channel on south side of Ash Landfill No. 4

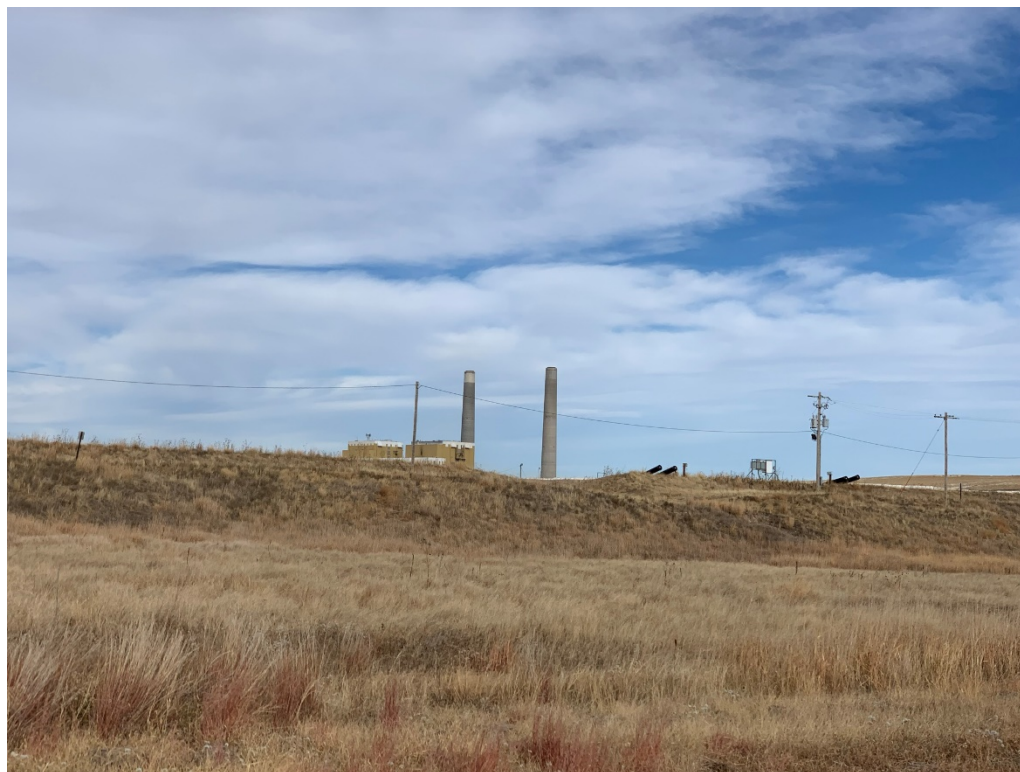
Ash Disposal Facility Annual Inspection, Gerald Gentleman Station**PHOTO 7**

Erosion was observed on the outer embankment slopes on the north, west, and south sides of Ash Landfill No. 3 and the south side of Ash Landfill No. 4. Erosion of the exterior slopes should be monitored and NPPD should continue to perform routine maintenance on the slopes. NPPD should address the areas on the south and west exterior slopes of Ash Landfill No. 3 that are frequently eroded so that appropriate surface water controls can be developed.

Southern exterior
slopes of Ash
Landfill No. 3

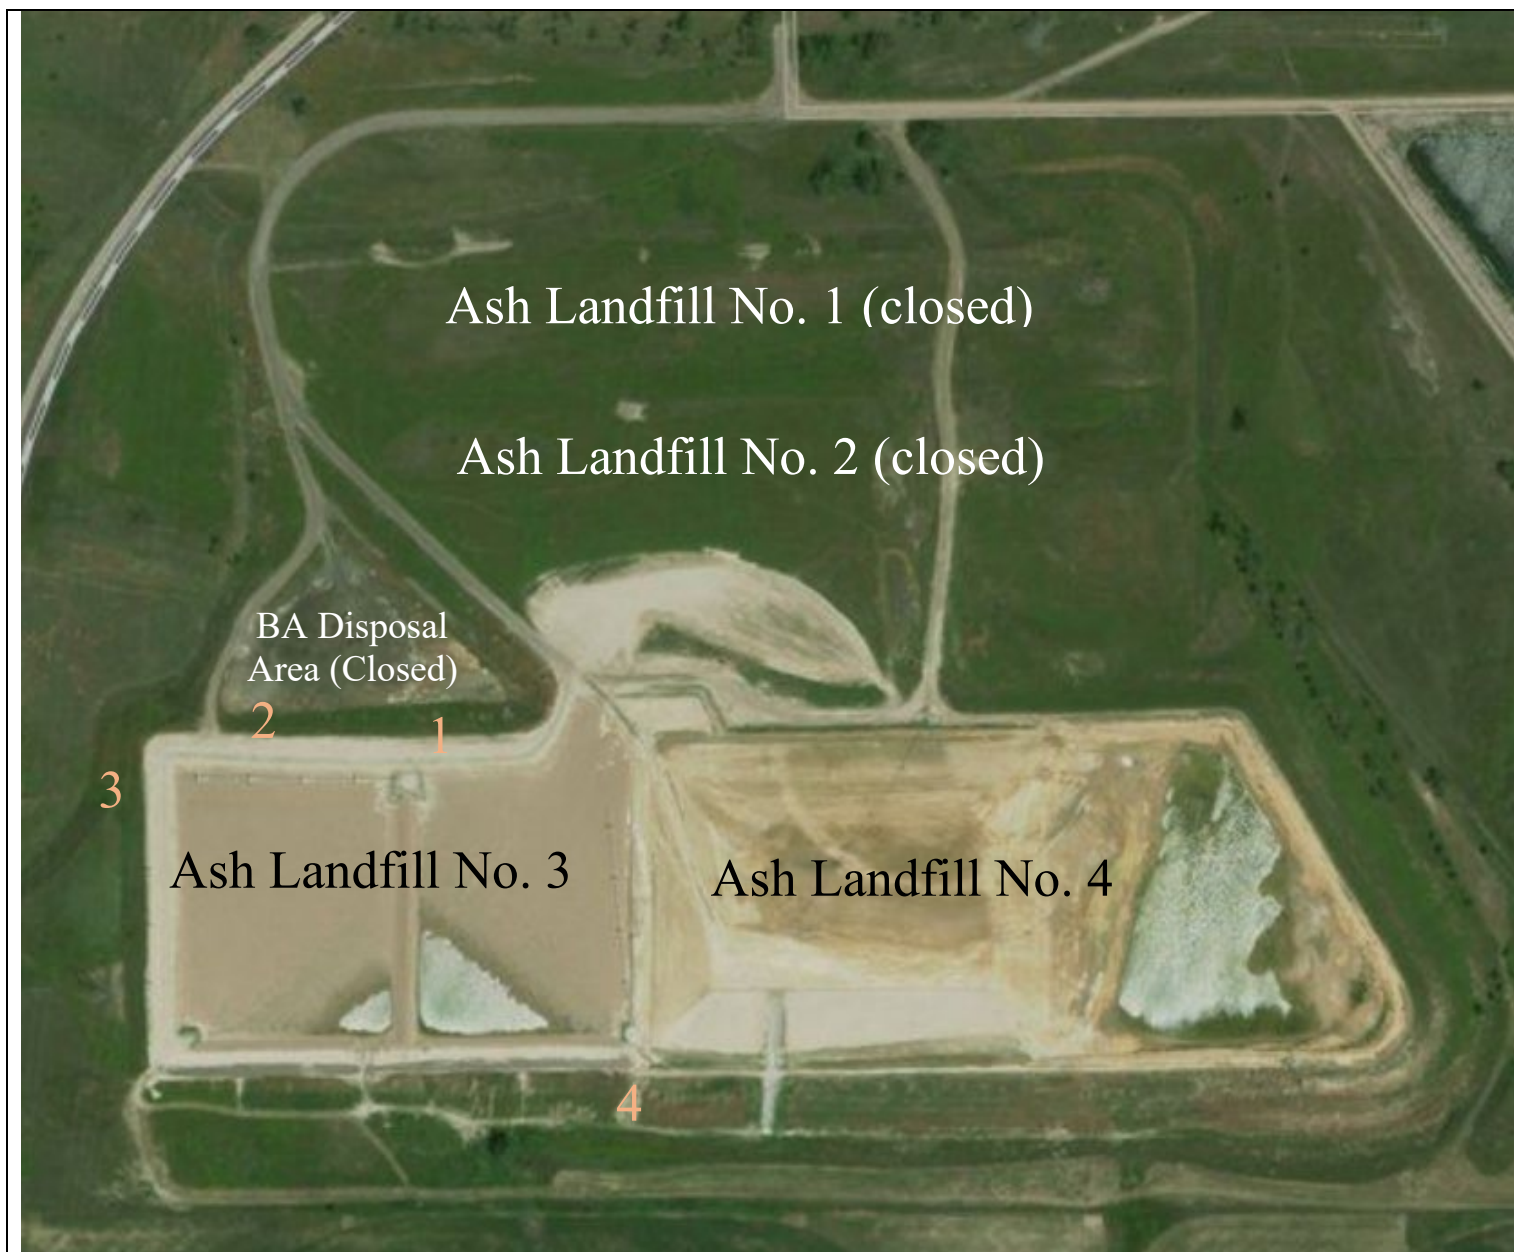
- 1 – Erosion
- 2 – Housekeeping
- 3 – Erosion
- 4 – Erosion
