# 2020 Annual Inspection Report

## *Sheldon Station Ash Landfill No. 4*

**Nebraska Public Power District**

**Golder Associates Inc.**

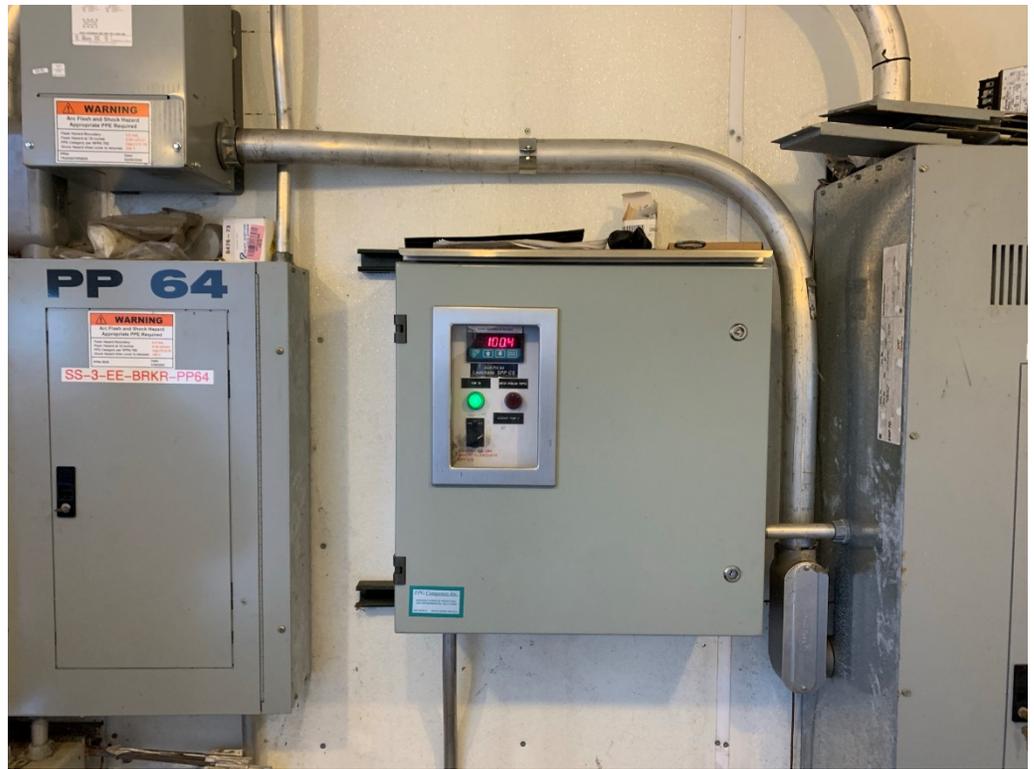
**PHOTO 1**

Control building for underdrain and sump pumps

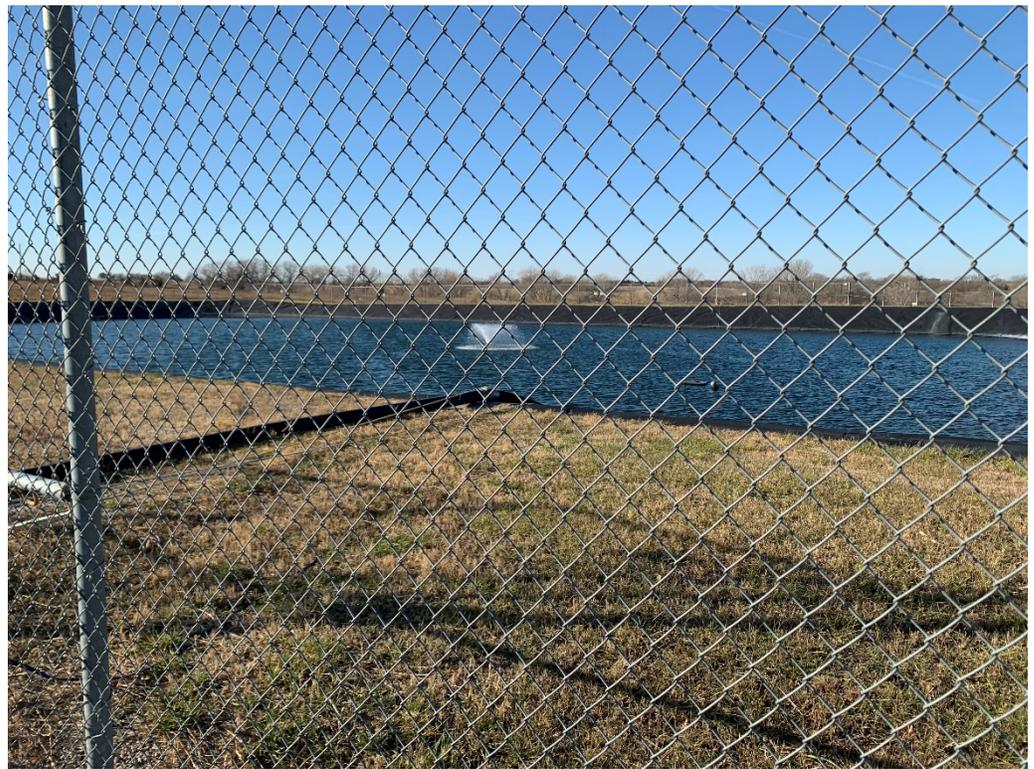
**PHOTO 2**

In March 2012, an aerator was installed in the Evaporation Pond to increase evaporation of contact water. A bubbler was installed during the fall of 2012. The bubbler helps prevent water in the Evaporation Pond from freezing so that the contact water can be used year-round for dust suppression within the lined landfill footprint.

Bubble aerator in contact water evaporation pond

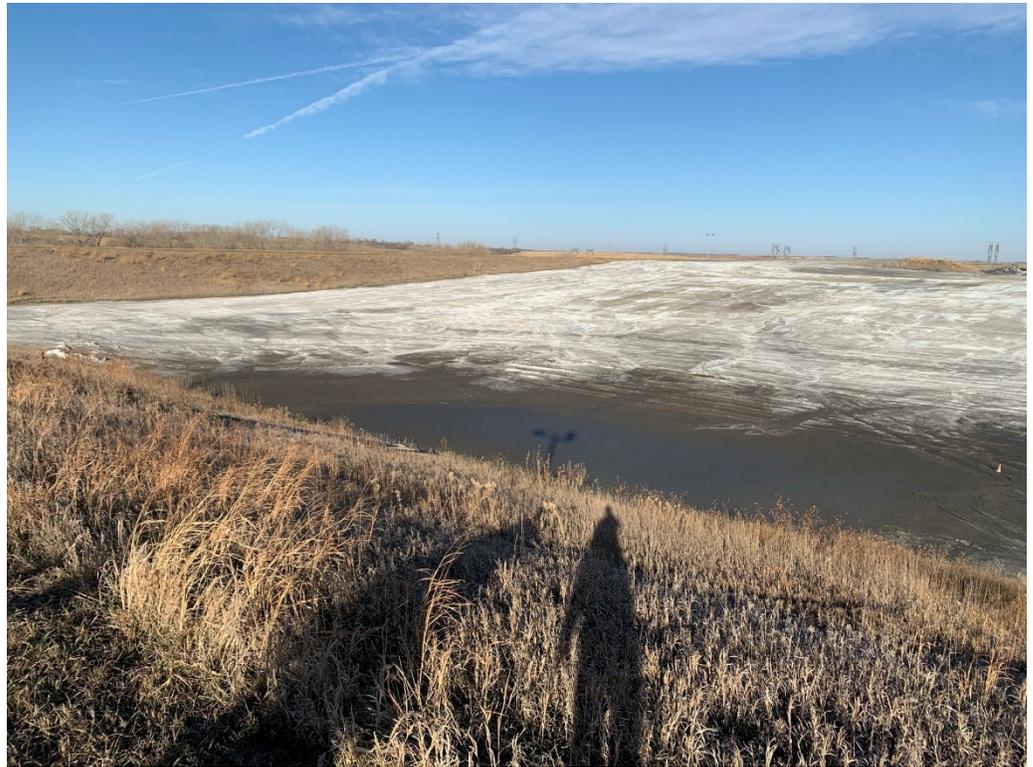
**PHOTO 3**

Contact water pond on south side of ash disposal facility

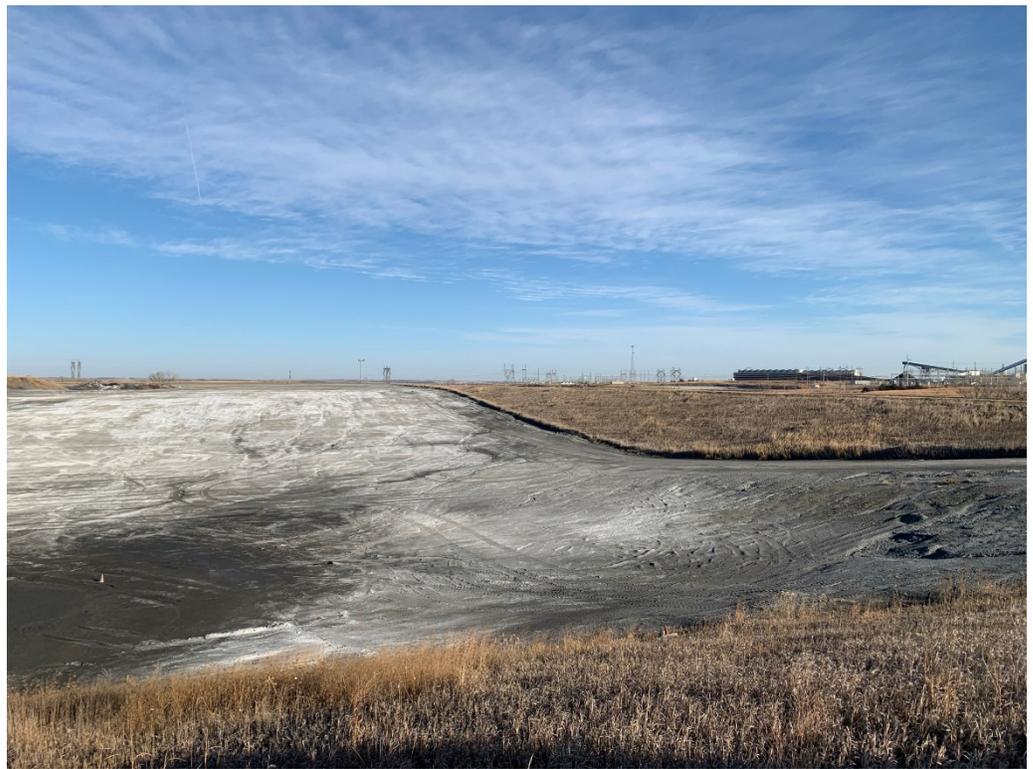
**PHOTO 4**

Access road into ash disposal facility

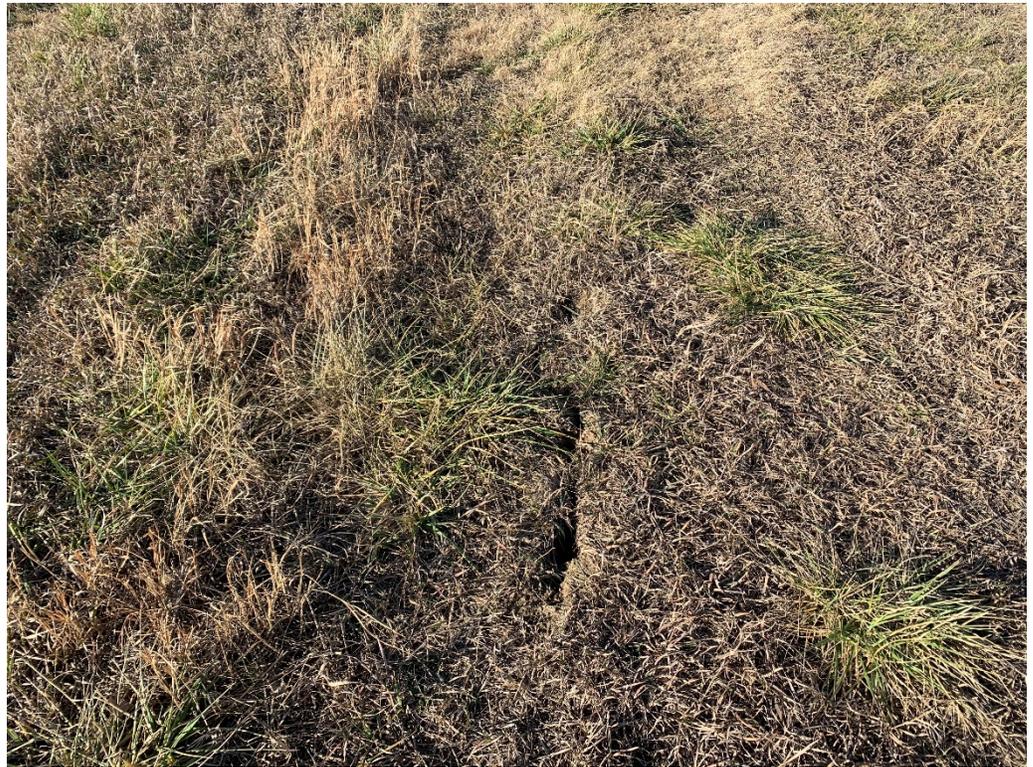
**PHOTO 5**

Surficial cracks were observed in the perimeter road around the crest of the facility embankment during the annual inspection. Cracks were observed in multiple locations around the perimeter, as large as approximately one inch wide. The cracking was not observed to be more than a few inches deep with no accompanying displacement and is likely due to warm and dry conditions desiccating the surface soils. NPPD should continue to closely monitor the cracking and report to Golder immediately if the cracks change in size or additional cracks appear or displacement is observed.

Crack in perimeter road along embankment top

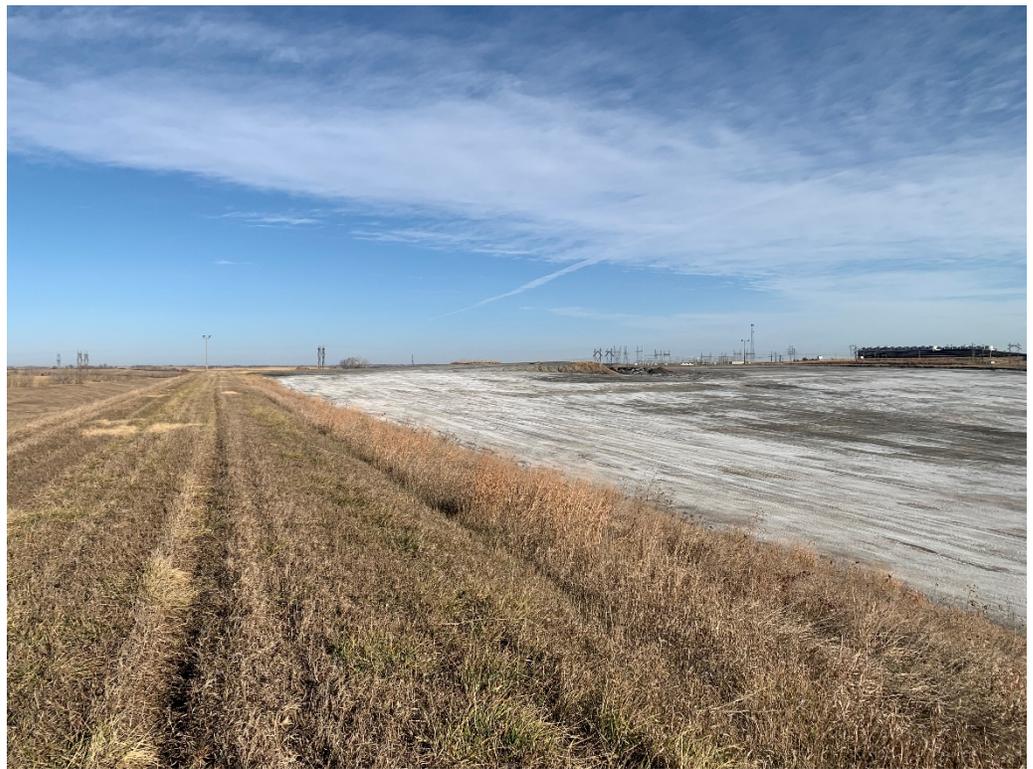
**PHOTO 6**

Perimeter access road

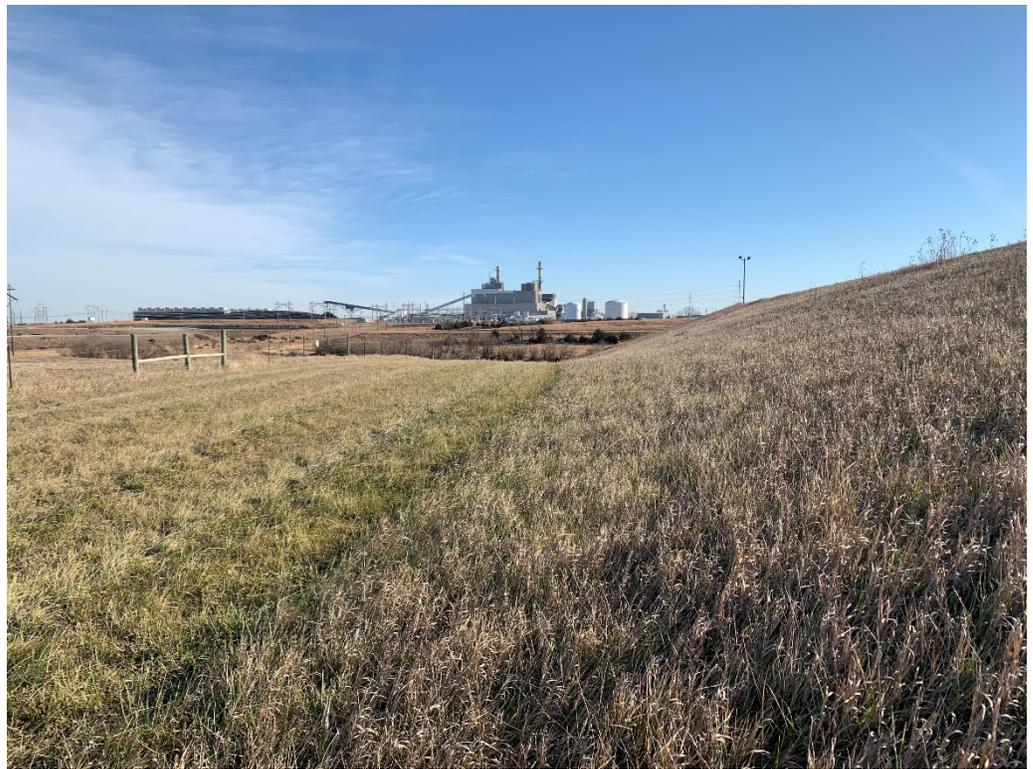
**PHOTO 7**

Northern exterior slope of ash disposal facility

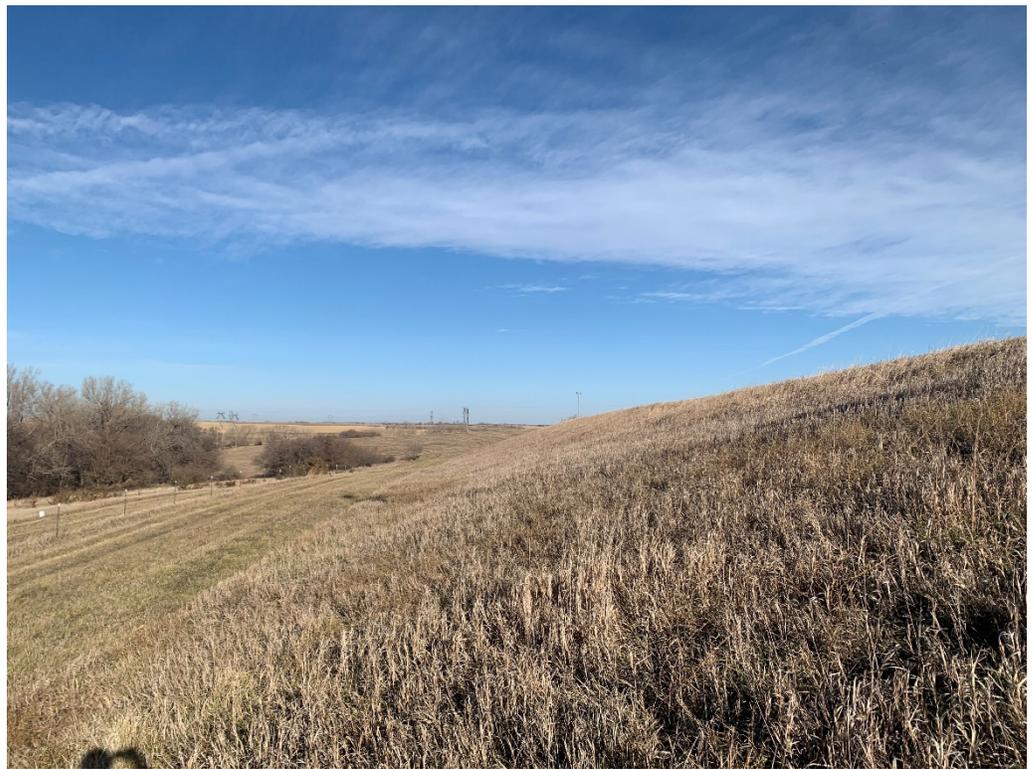
**PHOTO 8**

Western exterior slope of ash disposal facility

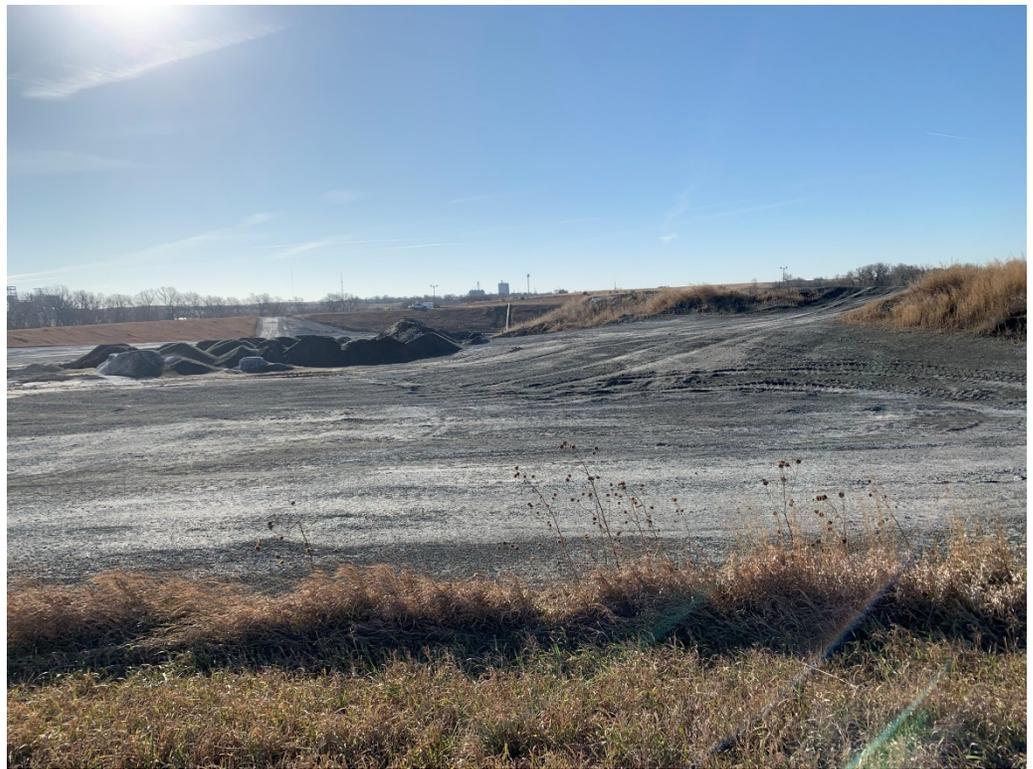
**PHOTO 9**

Active ash placement area

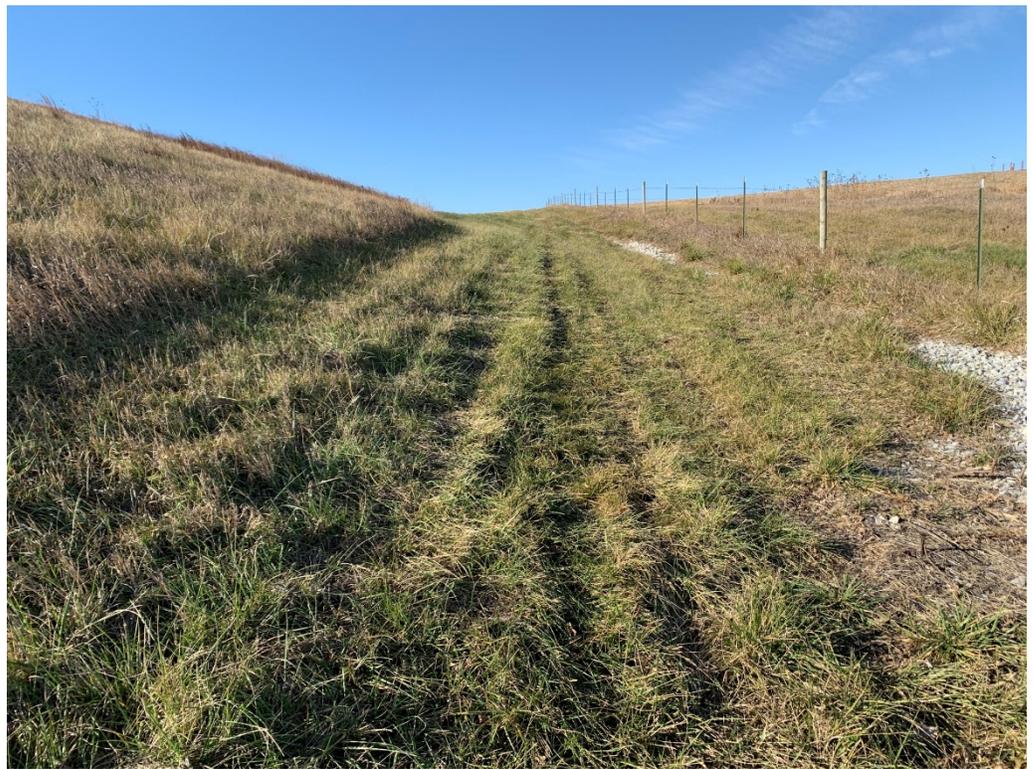
**PHOTO 10**

Exterior slope on north side of ash disposal facility

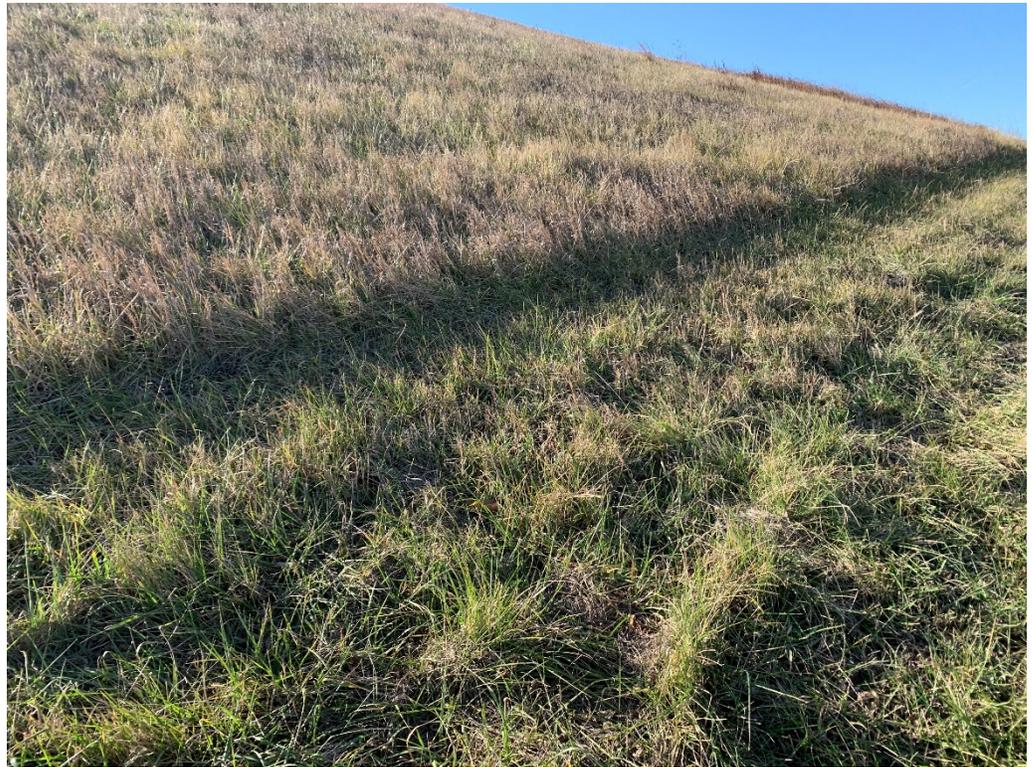
**PHOTO 11**

In reviewing the weekly inspection reports, NPPD noted that during the spring thaw apparent seepage was observed from the exterior perimeter road in the northeast corner of the facility. The water was suspected to be surface water infiltration and frost melt following the high-permeability surface gravel and daylighting in this area (and not indicative of seepage from ash disposal facility). No signs of seepage were observed during the annual inspection on November 19, 2020. Vegetation in this area was indistinguishable from the surrounding areas and no signs of instability were observed. NPPD should continue to monitor this area during weekly inspections and notify Golder if any changes are observed.

Area of seepage observed by NPPD in March 2020

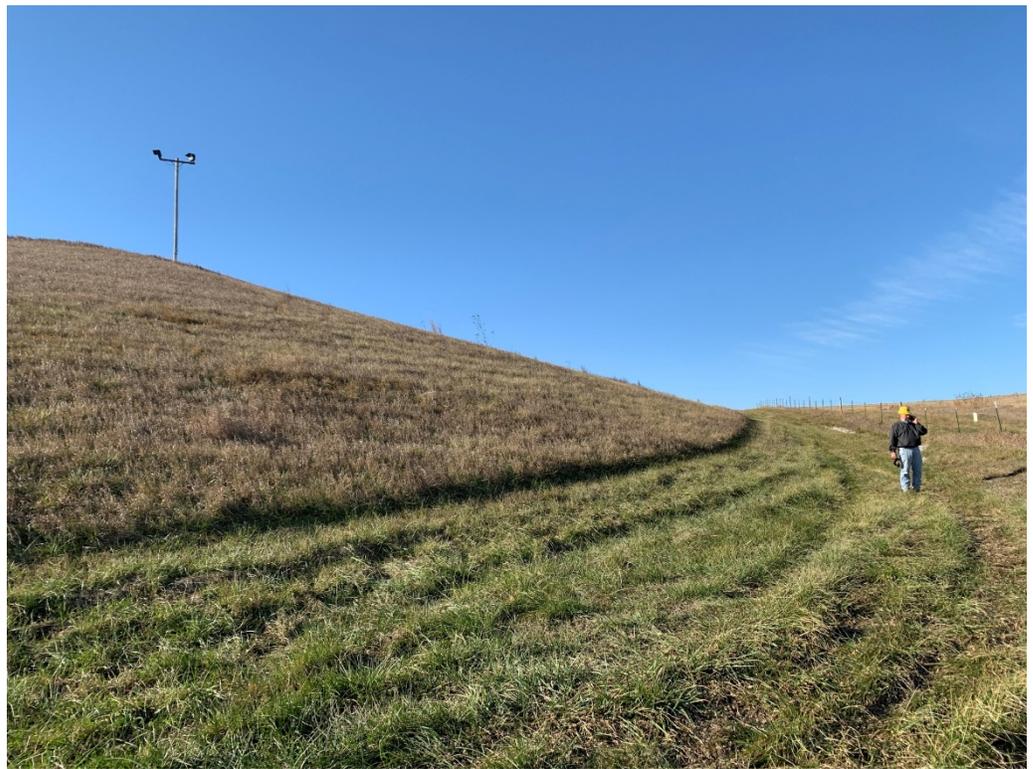
**PHOTO 12**

Minor erosional rills have been observed near the toe of the exterior slopes in the northeast corner and north side of the facility during previous inspections. NPPD has repaired these areas and backfilled the erosion rills with crushed rock. Vegetation has generally been established in the repaired areas, and significant erosion was not observed on the exterior slopes. NPPD should continue to monitor the exterior slopes and perimeter roads of the disposal facility for erosion, both during weekly inspections and after large rain events, making repairs, as necessary.

Exterior slope in northeast corner of ash disposal facility

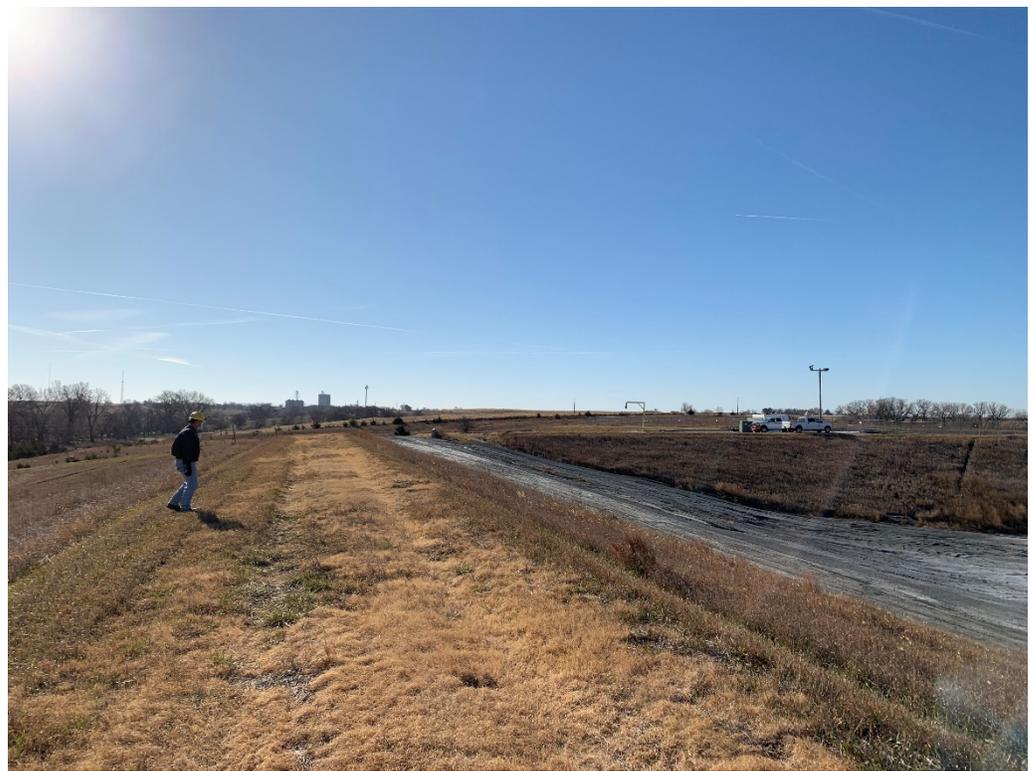
**PHOTO 13**

Perimeter road on east embankment crest

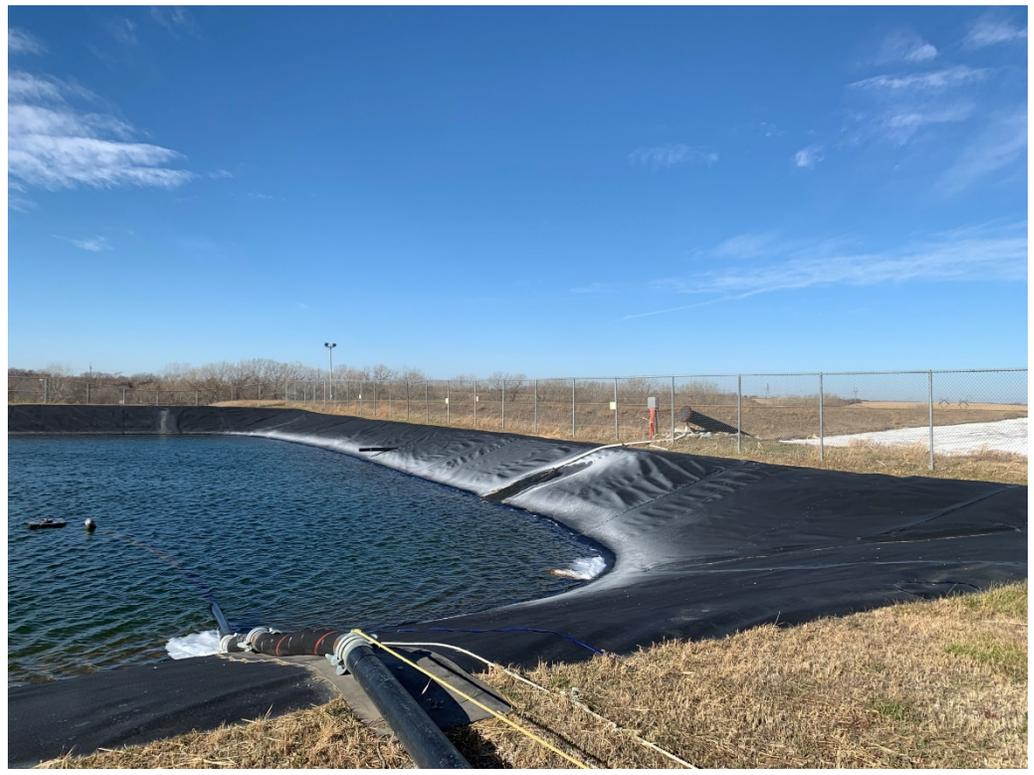
**PHOTO 14**

Contact water management pond
