# 2022 Annual Inspection Report

## *Gerald Gentleman Station Ash Disposal Facility*

### **Nebraska Public Power District**

20149028-7-R-0

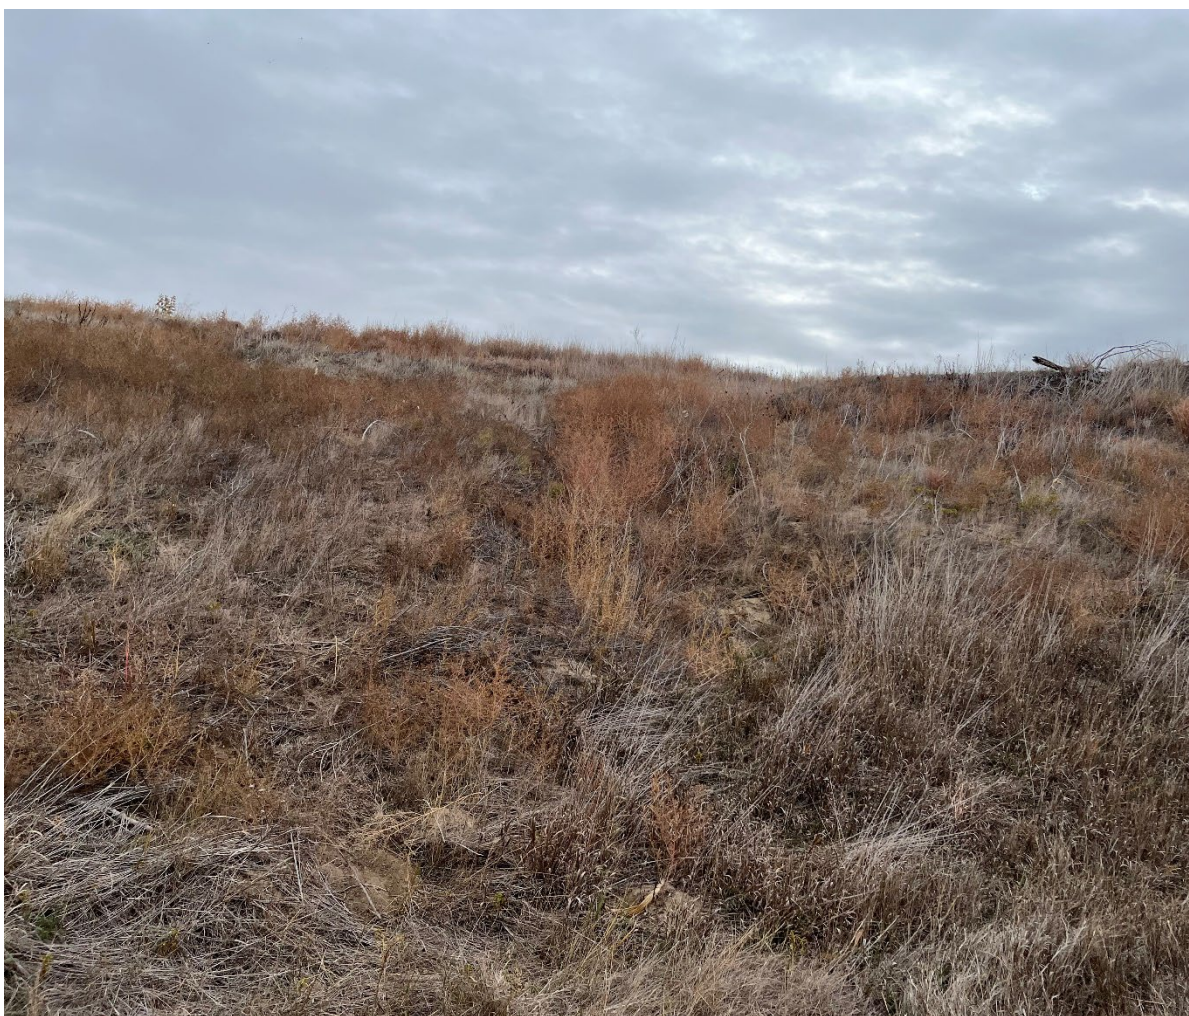
### PHOTO 1

Erosion was observed on the outer embankment slopes on the north, west, and south sides of Ash Landfill No. 3 and the south side of Ash Landfill No. 4. Erosion of the exterior slopes should be monitored and NPPD should continue to perform routine maintenance on the slopes. NPPD should address the areas on the south and west exterior slopes of Ash Landfill No. 3 and south side of Ash Landfill No. 4 that are frequently eroded so that appropriate surface water controls can be developed.

Erosion on  
outer  
slope east  
of Ash  
Landfill  
No. 3

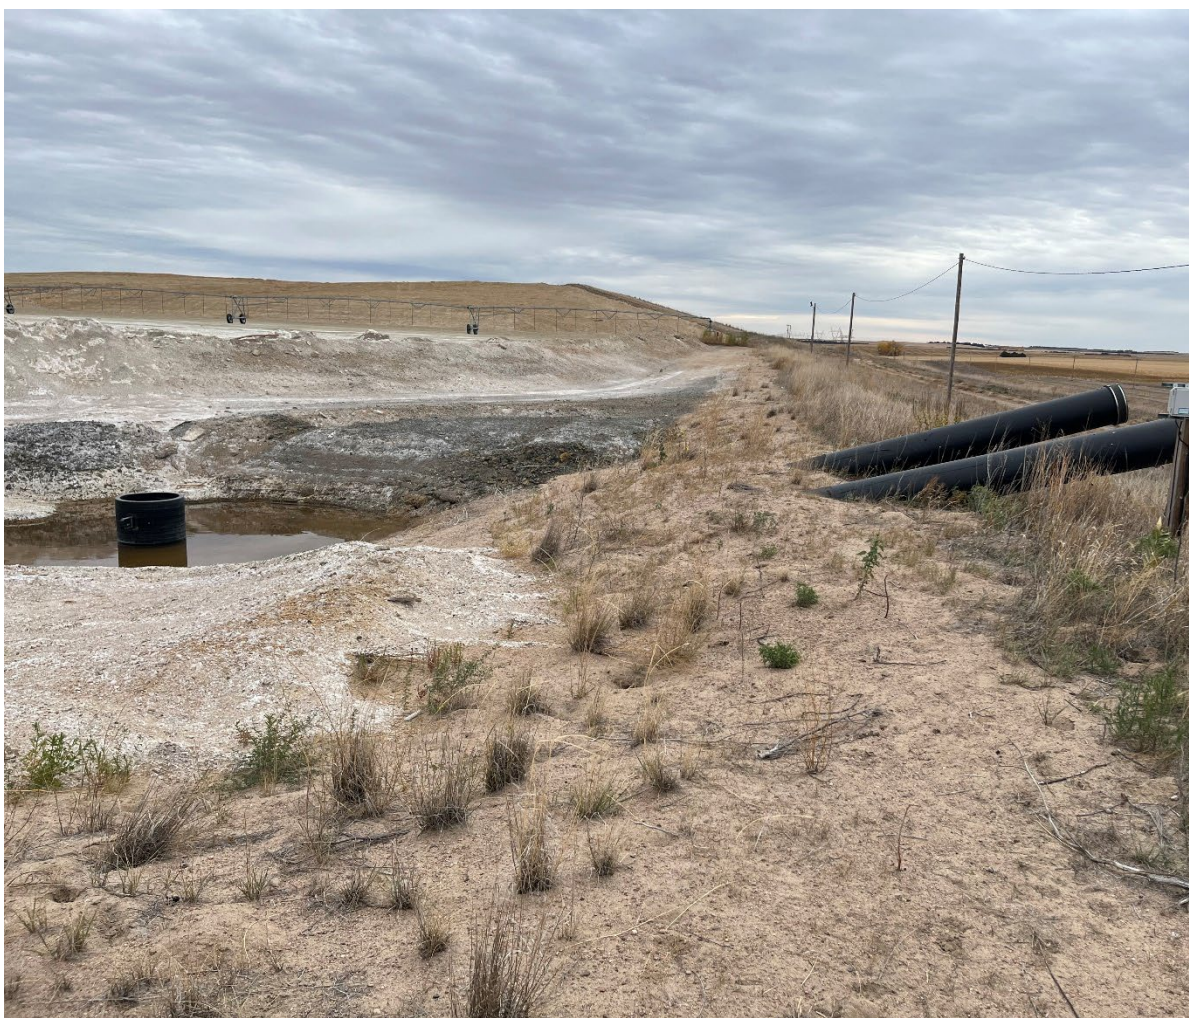
**Ash Disposal Facility Annual Inspection, Gerald Gentleman Station****PHOTO 2**

Leachate  
sump in  
east cell of  
Ash  
Landfill  
No. 3

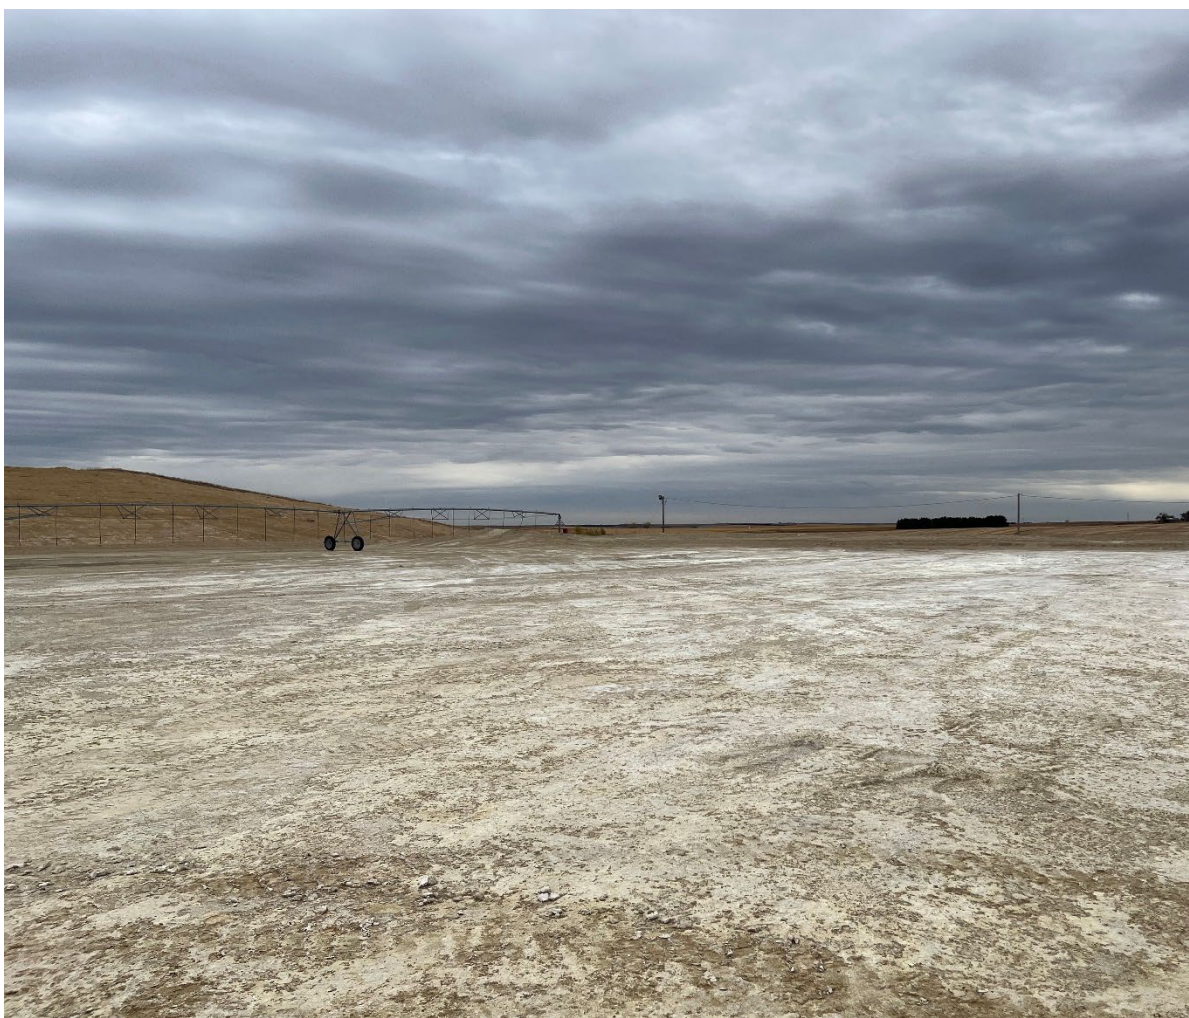
**Ash Disposal Facility Annual Inspection, Gerald Gentleman Station****PHOTO 3**

Ash deposition on east side of Ash Landfill No. 3.

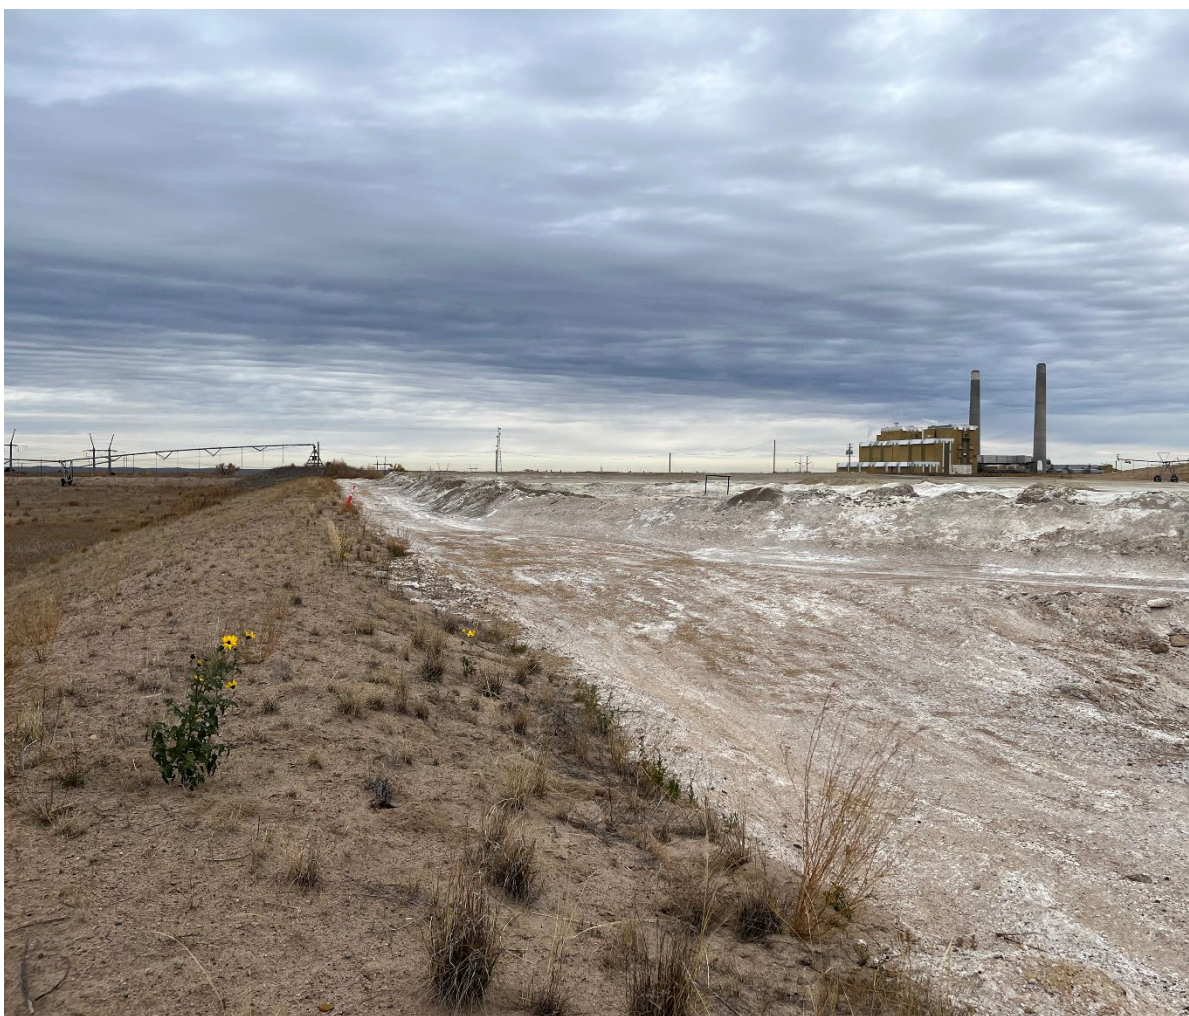
**Ash Disposal Facility Annual Inspection, Gerald Gentleman Station****PHOTO 4**

Ash  
deposition  
on east  
side of  
Ash  
Landfill  
No. 3

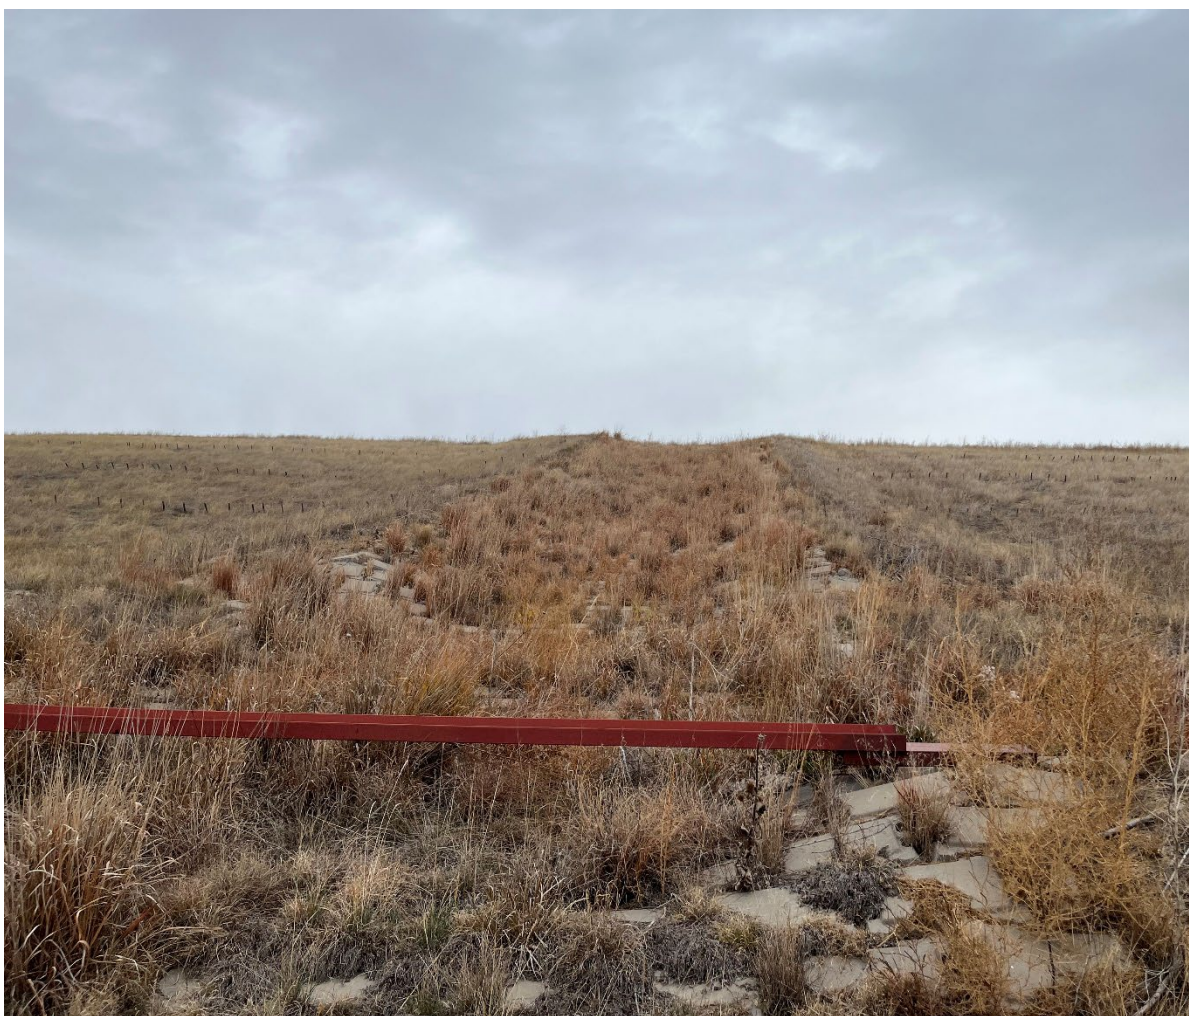
**Ash Disposal Facility Annual Inspection, Gerald Gentleman Station****PHOTO 5**

The terrace channels and downchute channel on the final cover appear to be functioning as designed.

Down-  
chute  
channel  
on south  
side of  
Ash  
Landfill  
No. 4

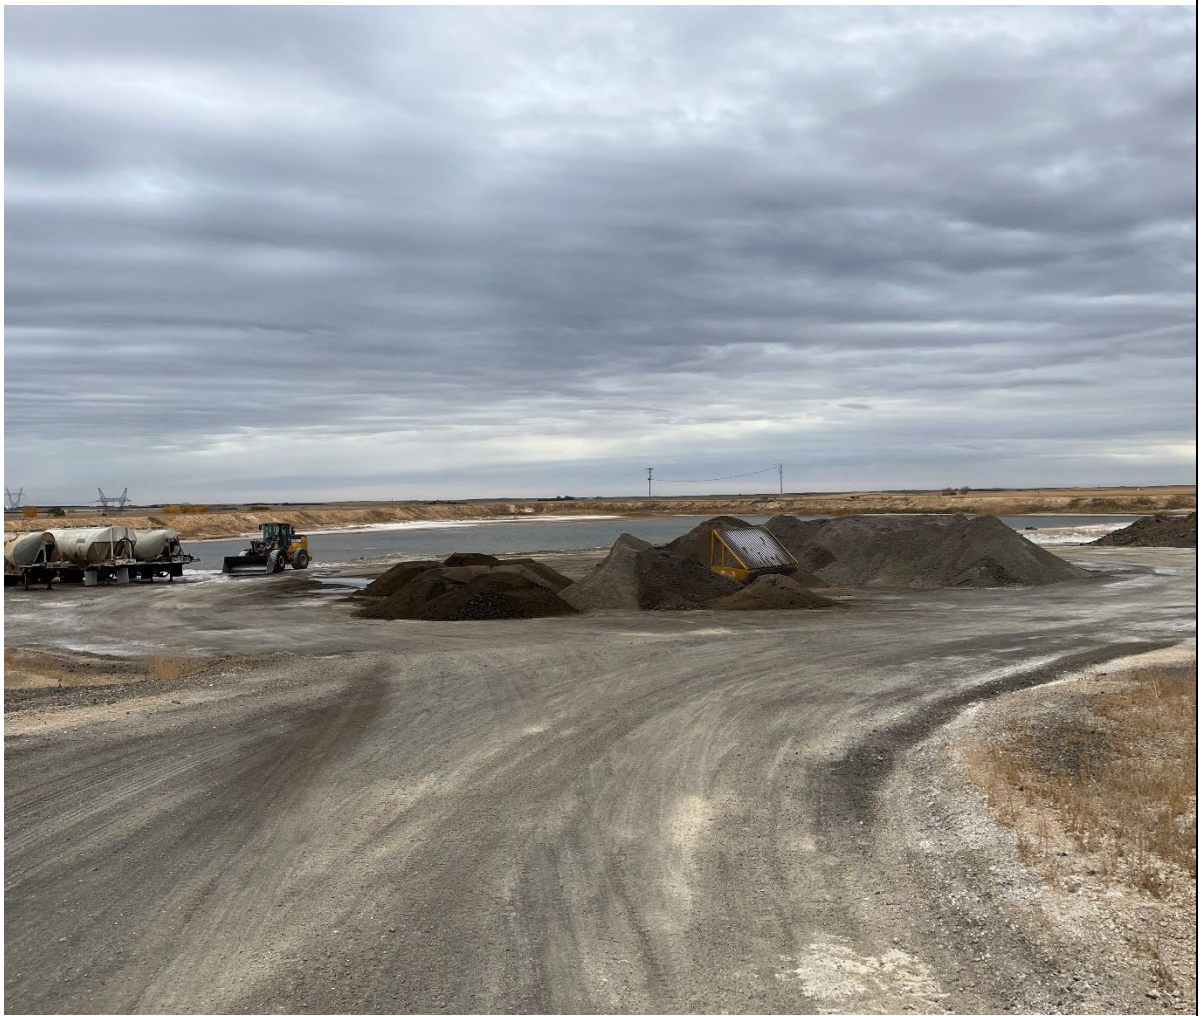
**Ash Disposal Facility Annual Inspection, Gerald Gentleman Station****PHOTO 6**

Bottom  
ash  
handling  
area

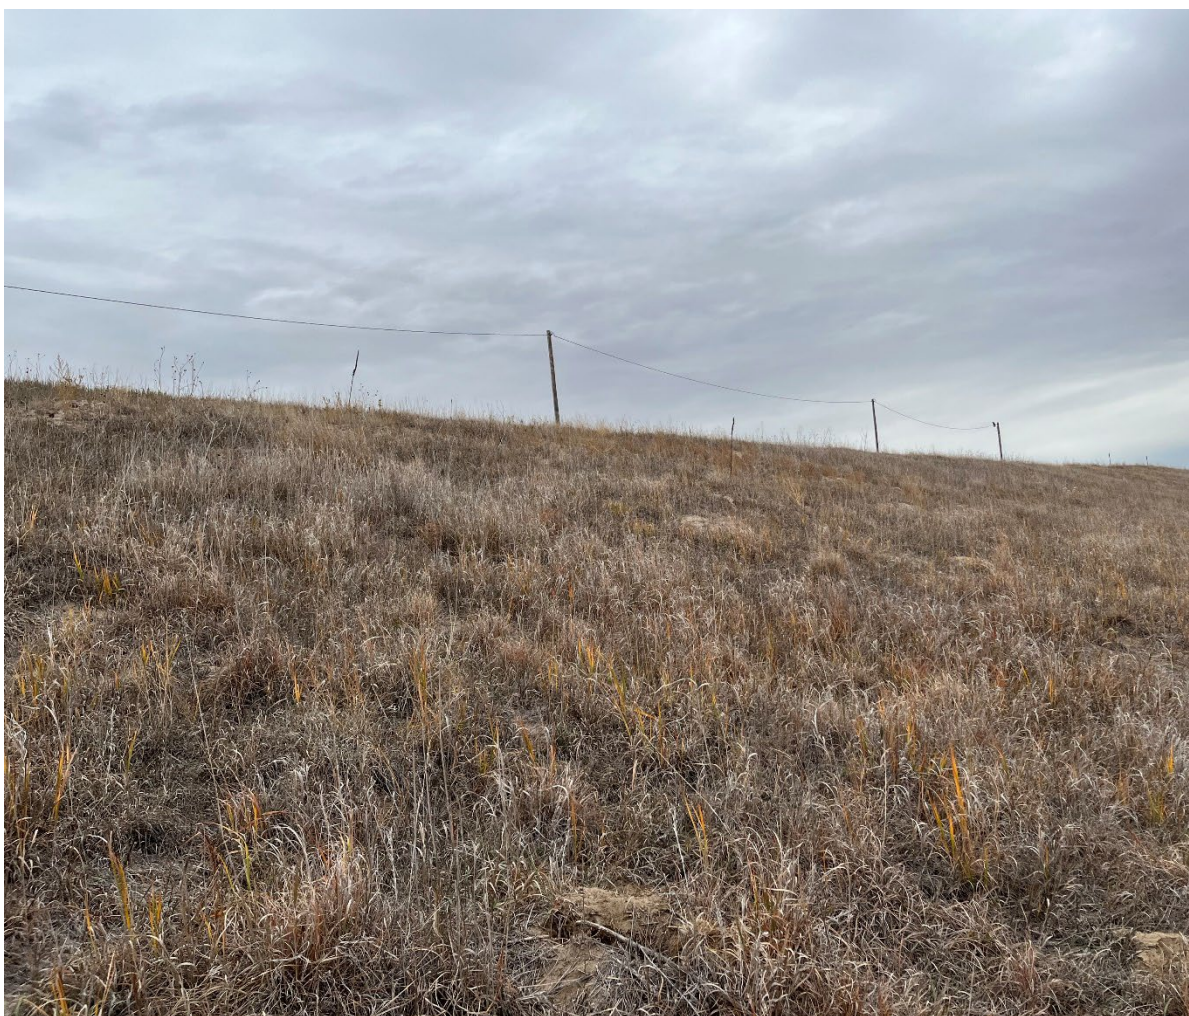
### PHOTO 7

Southern  
exterior  
slopes of  
Ash  
Landfill  
No. 3

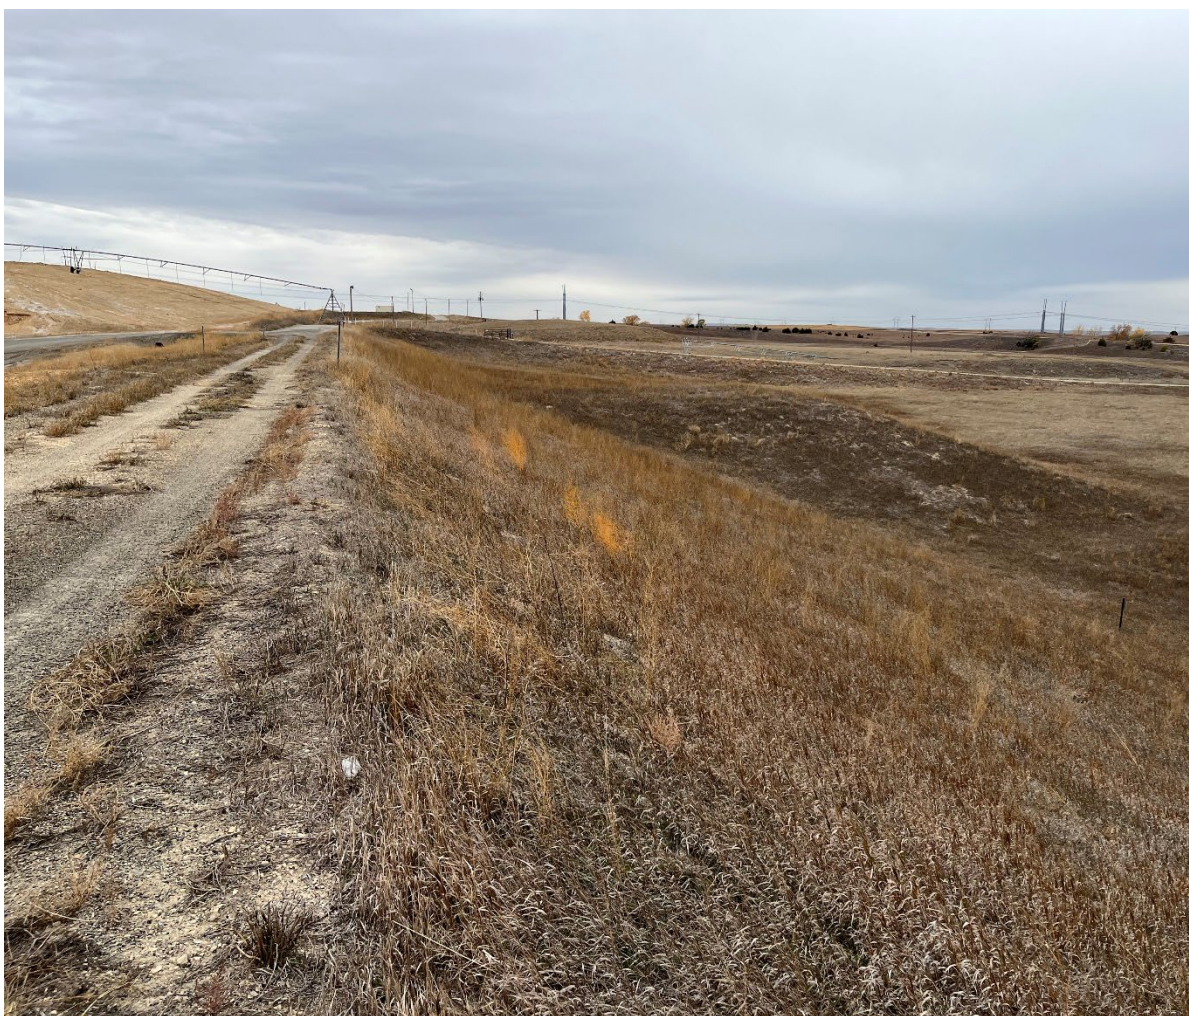
**Ash Disposal Facility Annual Inspection, Gerald Gentleman Station****PHOTO 8**

Access road and exterior slope on north side of Ash Landfill No. 4
