2022 Annual Inspection Report

Sheldon Station Ash Landfill No. 4

Nebraska Public Power District

20149025-7-R-0

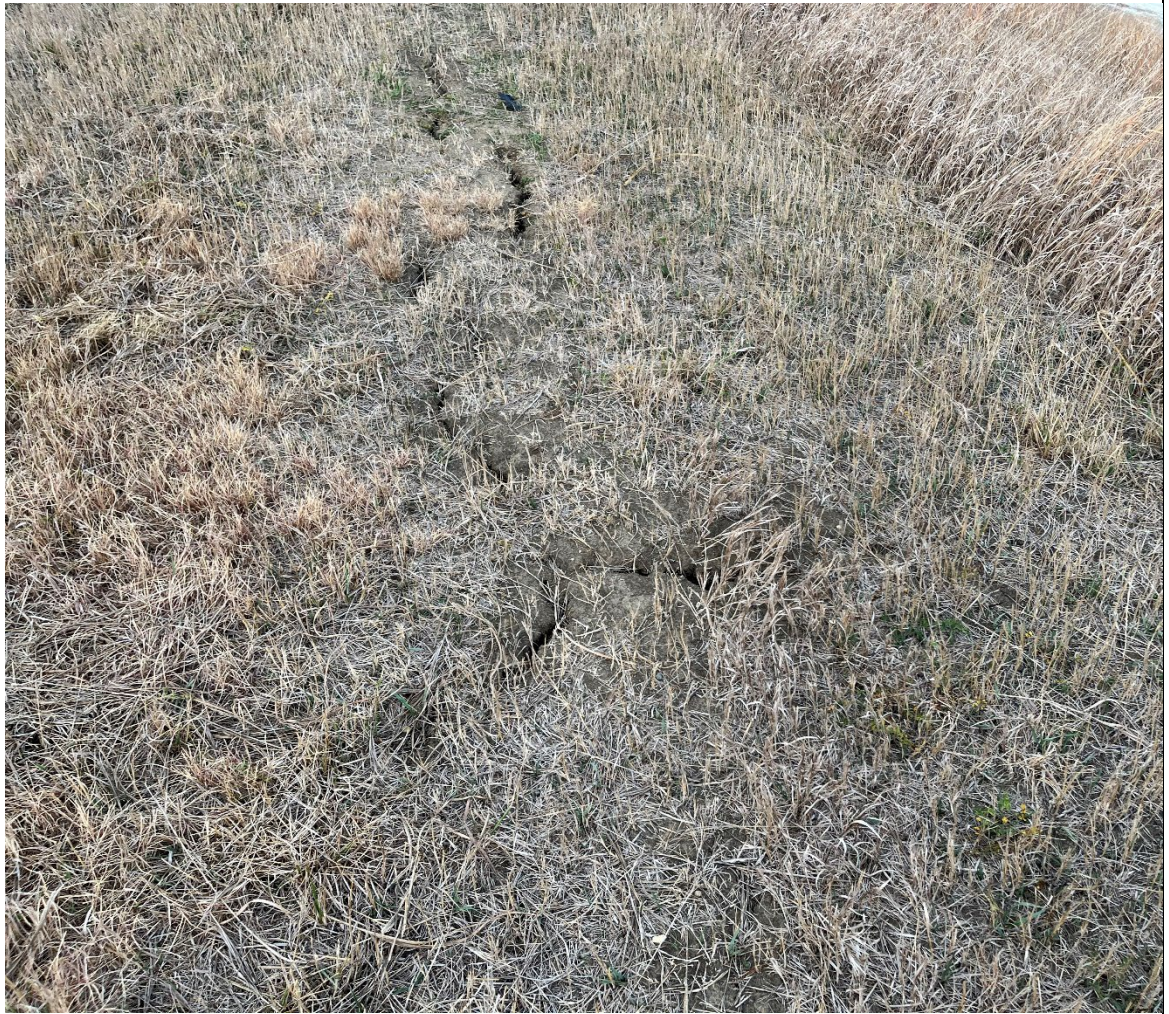
Ash Disposal Facility Annual Inspection, Sheldon Station**PHOTO 1**

Surficial cracks have been observed in the perimeter road around the crest of the facility embankment during previous annual inspections. The cracking was observed to be significantly more widespread during the site inspection on November 3, 2022. Cracks were observed along significant stretches of the embankment crest, both along the interior and exterior, especially on the south, east, and west sides of the facility. Cracks were also

observed on the exterior embankment slopes, particularly near the downchute channels. The cracks were as large as approximately two inches wide and more than eighteen inches deep in several locations. The cracking was not continuous, but there were areas with cracks as long as approximately 12 feet. The cracks were generally parallel with the crest, but in several locations, cracking perpendicular to the crest was also observed. No signs of bulking or slope movement were observed along the surface or toe of interior or exterior slopes. The cracking may be due to drought conditions desiccating the surface soils. NPPD should fill the cracks with soil and continue to closely monitor the cracking and report to Golder immediately if the cracks reappear or change in size, or if additional cracks appear or displacement is observed.

Crack
observed
on south
embankm
ent crest

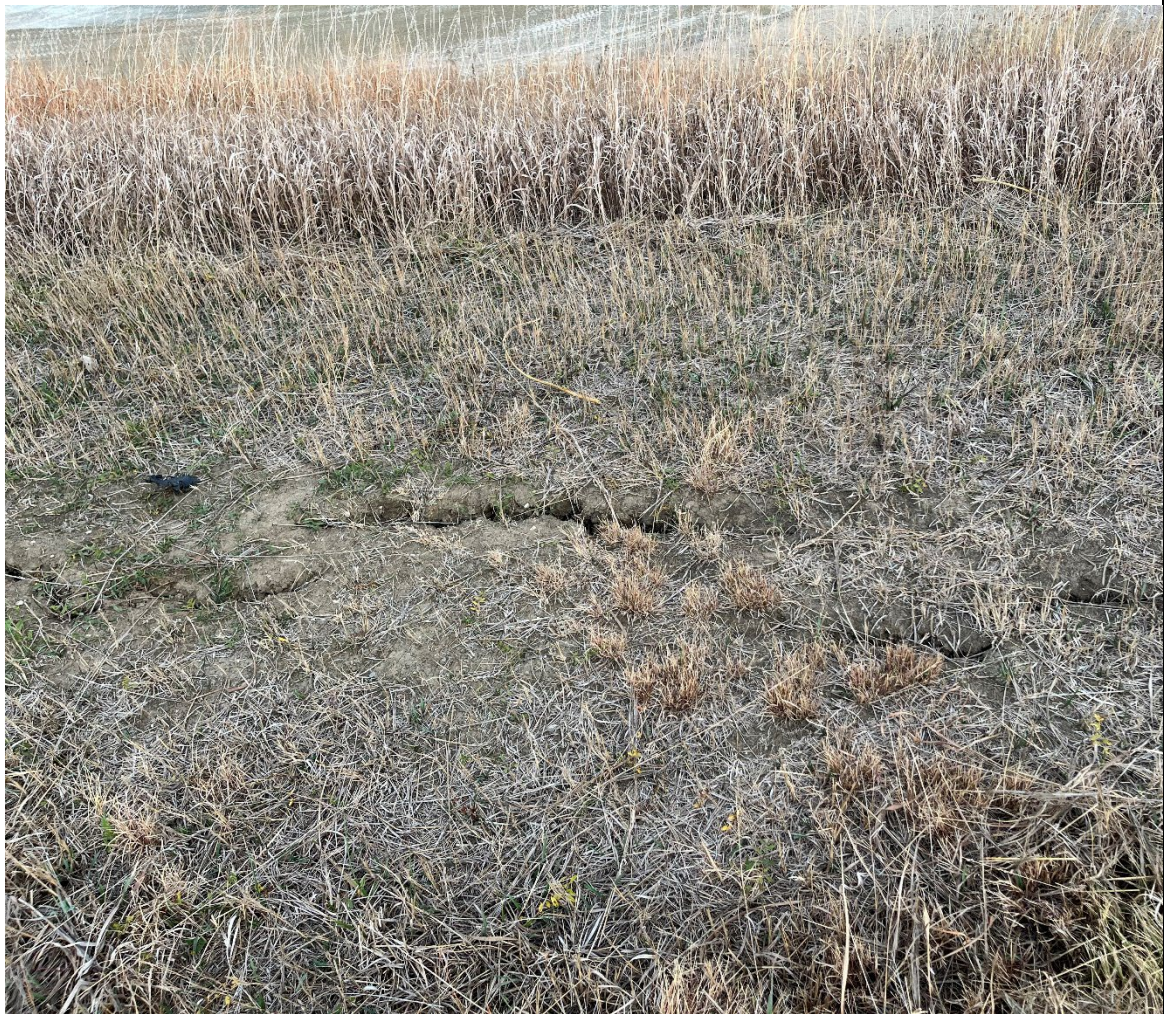
Ash Disposal Facility Annual Inspection, Sheldon Station**PHOTO 2**

Crack
observed
on south
embankm
ent crest

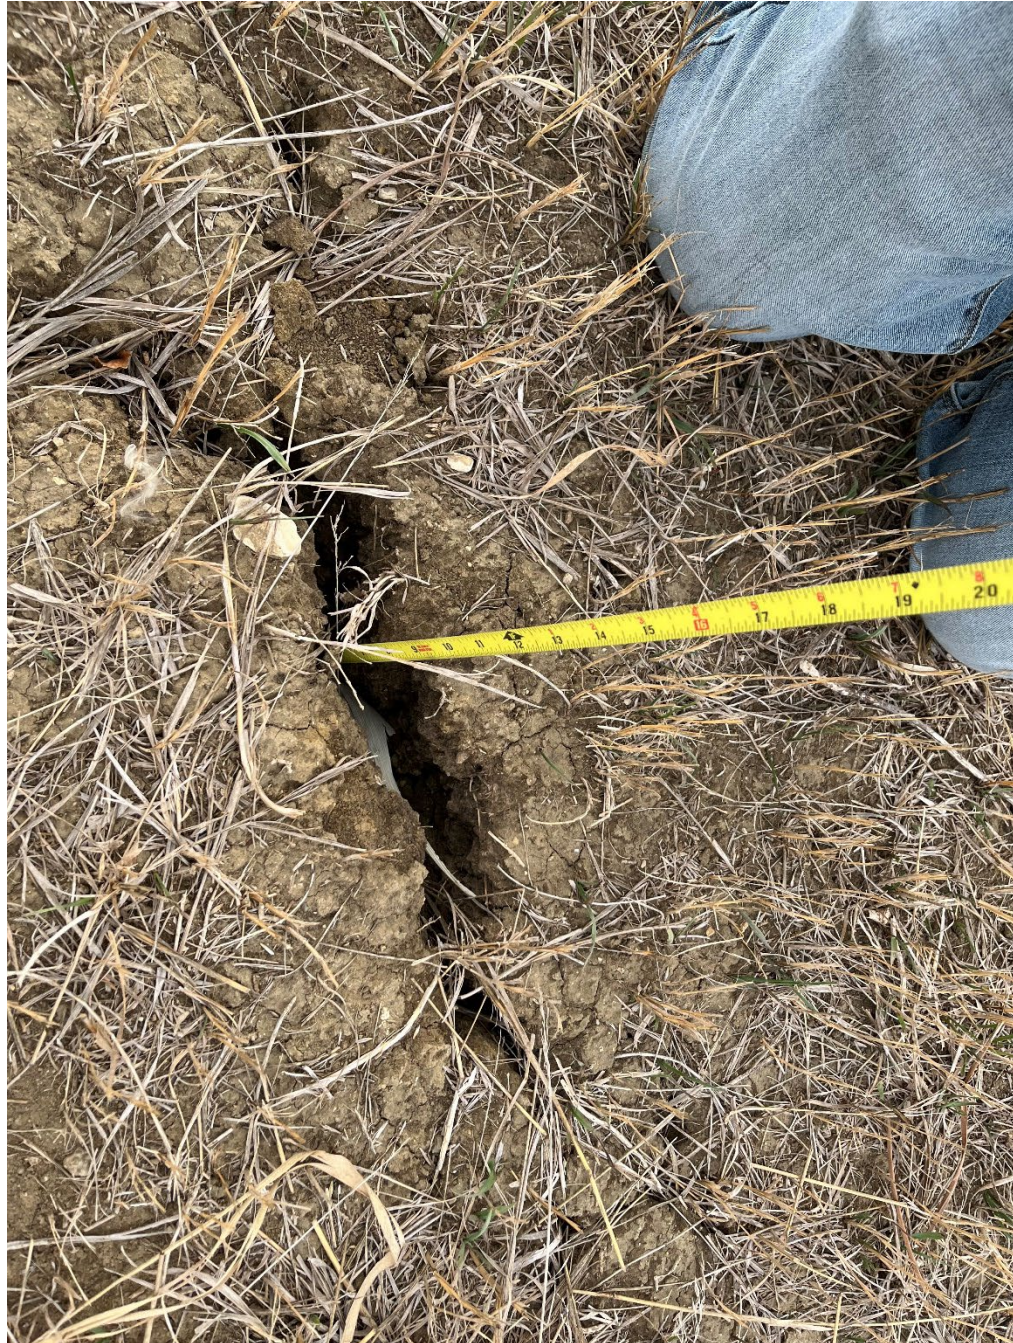
Ash Disposal Facility Annual Inspection, Sheldon Station**PHOTO 3**

Crack
observed
on south
embankm
ent crest

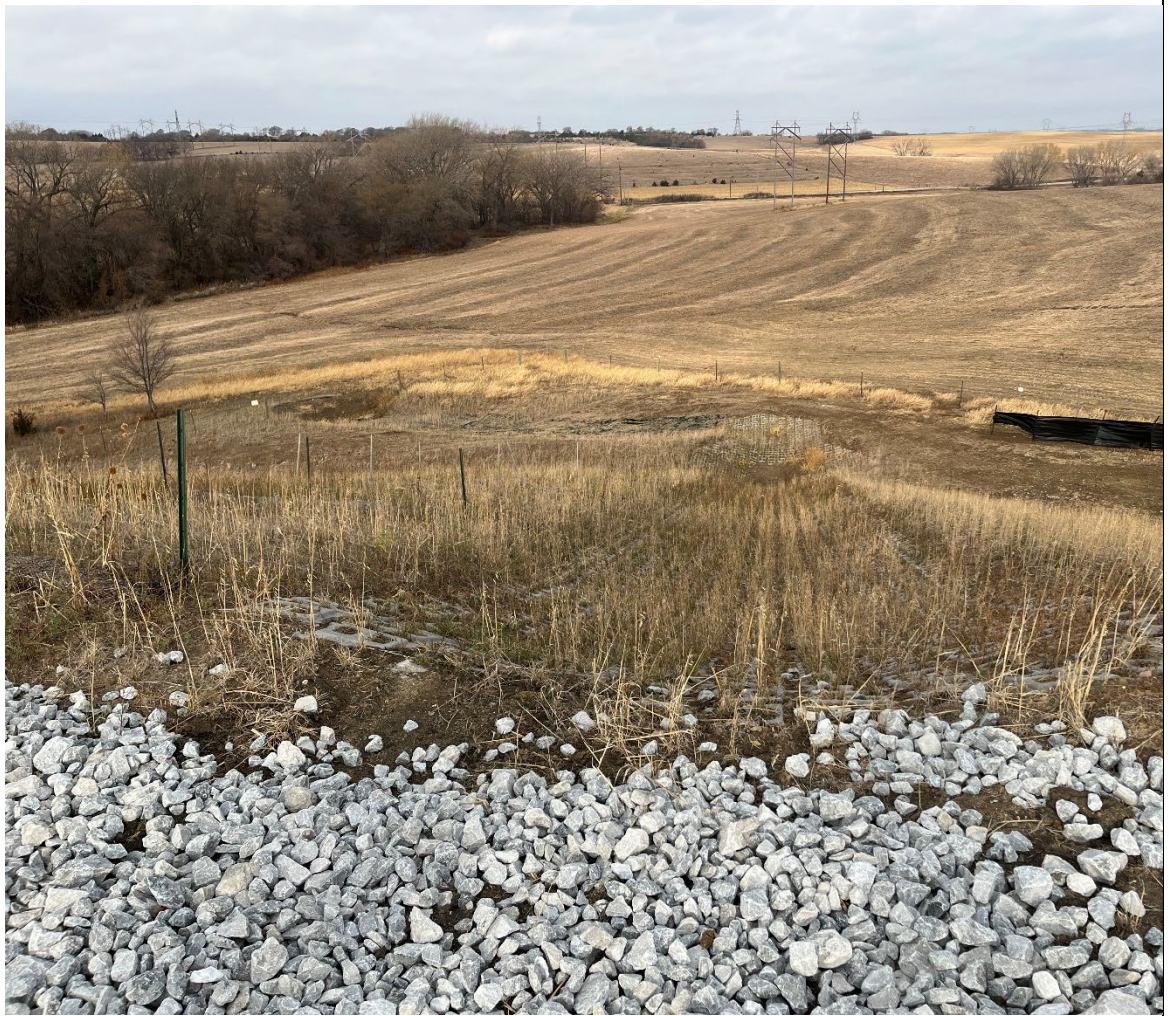
PHOTO 4

Northwest
downchute
channel

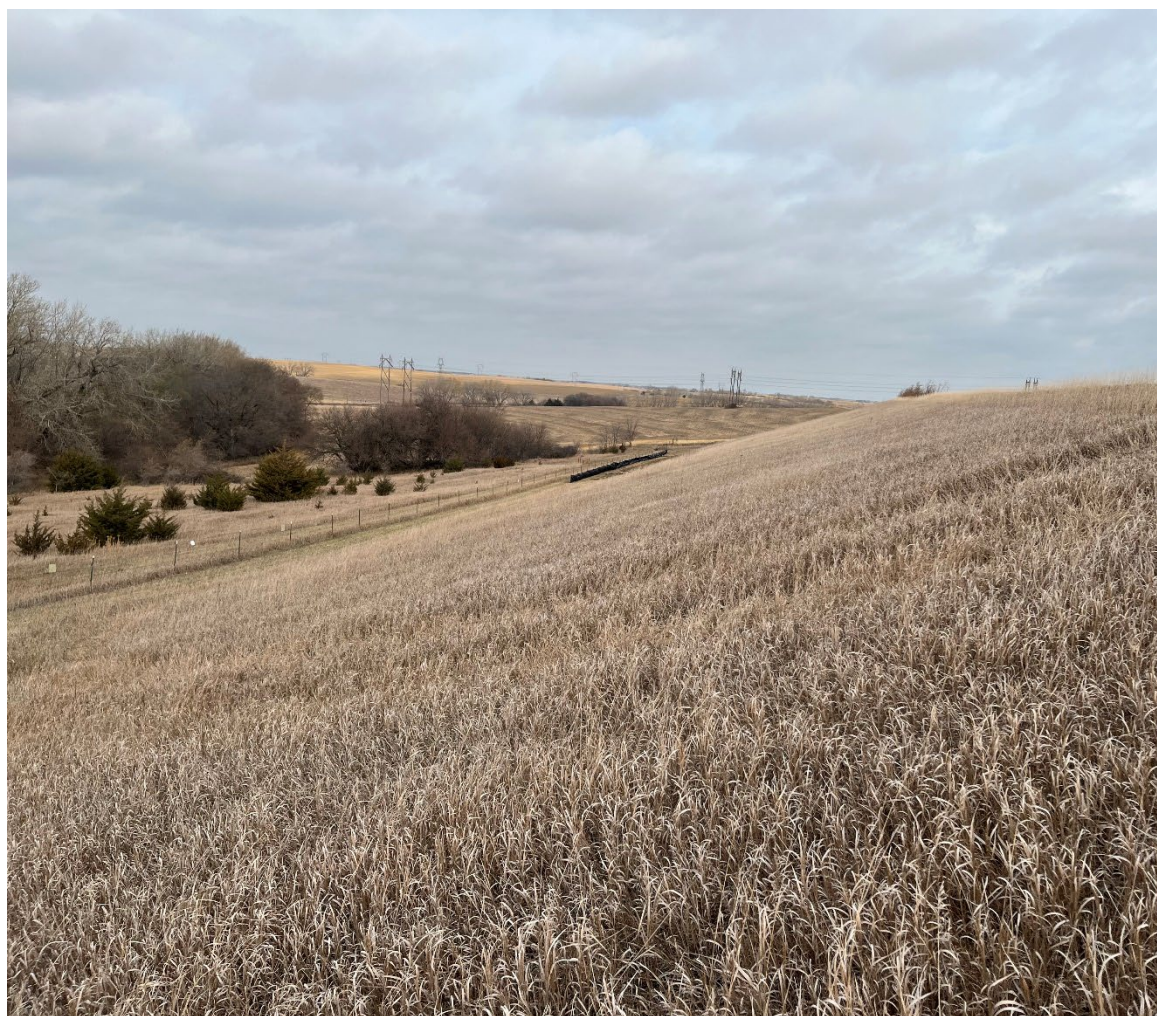
Ash Disposal Facility Annual Inspection, Sheldon Station**PHOTO 5**

Vegetation
on west
exterior
slope

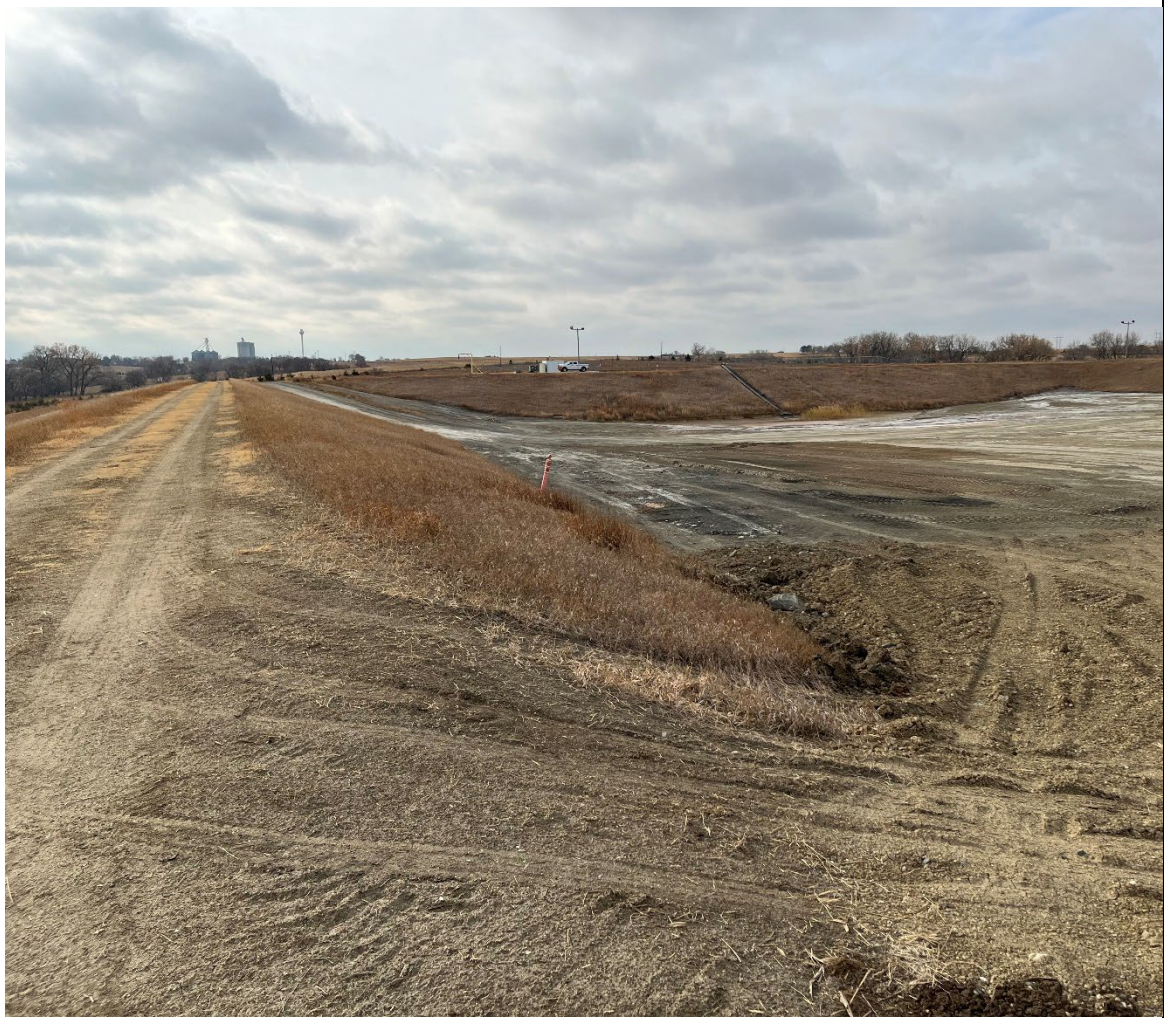
Ash Disposal Facility Annual Inspection, Sheldon Station**PHOTO 6**

Active ash
placement
area

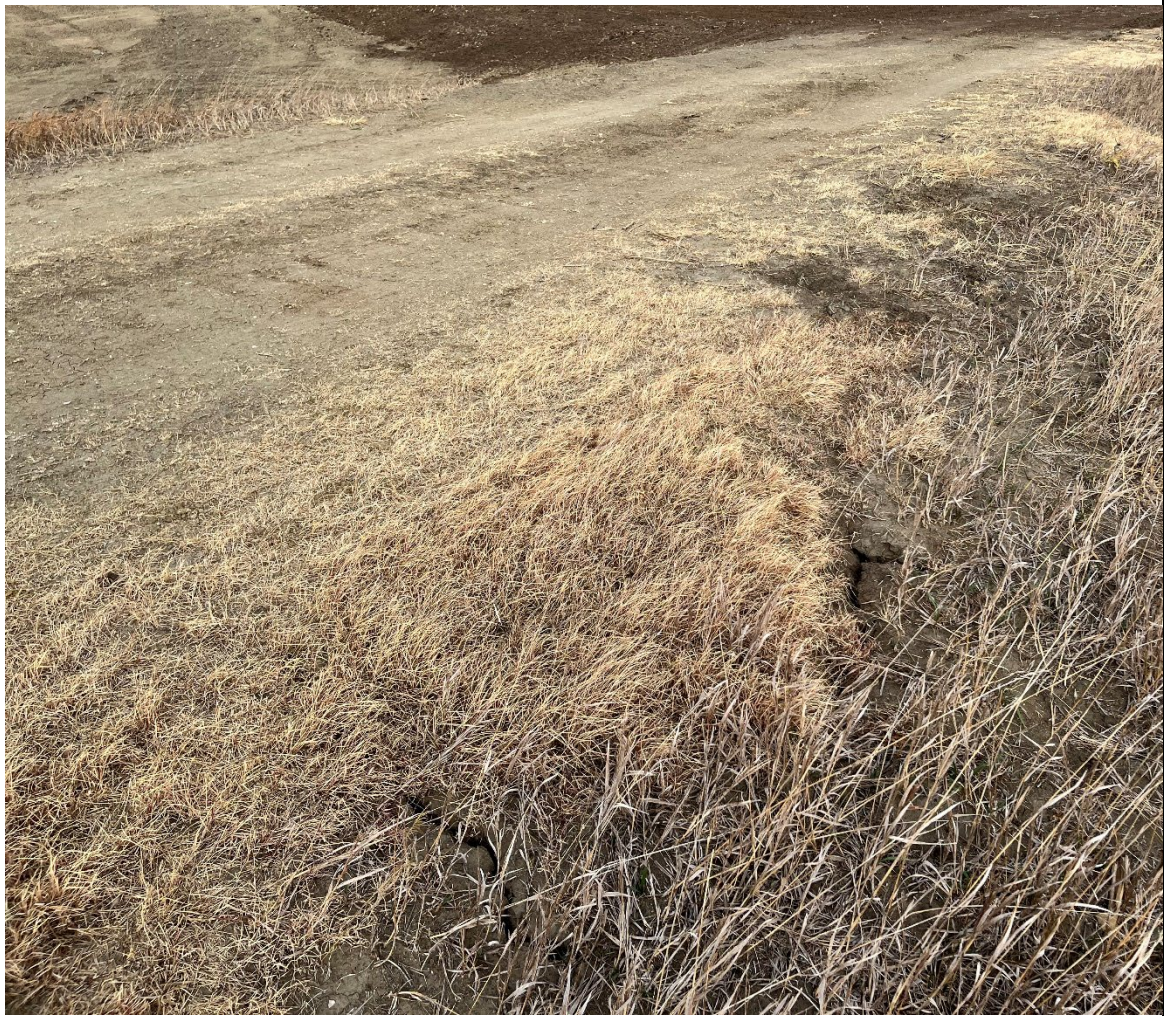
Ash Disposal Facility Annual Inspection, Sheldon Station**PHOTO 7**

Crack
observed
on east
embankm
ent crest

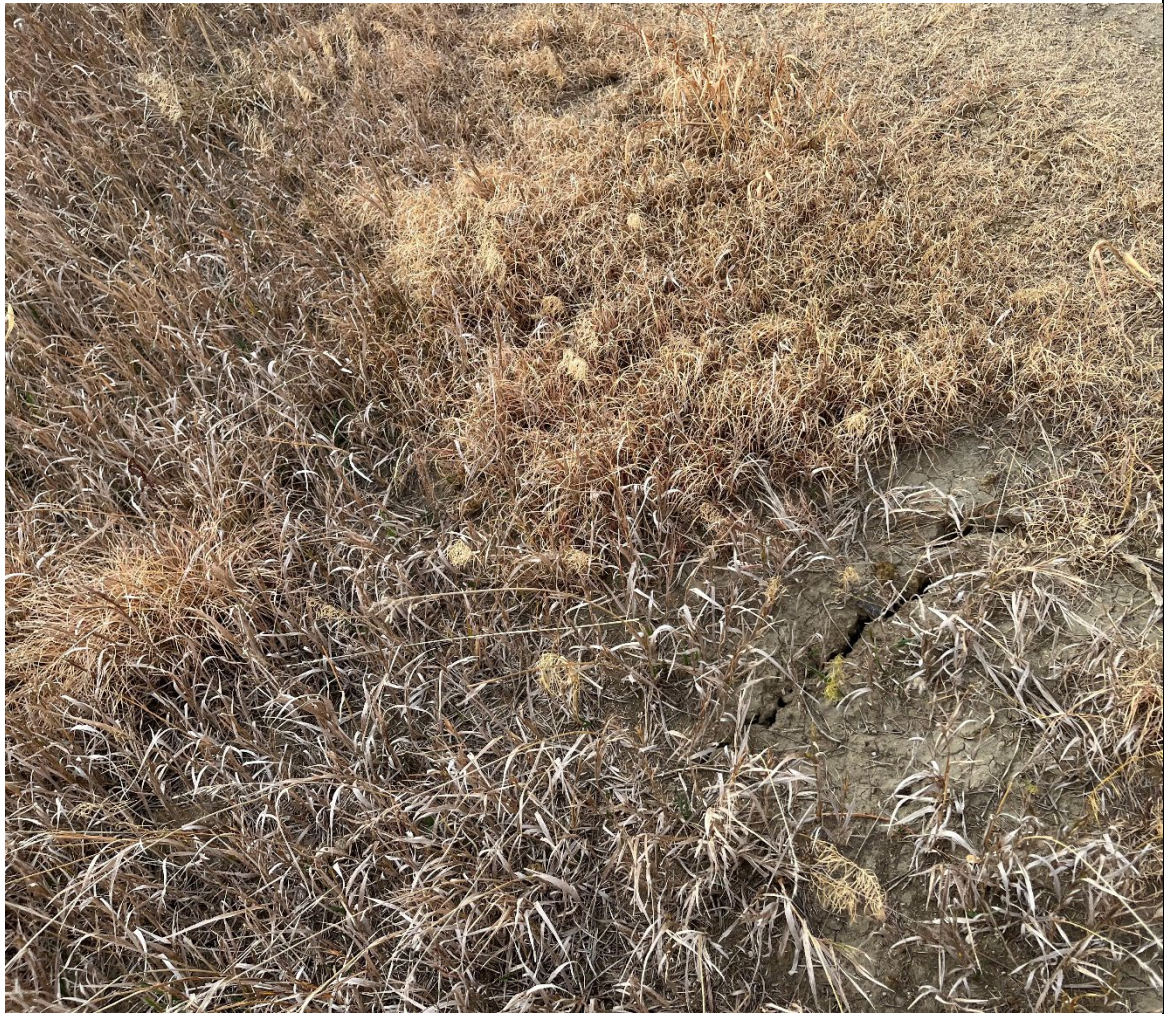
Ash Disposal Facility Annual Inspection, Sheldon Station**PHOTO 8**

Crack
observed
on east
embankm
ent crest

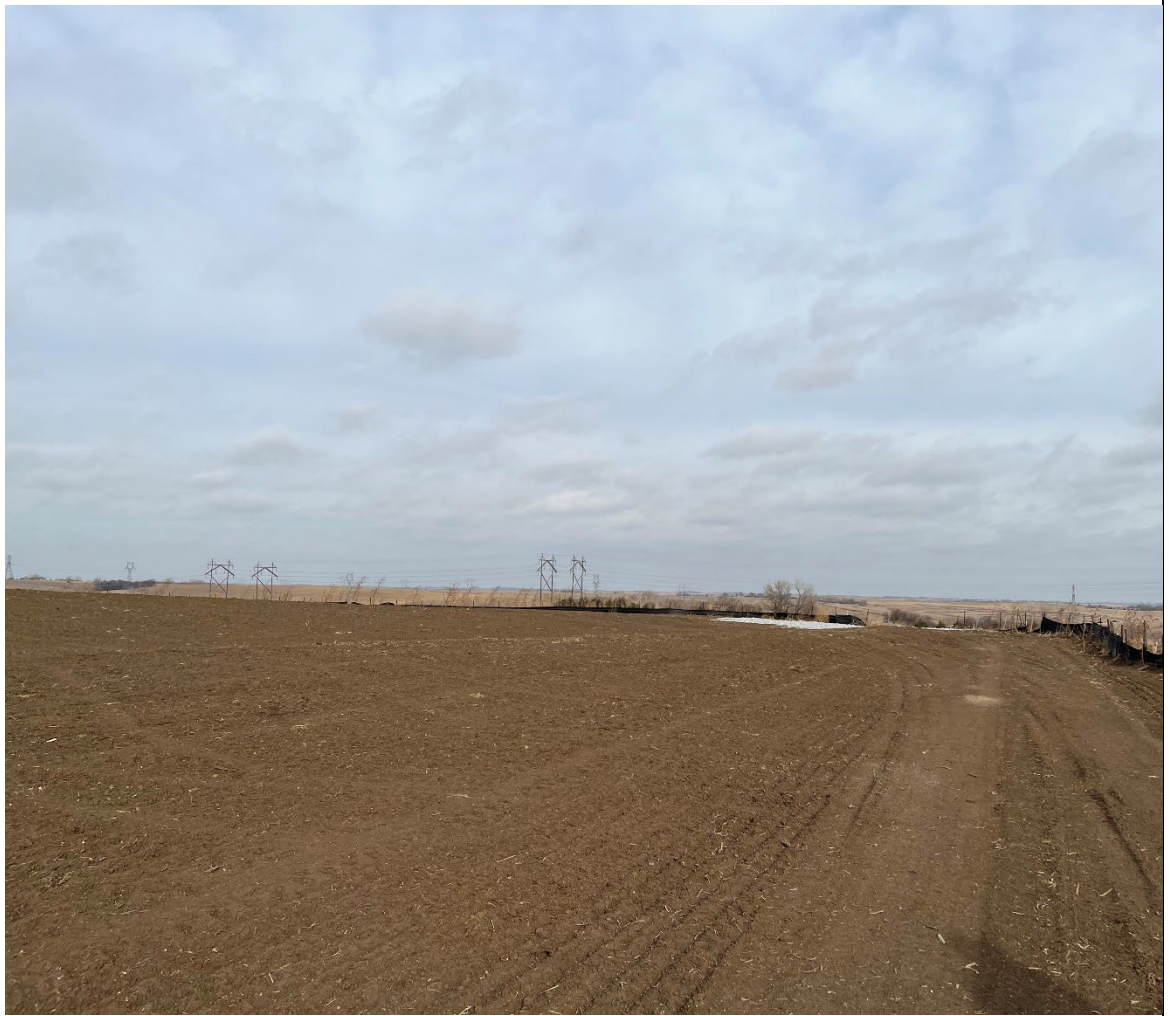
Ash Disposal Facility Annual Inspection, Sheldon Station**PHOTO 9**

Final cover
on
northern
end of ash
disposal
facility

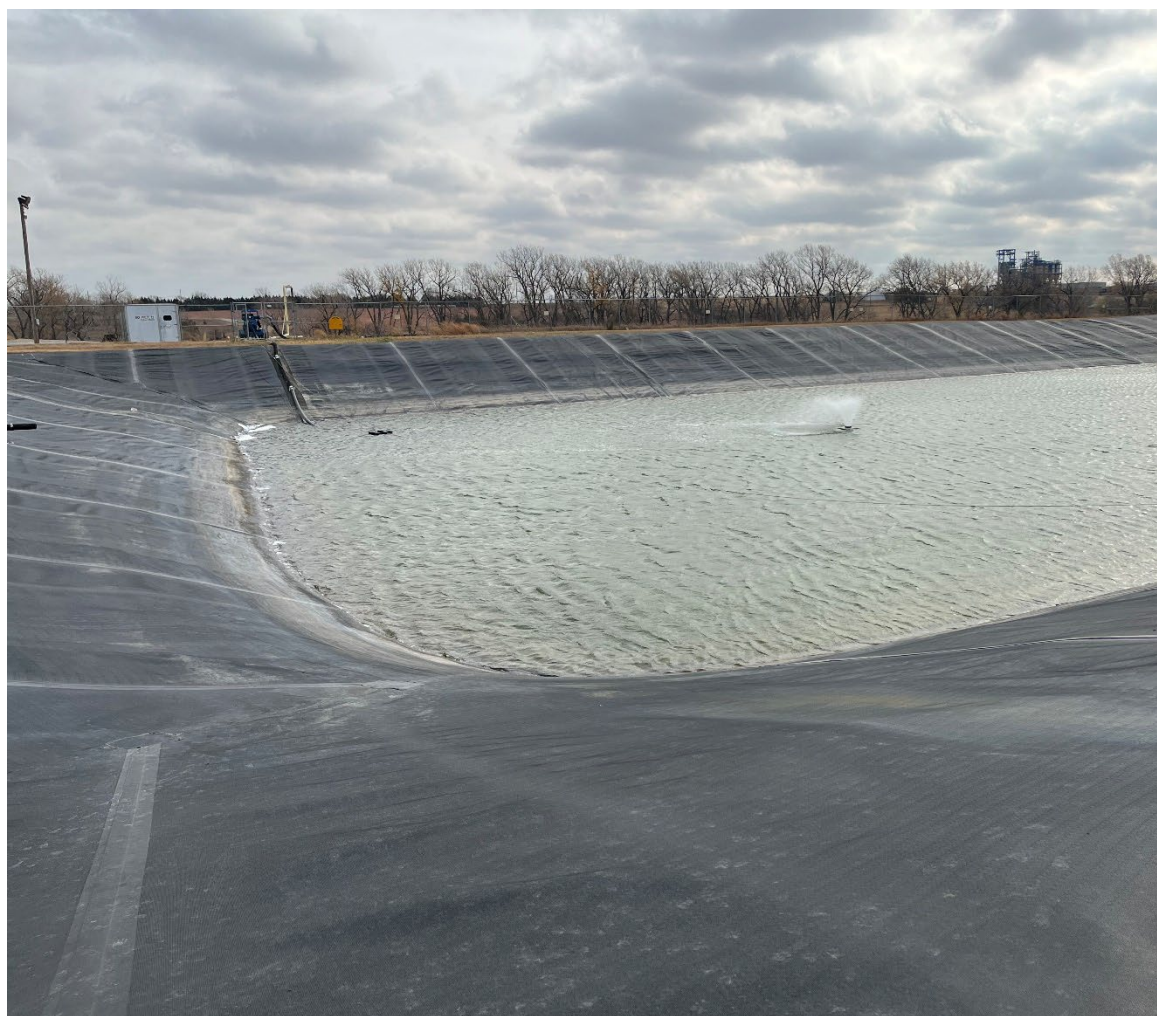
Ash Disposal Facility Annual Inspection, Sheldon Station**PHOTO
10**

Leachate
evaporatio
n pond

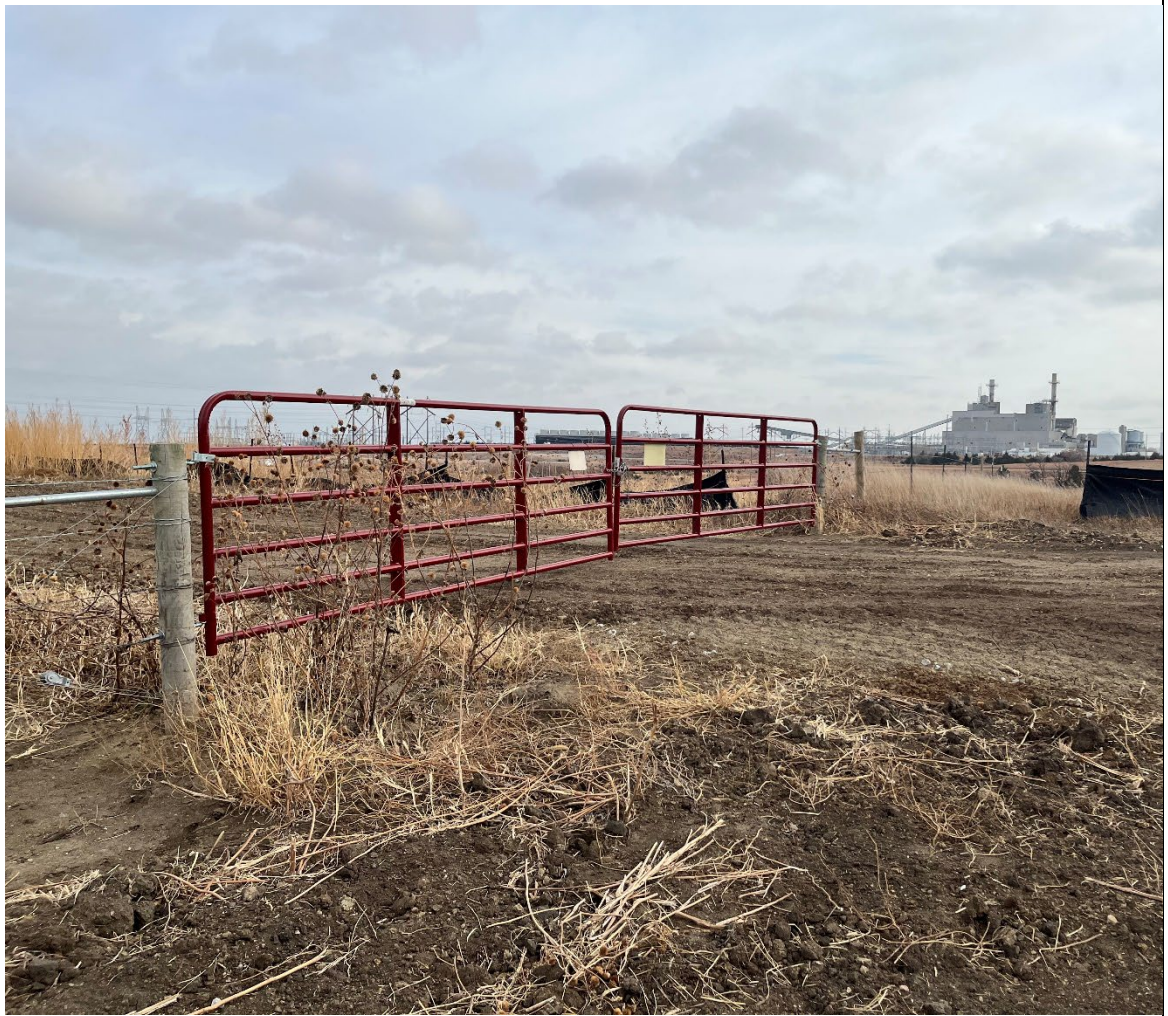
Ash Disposal Facility Annual Inspection, Sheldon Station**PHOTO
11**

Secure
access on
south side
of ash
disposal
facility

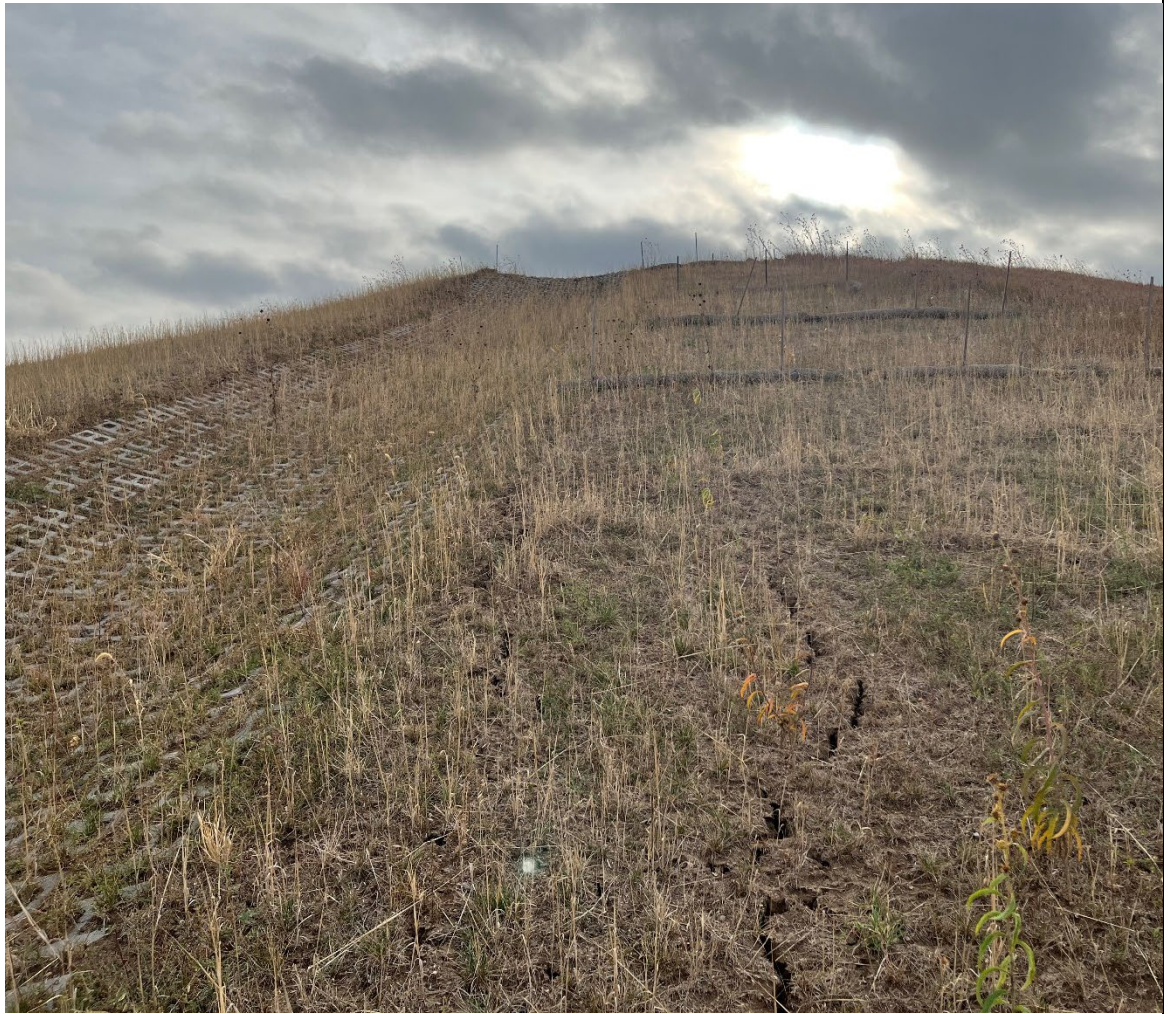
PHOTO 12

Northeast
downchute
channel
