# 2023 Annual Inspection Report

## *Gerald Gentleman Station Ash Disposal Facility*

### **Nebraska Public Power District**

31405886.003-003-RPT-0

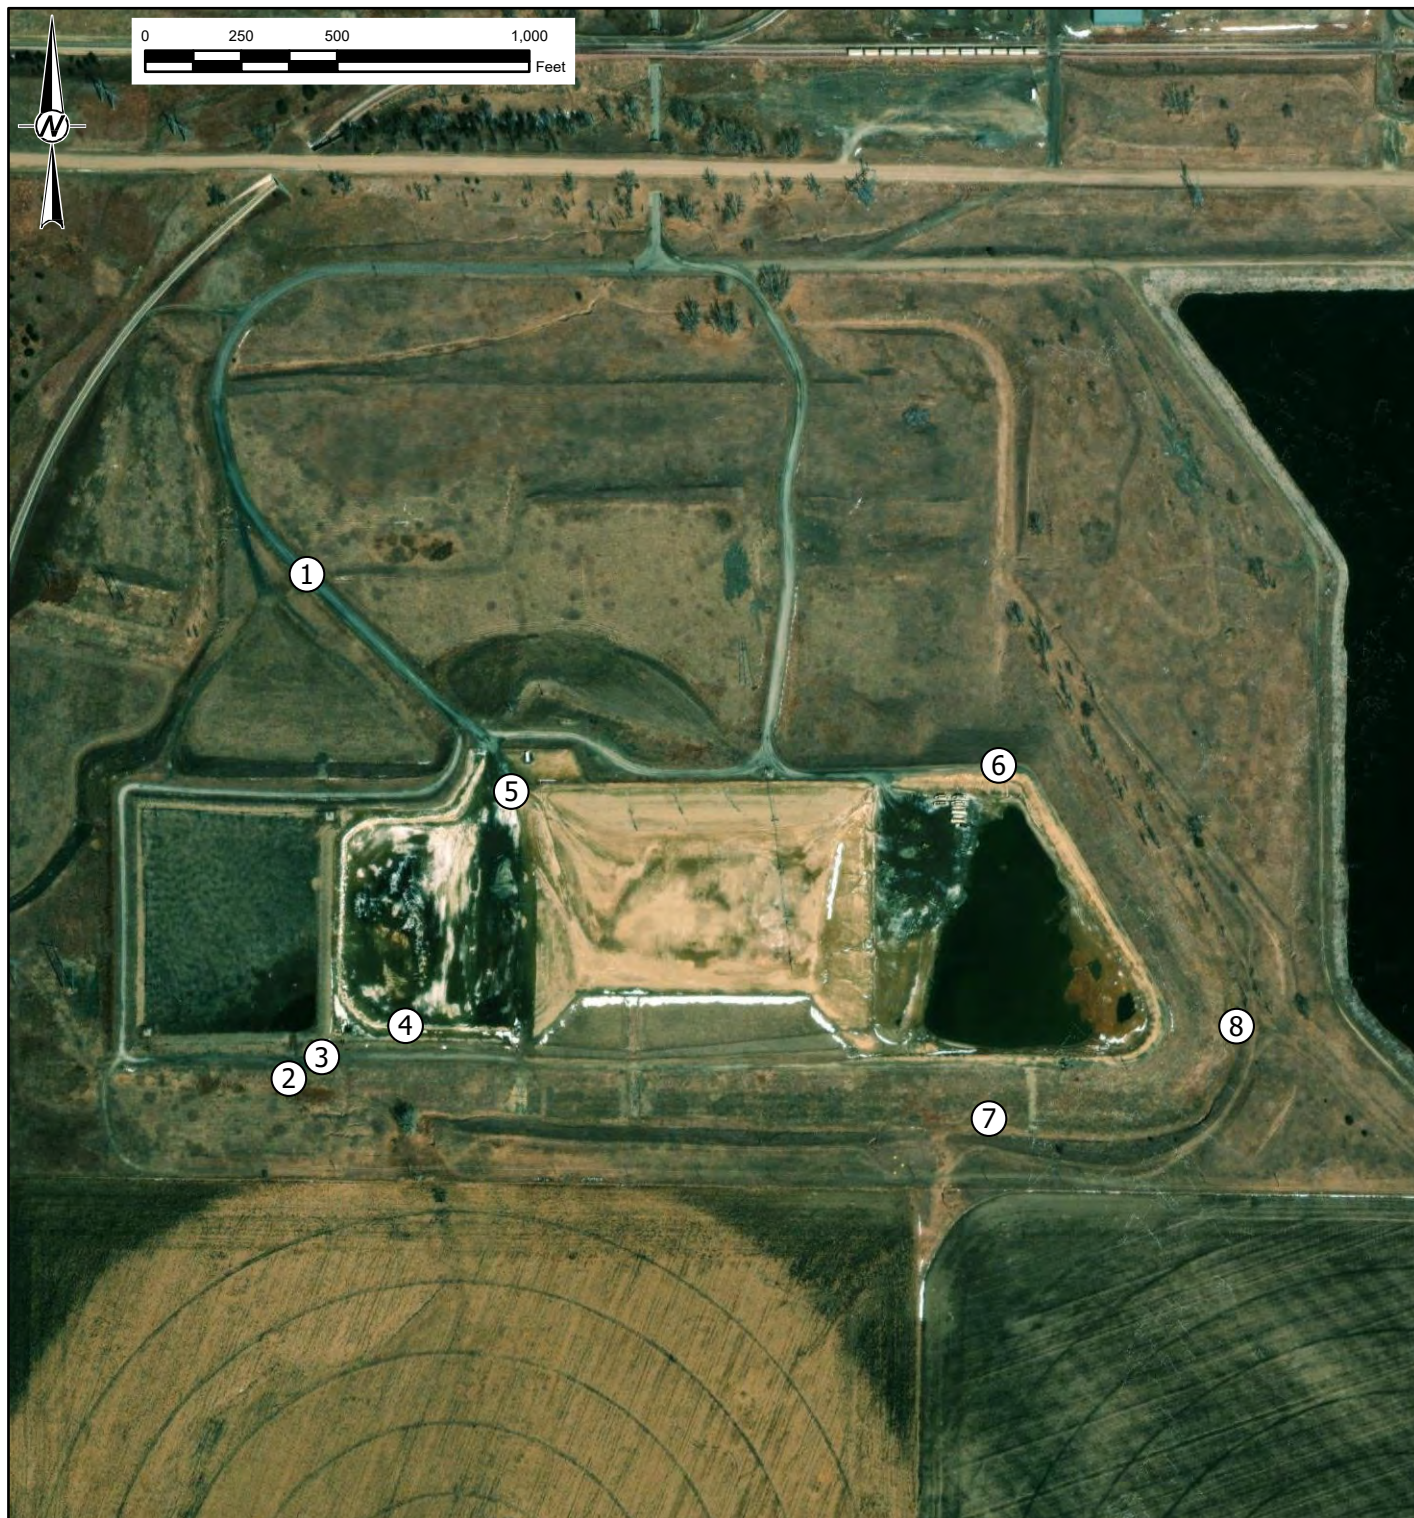
## PHOTO LOG LOCATIONS

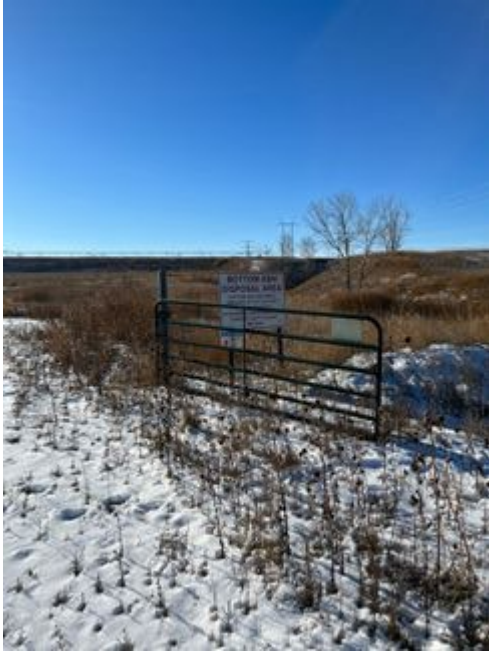
Photo Location 1

<b>IMG_3124.JPG</b>
	Site access gate

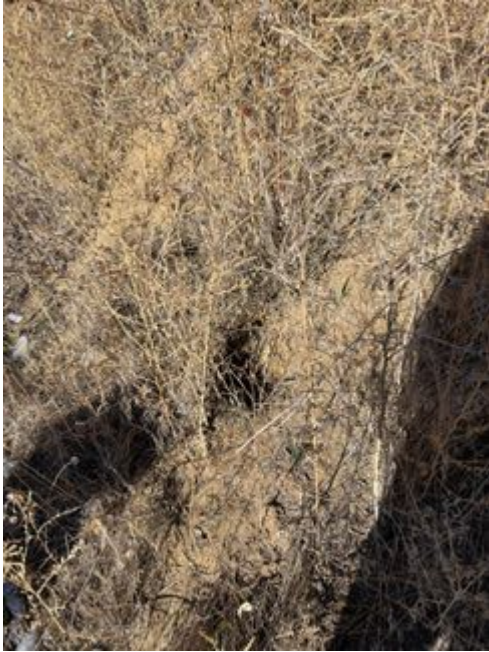
Photo Location 7

Evidence of burrowing animals was observed near the toe of the south exterior slopes of Ash Landfill No. 4 (likely badger holes). NPPD inspects the embankments weekly, and signs of burrowing animals are documented. Animal burrows on the embankment slopes should continue to be addressed and repaired, as necessary. Animal burrowing did not pose a threat to the structural stability of the facility at the time of the annual inspection.

<b>IMG_3147.JPG</b>
	Small animal burrow
