2023 Annual Inspection Report

Sheldon Station Ash Landfill No. 4

Nebraska Public Power District

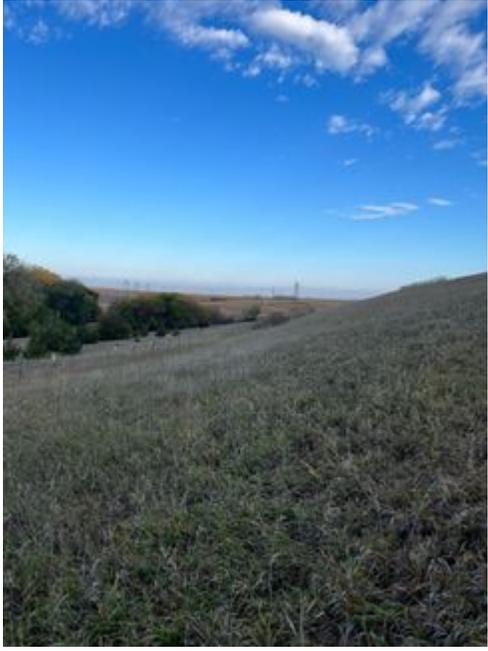
Photo Location 1

IMG_2984.JPG
	West exterior slope vegetation

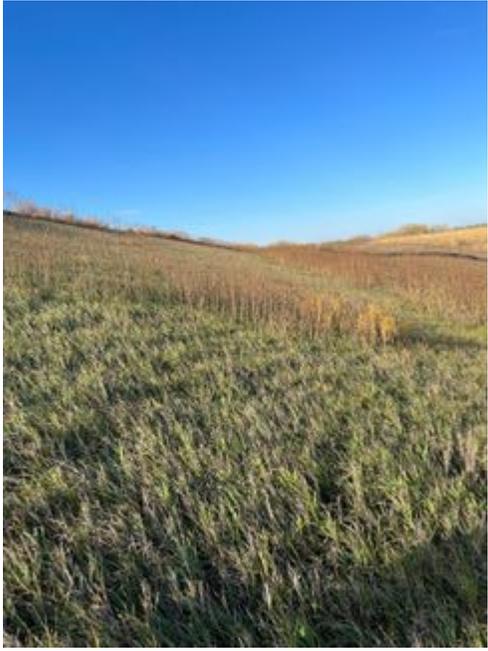
Photo Location 2

IMG_3008.JPG
	Northern interior slope

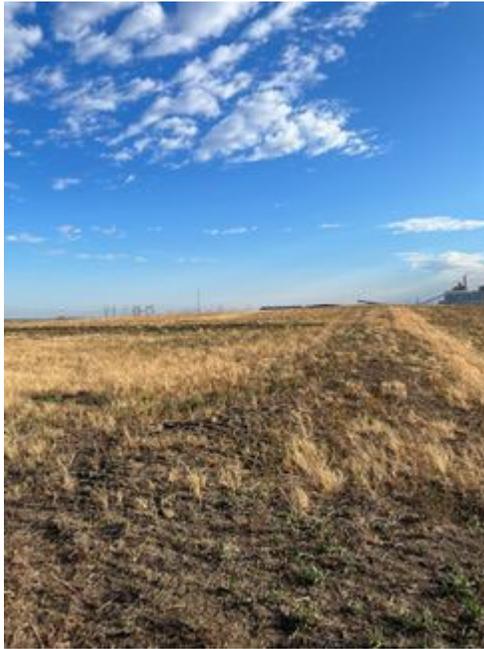
Photo Location 3

Vegetation on partial final cover

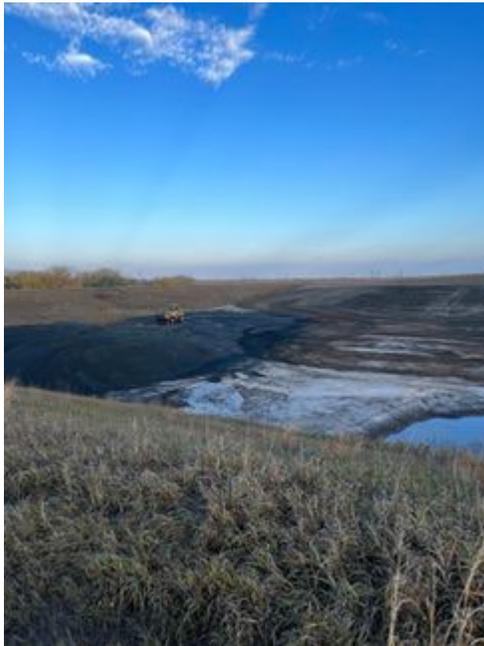
Photo Location 4

Bottom ash stockpile area

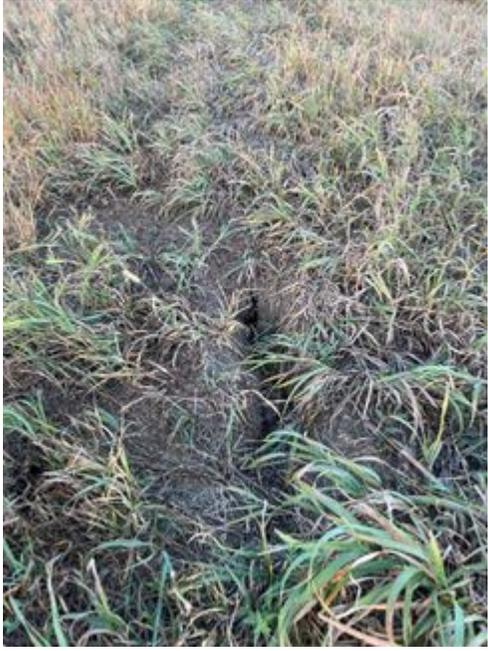
Photo Location 5

Surficial cracks have been observed in the perimeter road around the crest of the facility embankment during previous annual inspections. The cracking was observed to be significantly more widespread during the site inspection on October 24, 2023. Cracks were observed along significant stretches of the embankment crest, both along the interior and exterior, especially on the south, east, and west sides of the facility. The cracks were as large as approximately two inches wide and were over a foot deep (and as much as 3+ feet deep) in several locations. The cracking was not continuous, but there were areas with cracks as long as approximately 15 feet. The cracks were generally parallel with the crest, but in several locations, cracking perpendicular to the crest was also observed. No signs of bulking or slope movement were observed along the surface or toe of interior or exterior slopes. The cracking may have initially appeared due to drought conditions desiccating the surface soils, but it appears to have worsened due to freeze/thaw cycles and/or water infiltration. WSP recommends that NPPD develop a plan to repair the cracks. NPPD should continue to closely monitor the cracking and report to WSP immediately if the cracks change in size, or if additional cracks appear or displacement is observed.

IMG_2963.JPG
	Cracking in perimeter road on south side of facility

The 2023 annual inspection for Ash Landfill No. 4 at Sheldon Station was performed on October 24, 2023. The inspection met the requirements for CCR landfills under 40 CFR Part 257.84. The inspection found no indication of major structural deficiencies. NPPD should continue to monitor the cracking in the perimeter and notify WSP of any changes.

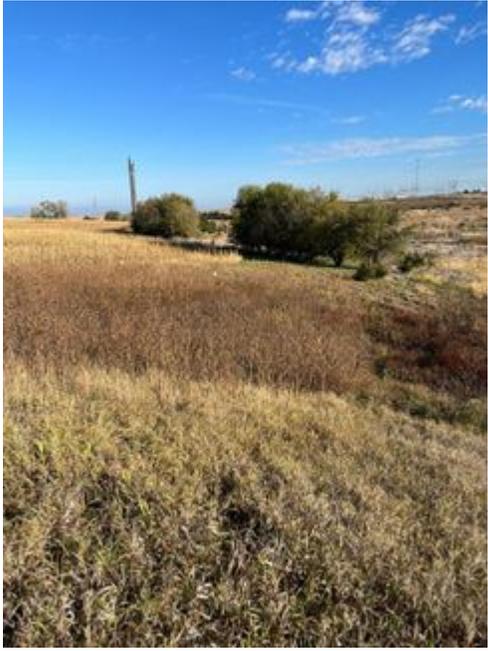
Photo Location 6

IMG_3009.JPG
	Eastern exterior slope

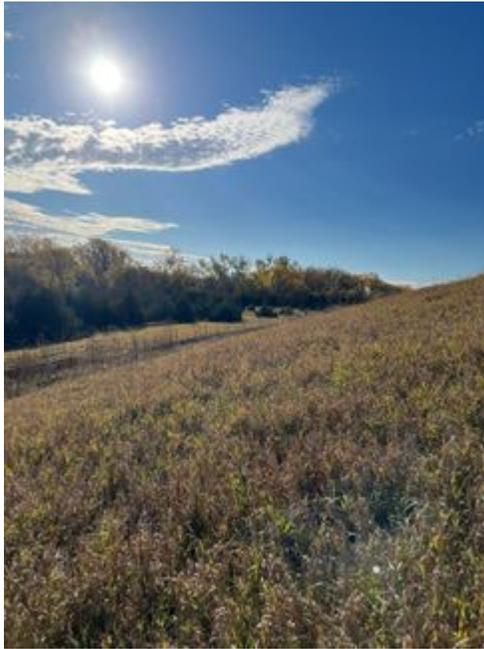
Photo Location 7

Eastern exterior slope

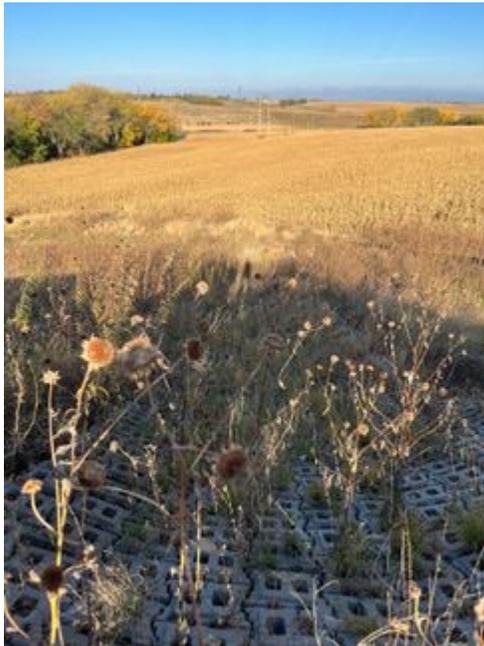
Photo Location 8

Downchute channel

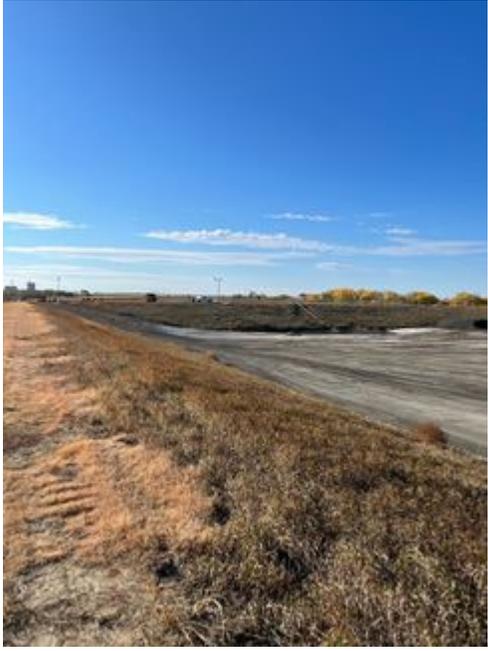
Photo Location 9

IMG_3012.JPG
	Entrance to ash disposal facility

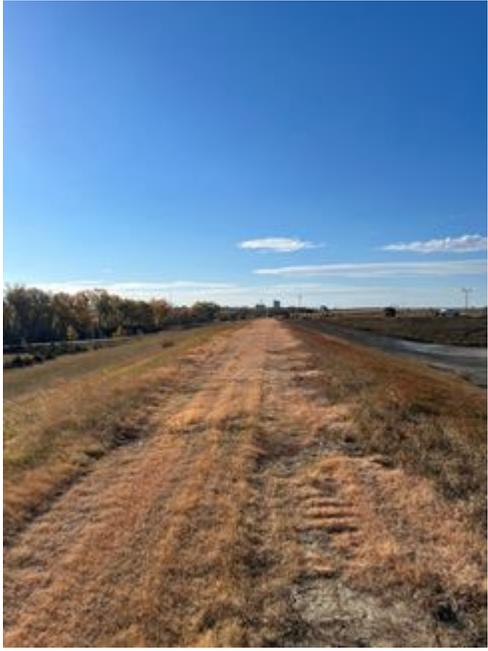
Photo Location 10

IMG_3013.JPG
	Perimeter road

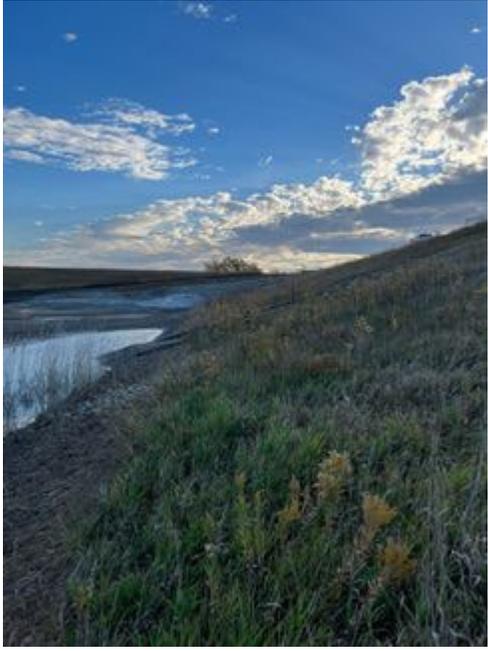
Photo Location 11

IMG_2975.JPG
	Southern interior slope

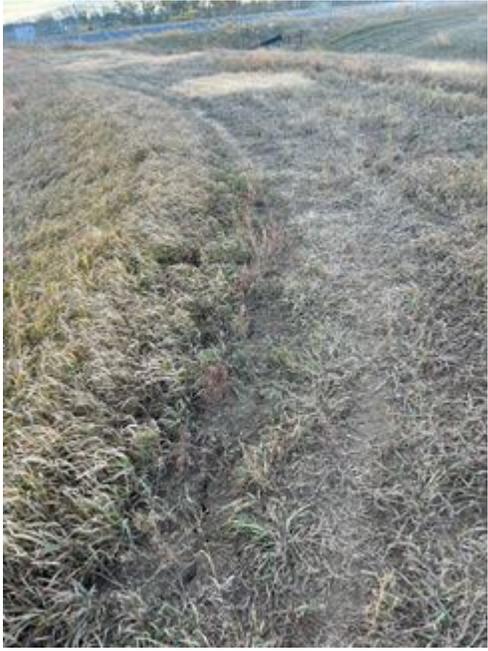
Photo Location 12

IMG_2983.JPG
	Cracking in perimeter road on south side of facility

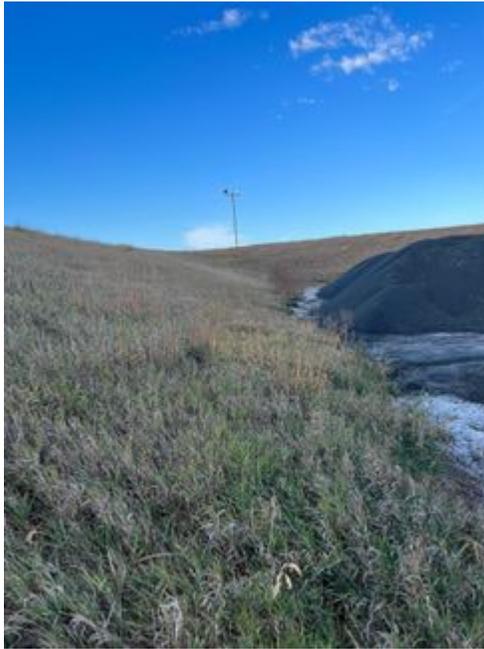
Photo Location 13

Southern interior slope

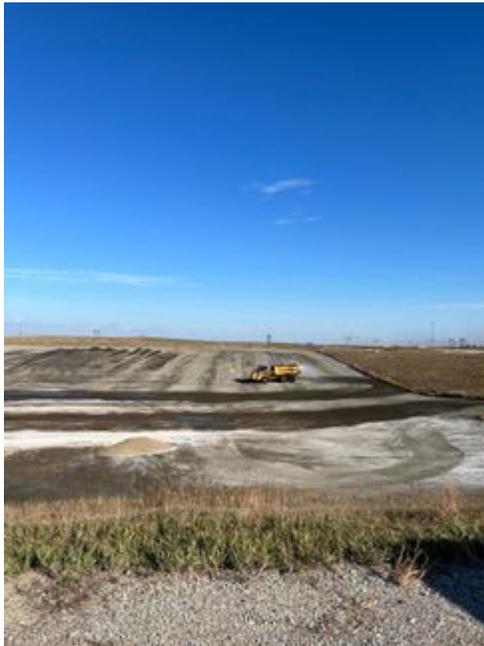
Photo Location 14

Dust management activities in disposal area

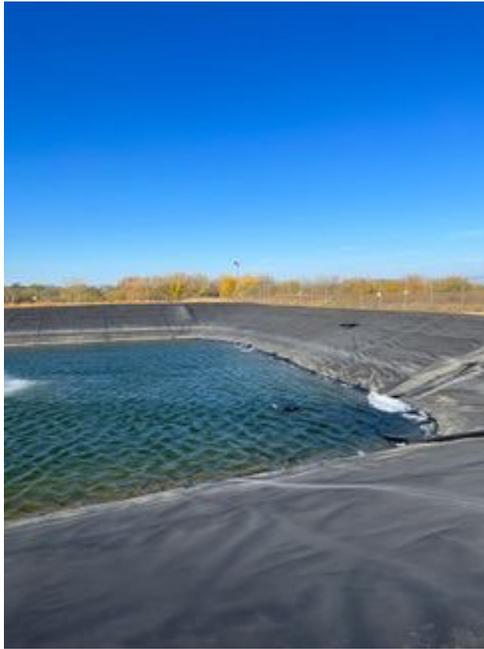
Photo Location 15

Leachate evaporation pond
