# 2024 Annual Inspection Report

## *Gerald Gentleman Station Ash Disposal Facility*

**Nebraska Public Power District**

December 12, 2024

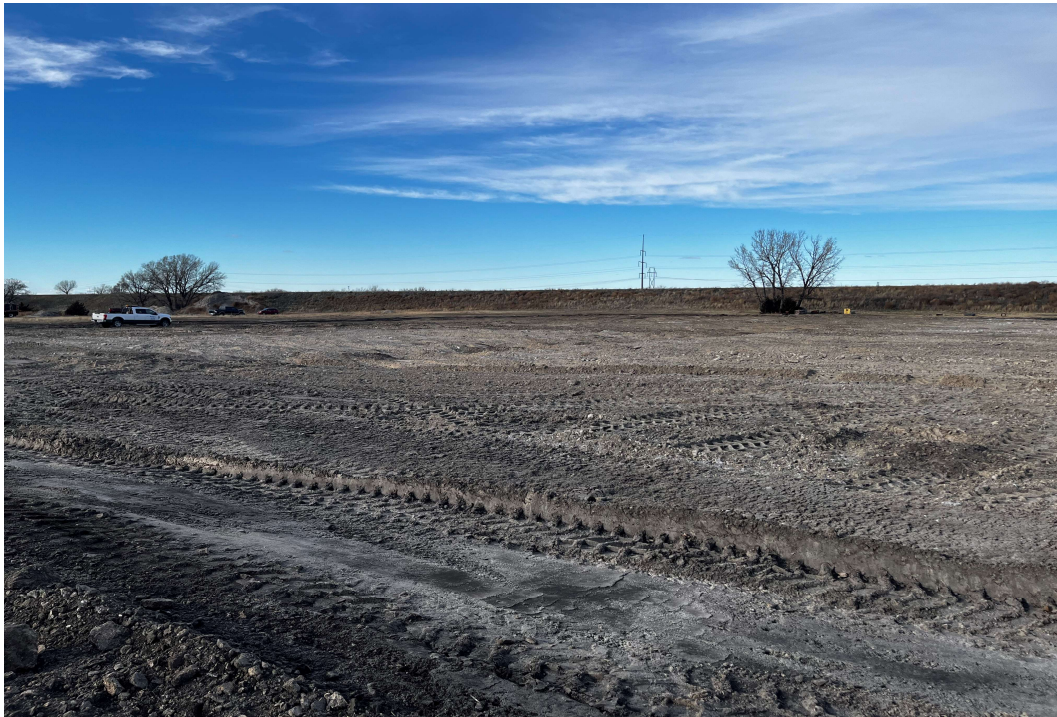
Photograph 1  
West cell of Ash Landfill No. 3. (IMG\_4166.JPG)

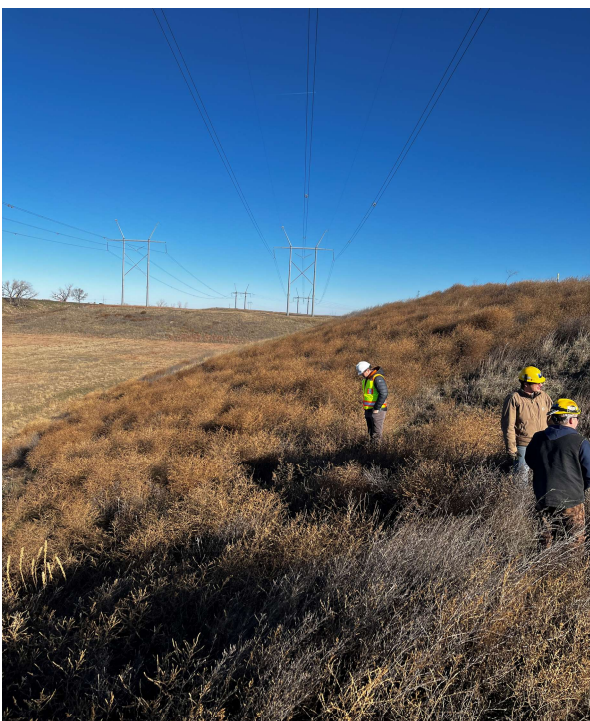
Erosion was observed on the outer embankment slopes on the west and south sides of Ash Landfill No. 3 and the south side of Ash Landfill No. 4. Erosion of the exterior slopes should be monitored, and NPPD should continue to perform routine maintenance on the slopes. NPPD should address the areas on the south and west exterior slopes of Ash Landfill No. 3 and south side of Ash Landfill No. 4 that have experienced erosion so that vegetation can be established to minimize future erosion.

Photograph 2  
West exterior slope of Ash Landfill No. 3. (IMG\_4175.JPG)

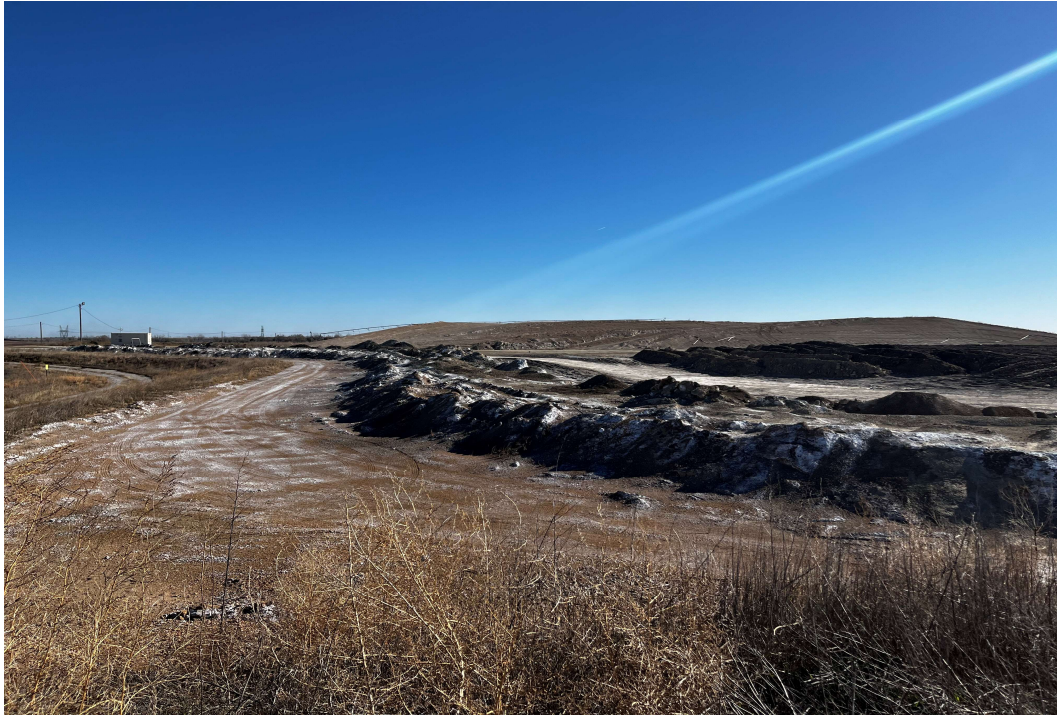
Photograph 3  
Ash deposition on the east side of Ash Landfill No. 3. (IMG\_4191.JPG)

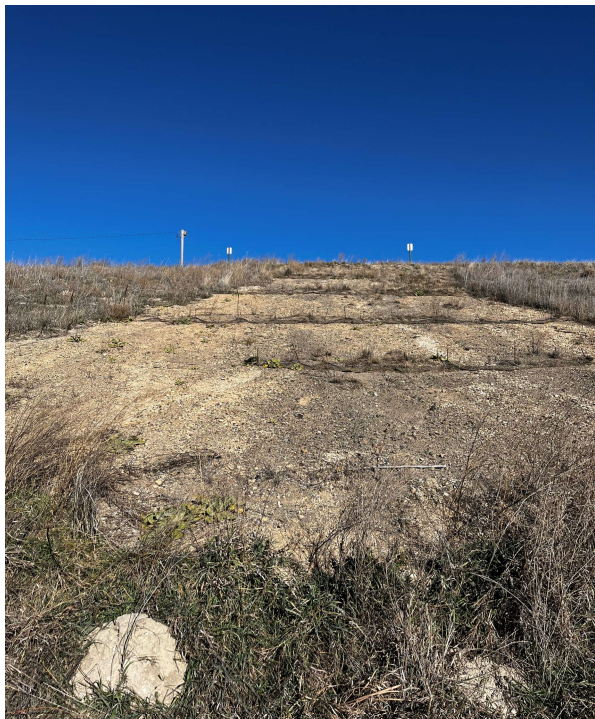
Photograph 4  
Sparsely vegetated south exterior slope of Ash Landfill No. 3. (IMG\_4199.JPG)

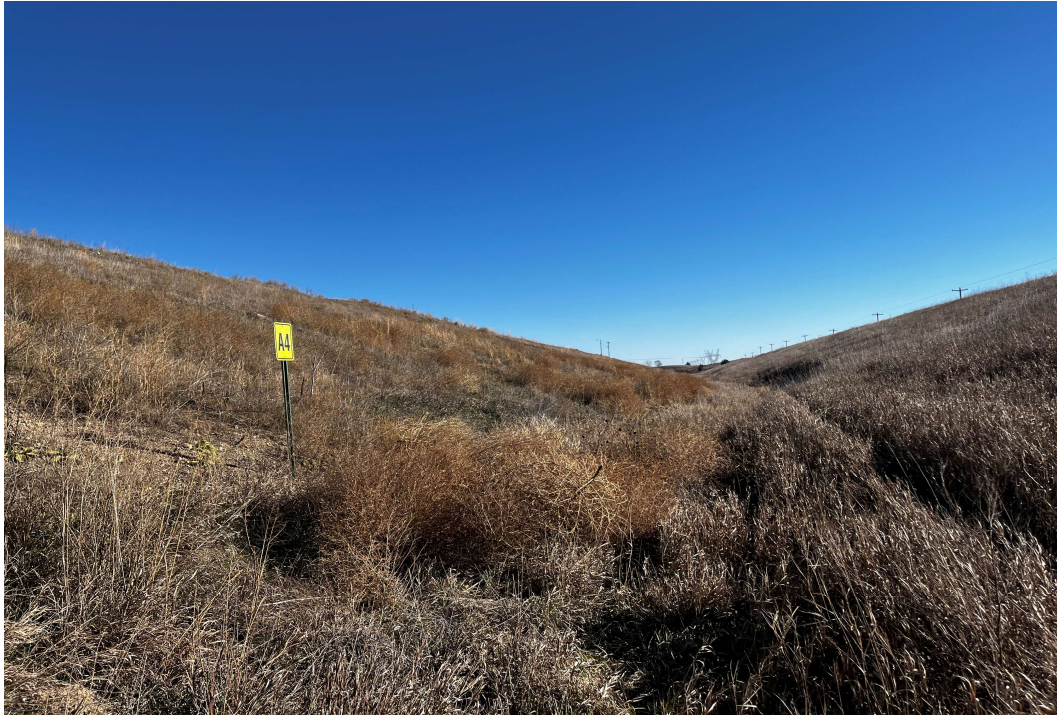
Photograph 5  
South exterior slope of Ash Landfill No. 4. (IMG\_4203.JPG)

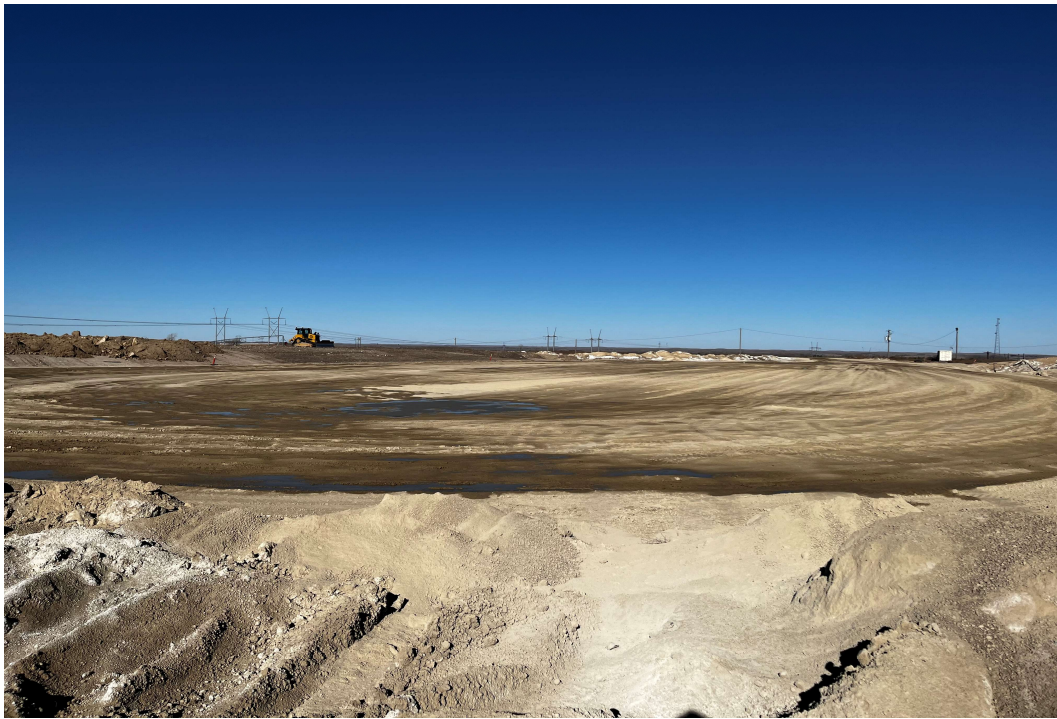
Photograph 6  
Active deposition area of Ash Landfill No. 3. (IMG\_4209.JPG)

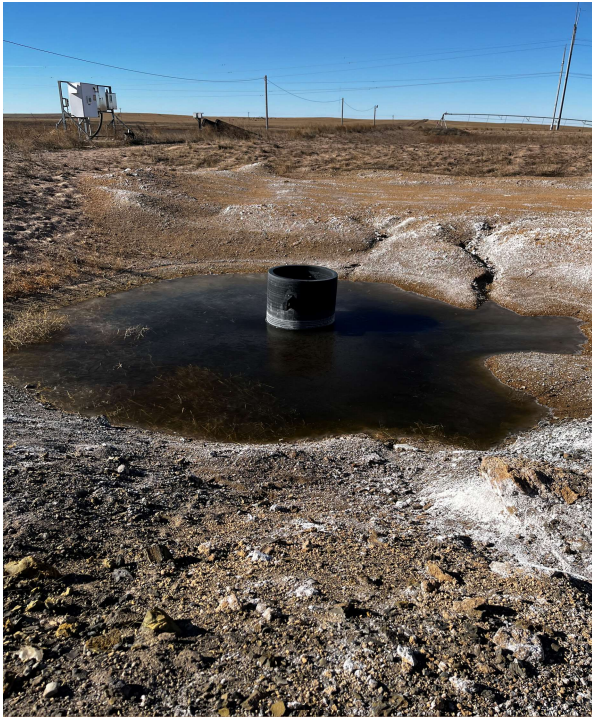
Photograph 7  
Leachate sump in east cell of Ash Landfill No. 3. (IMG\_4210.JPG)

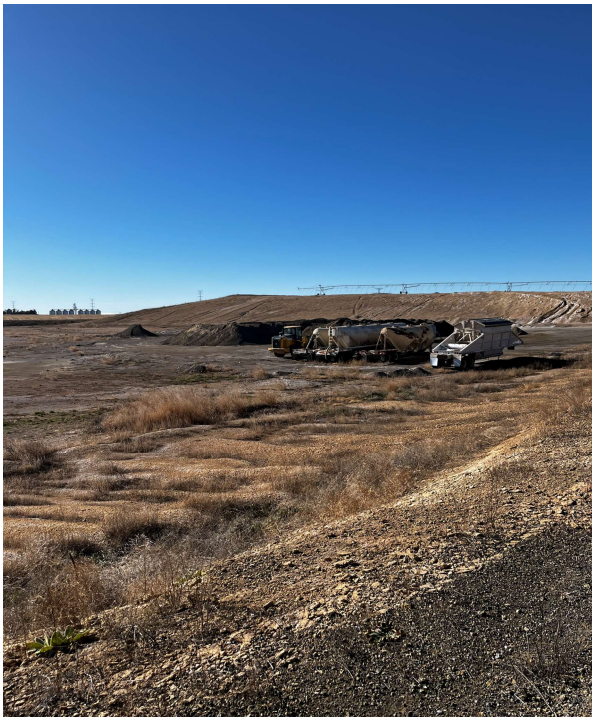
Photograph 8  
Bottom ash handling area. (IMG\_4213.JPG)

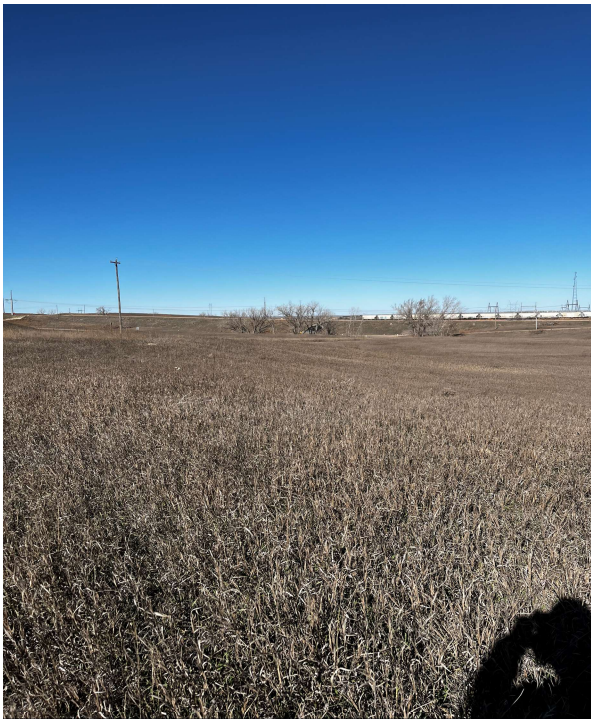
Evidence of burrowing animals were observed at several locations around the perimeter of Ash Landfill Nos. 3 and 4. One area with a notable increase in animal activity is the north exterior slope of Ash Landfill No. 3. NPPD inspects the embankments weekly, and signs of burrowing animals are documented. Animal burrows on the embankment slopes should continue to be addressed and repaired, as necessary. Animal burrowing did not pose a threat to the structural stability of the facility at the time of the annual inspection.

Photograph 9  
North exterior slope of Ash Landfill No. 3. (IMG\_4216.JPG)

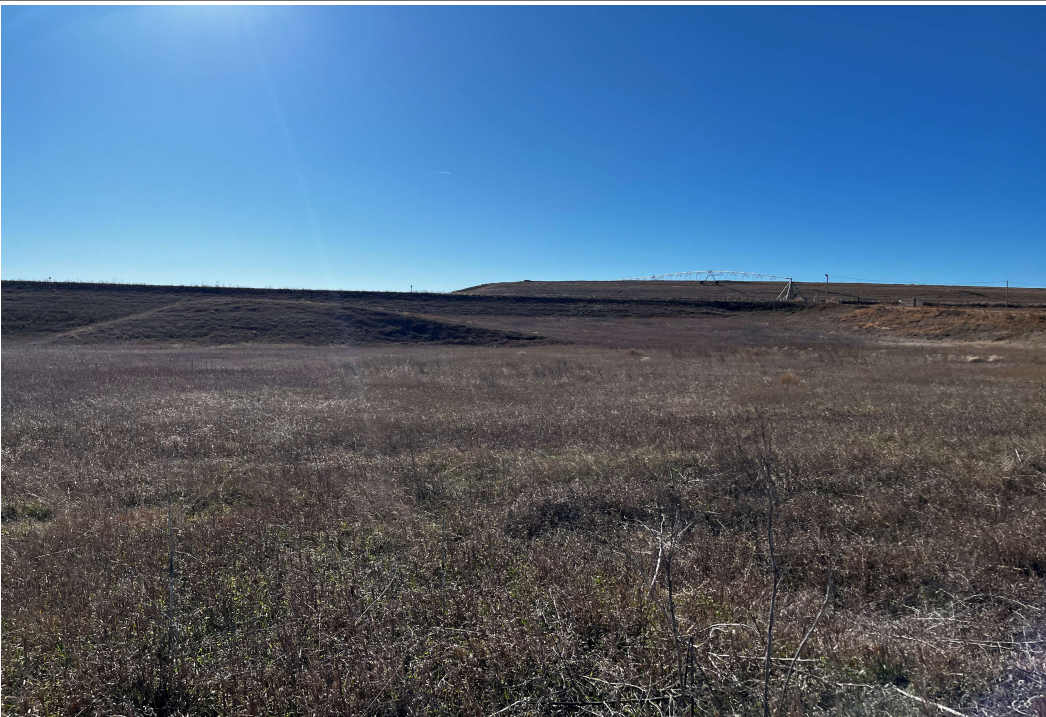
Photograph 10  
North exterior slope of Ash Landfill No. 4. (IMG\_4219.JPG)
