2024 Annual Inspection Report

Sheldon Station Ash Landfill No. 4

Nebraska Public Power District

WSP USA Inc.

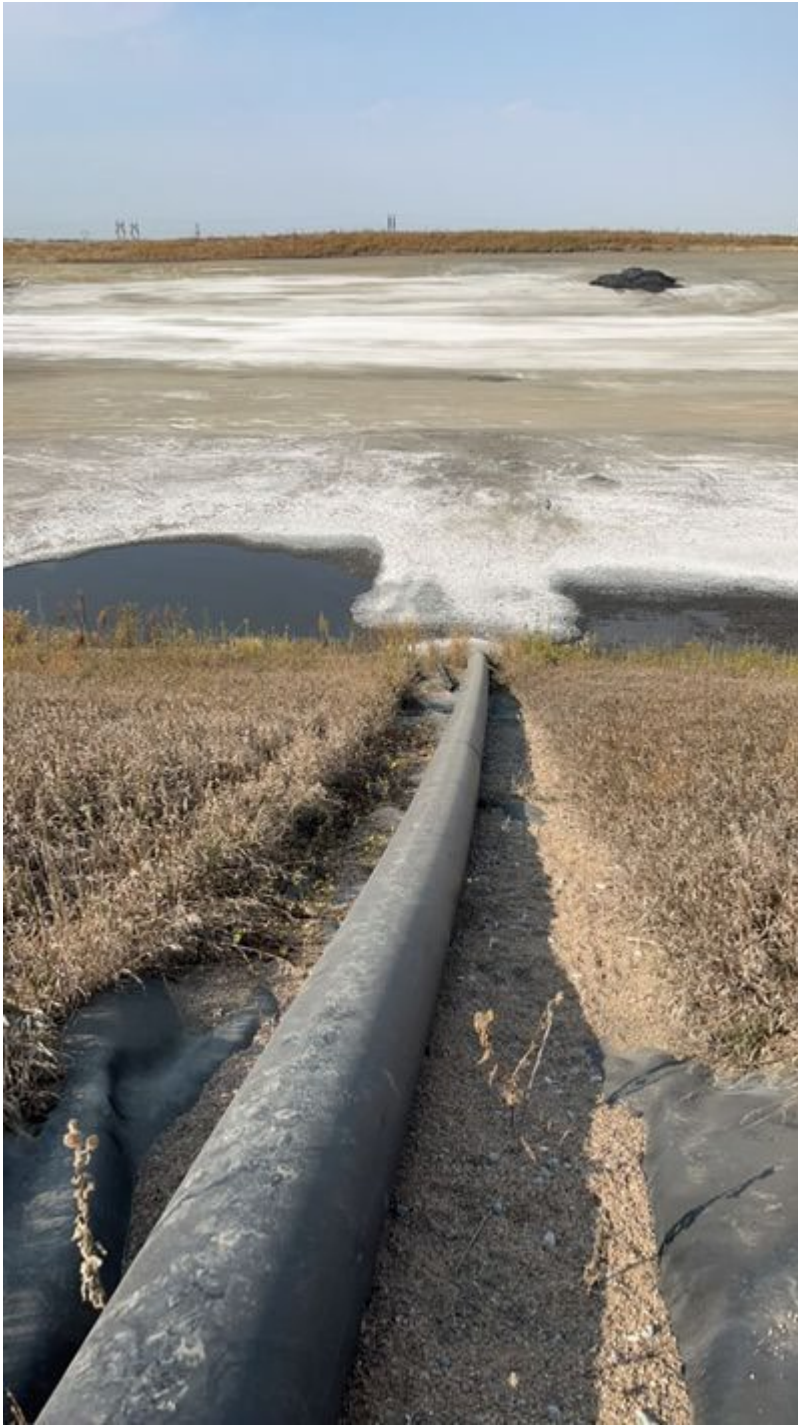
Photo Location: 1

Photo Caption: Sump riser.

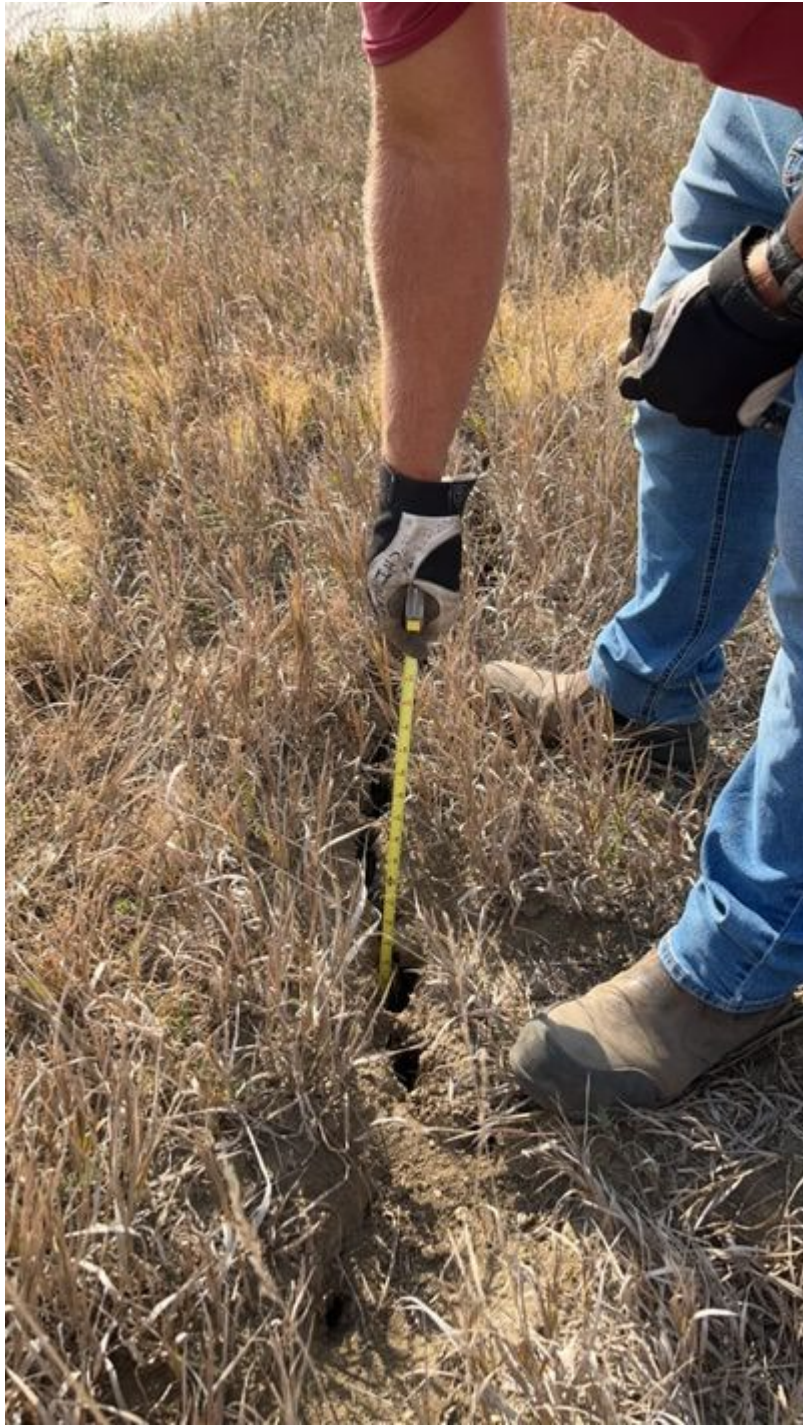
Photo Location: 2

Surficial cracks have been observed in the perimeter road around the crest of the facility embankment during previous annual inspections. The cracking was observed to be significantly more widespread during the site inspection on October 7, 2024. Cracks were observed along significant stretches of the embankment crest, both along the interior and exterior, especially on the south, east, and west sides of the facility. The cracks were as large as approximately 2 inches wide and were over 1 foot deep (and as much as 6+ feet deep) in several locations. The cracking was not continuous, but there were areas with cracks as long as approximately 15 feet. The cracks were generally parallel with the crest, but in several locations, cracking perpendicular to the crest was also observed. Cracking was also observed on the final cover and across widespread grassy areas elsewhere on site. No signs of bulking or slope movement were observed along the surface or toe of interior or exterior slopes. The cracking may have initially appeared due to drought conditions desiccating the surface soils, but it appears to have worsened due to freeze/thaw cycles and/or water infiltration. WSP recommends that NPPD develop a plan to repair the cracks. NPPD should continue to closely monitor the cracking and report to WSP immediately if the cracks change in size, or if additional cracks appear or displacement is observed.

Photo Caption: Crack observed on south embankment crest.

The 2024 annual inspection for Ash Landfill No. 4 at Sheldon Station was performed on October 7, 2024. The inspection met the requirements for CCR landfills under 40 CFR Part 257.84. The inspection found no indication of major structural deficiencies. NPPD should continue to monitor the cracking in the perimeter and notify WSP of any changes.

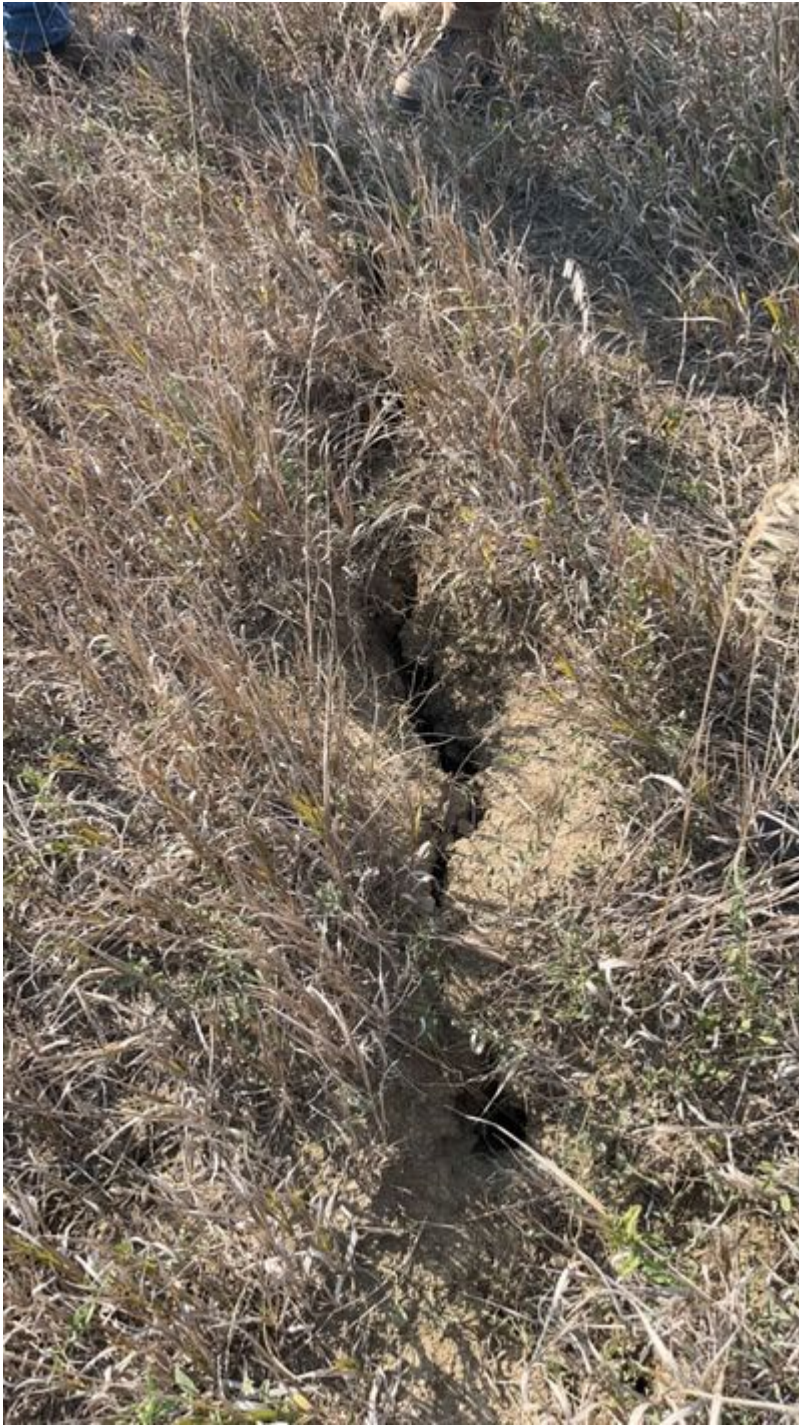
Photo Location: 3

Photo Caption: Crack observed on south embankment crest.

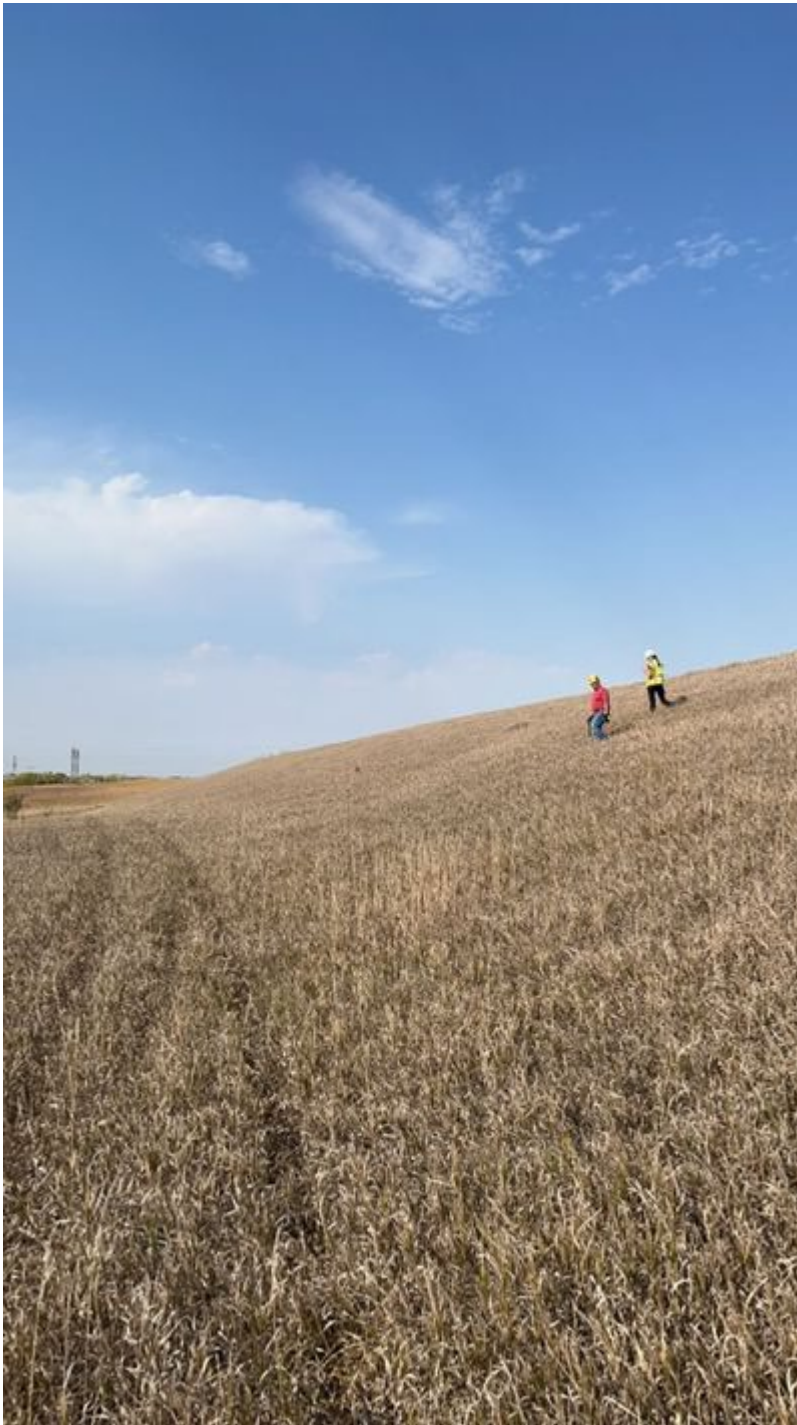
Photo Location: 4

Photo Caption: Vegetation on the west exterior slope.

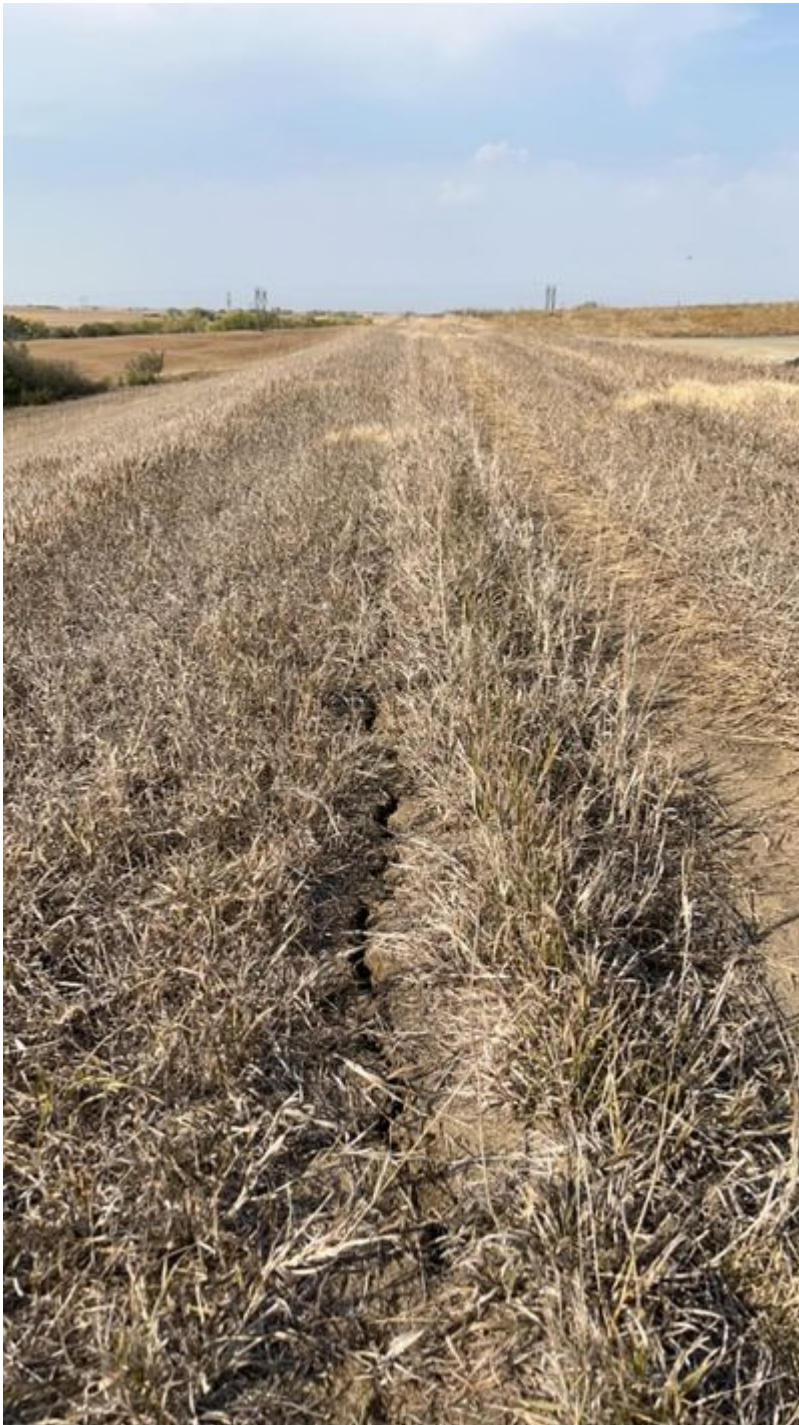
Photo Location: 5

Photo Caption: Crack in the west embankment crest.

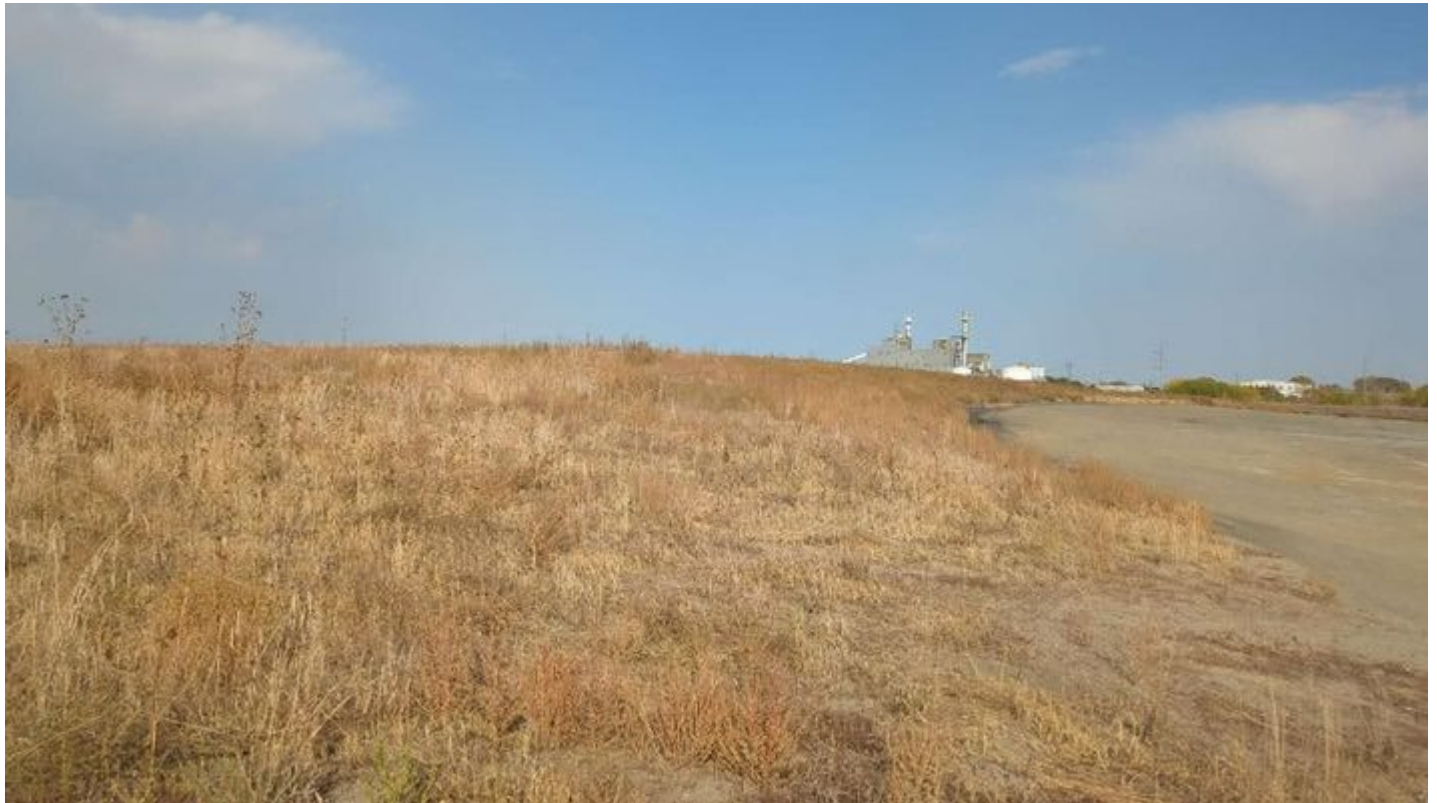
Photo Location: 6

Photo Caption: South edge of area with final cover.

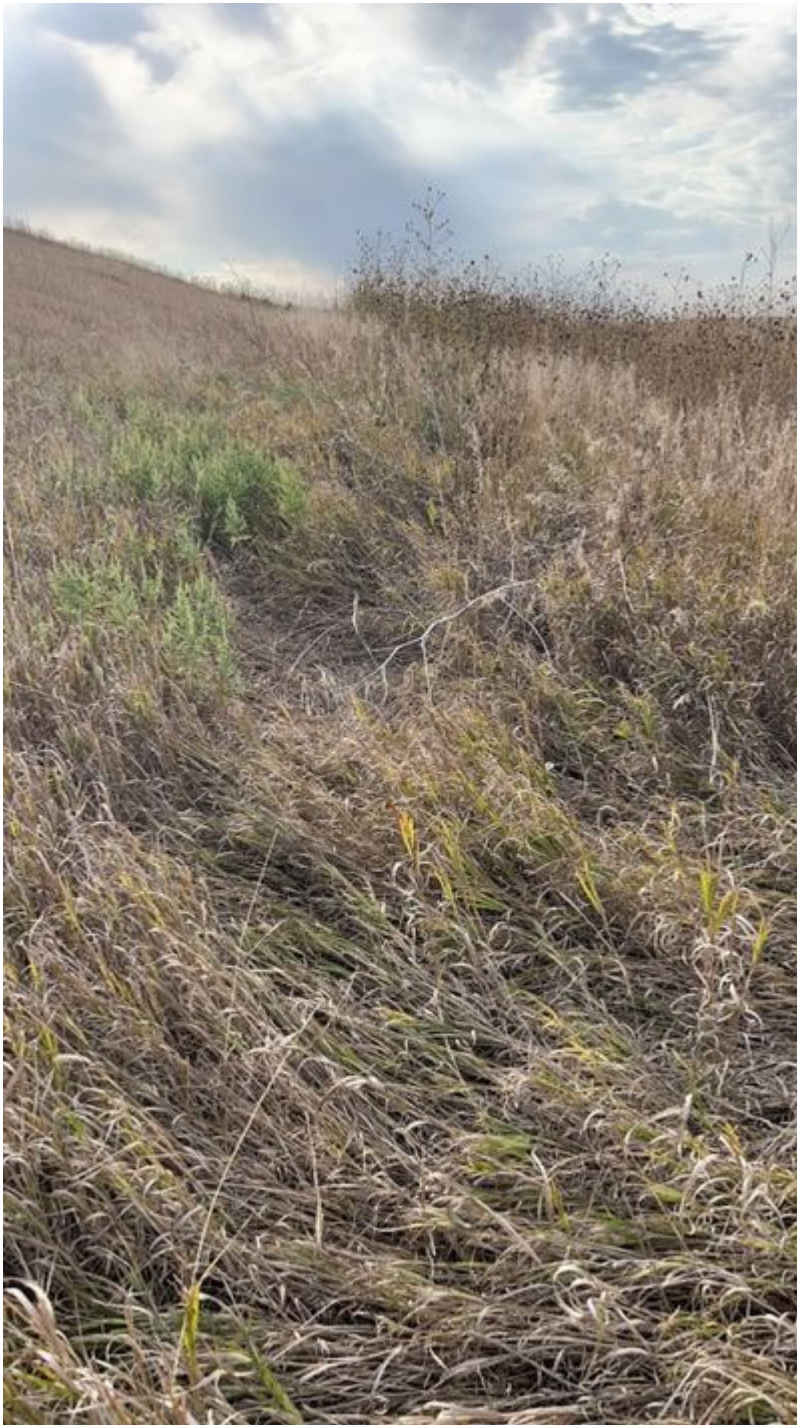
Photo Location: 7

Photo Caption: Vegetation near outside toe of north exterior slope.

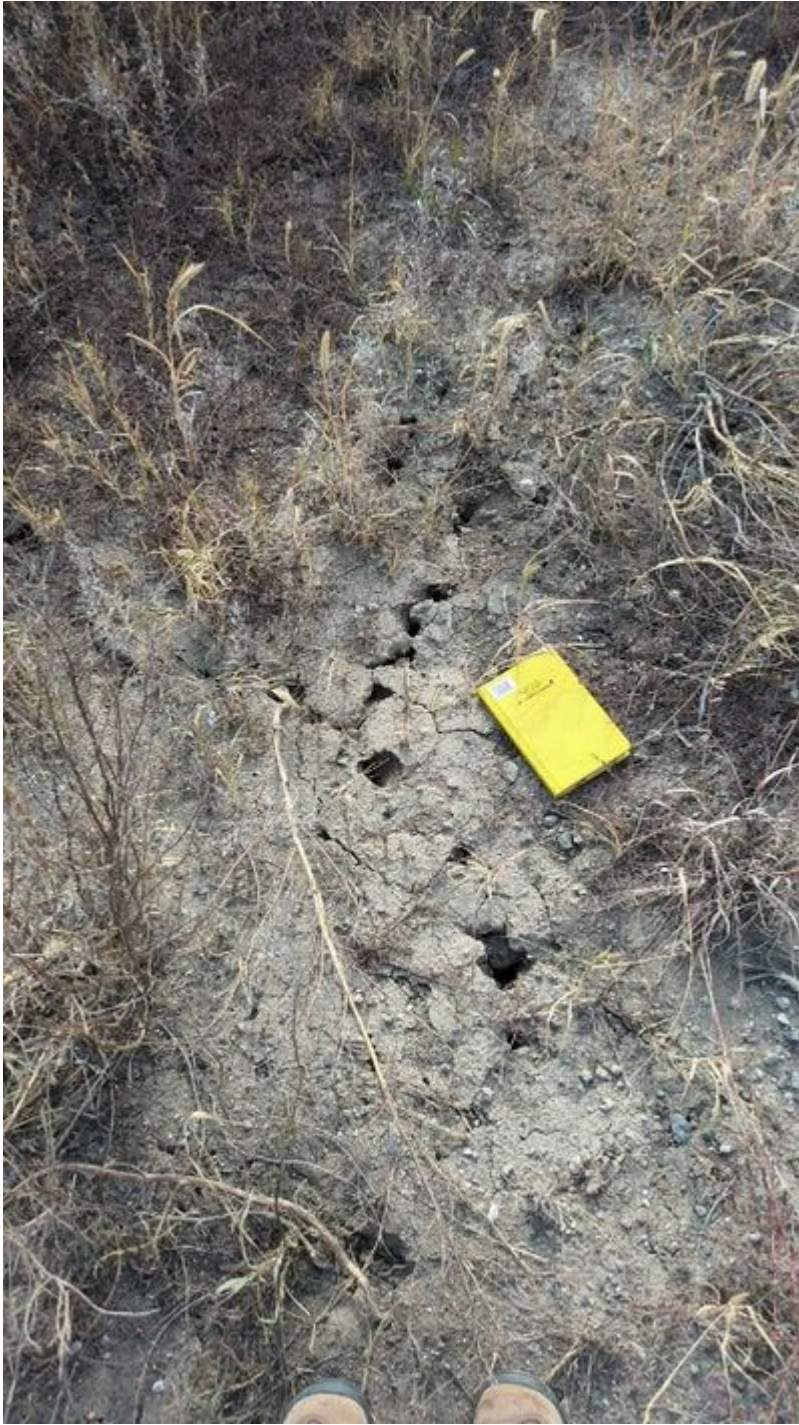
Photo Location: 8

Photo Caption: Dry surface of final cover.

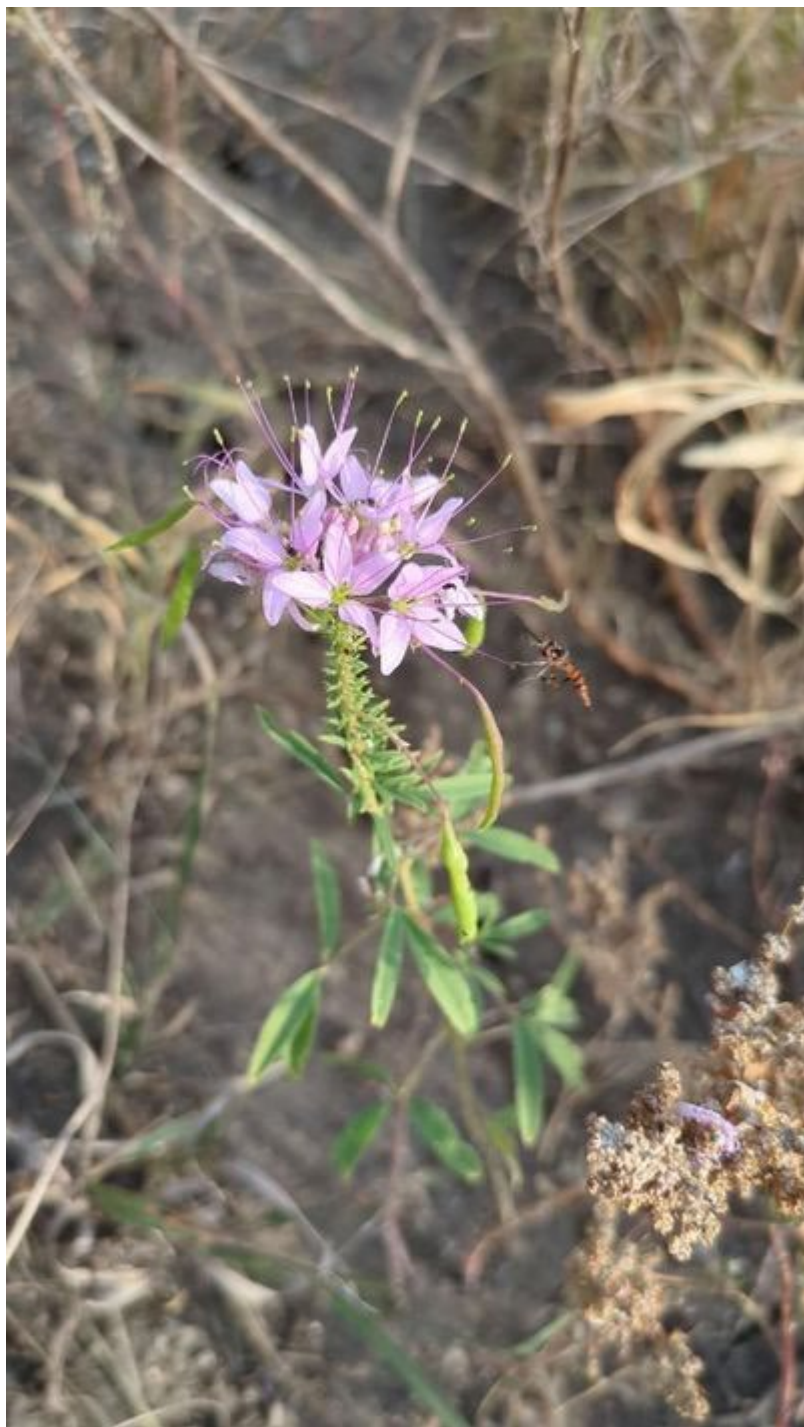
Photo Location: 9

Photo Caption: Pollinator on flower on the final cover vegetation.

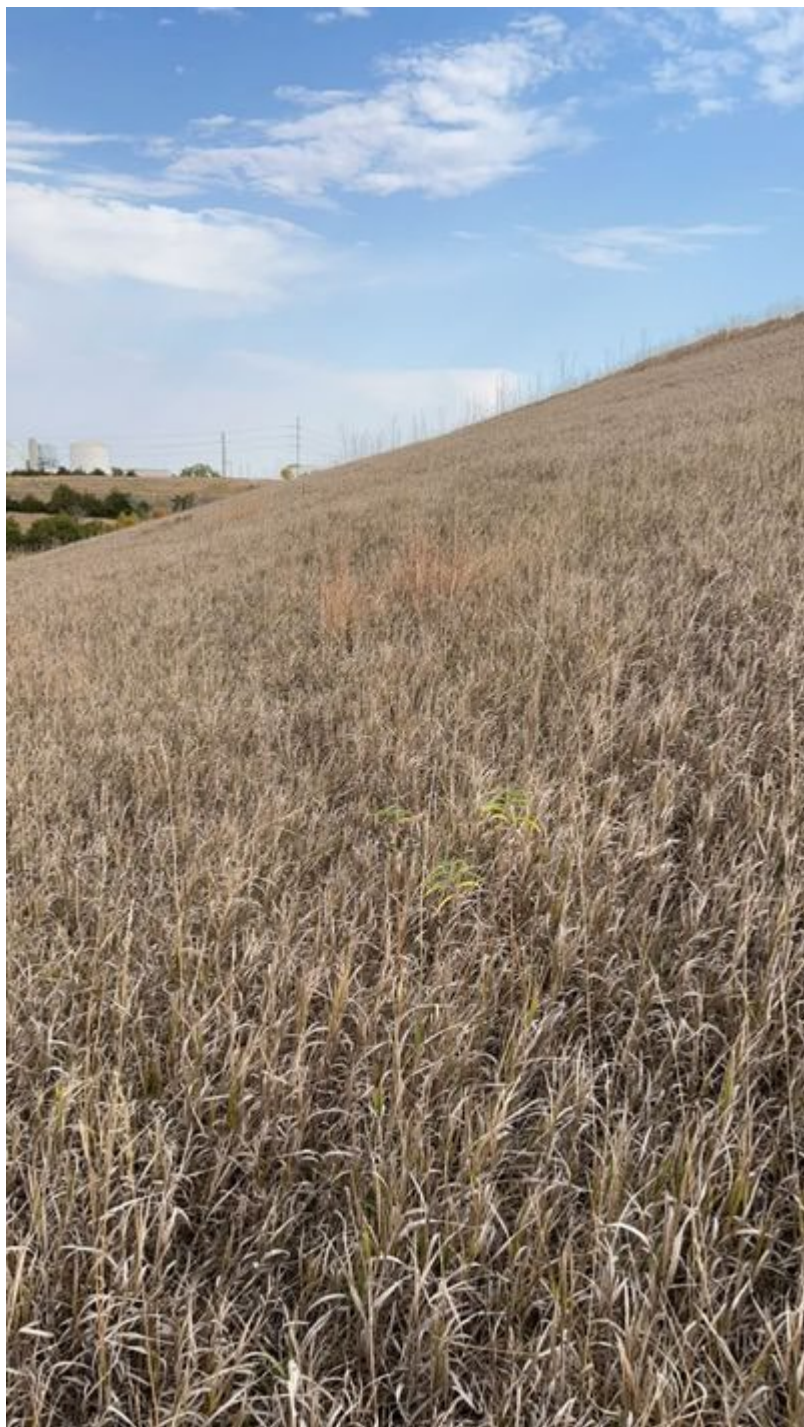
Photo Location: 10

Photo Caption: Slope approaching down chute in the northeast.

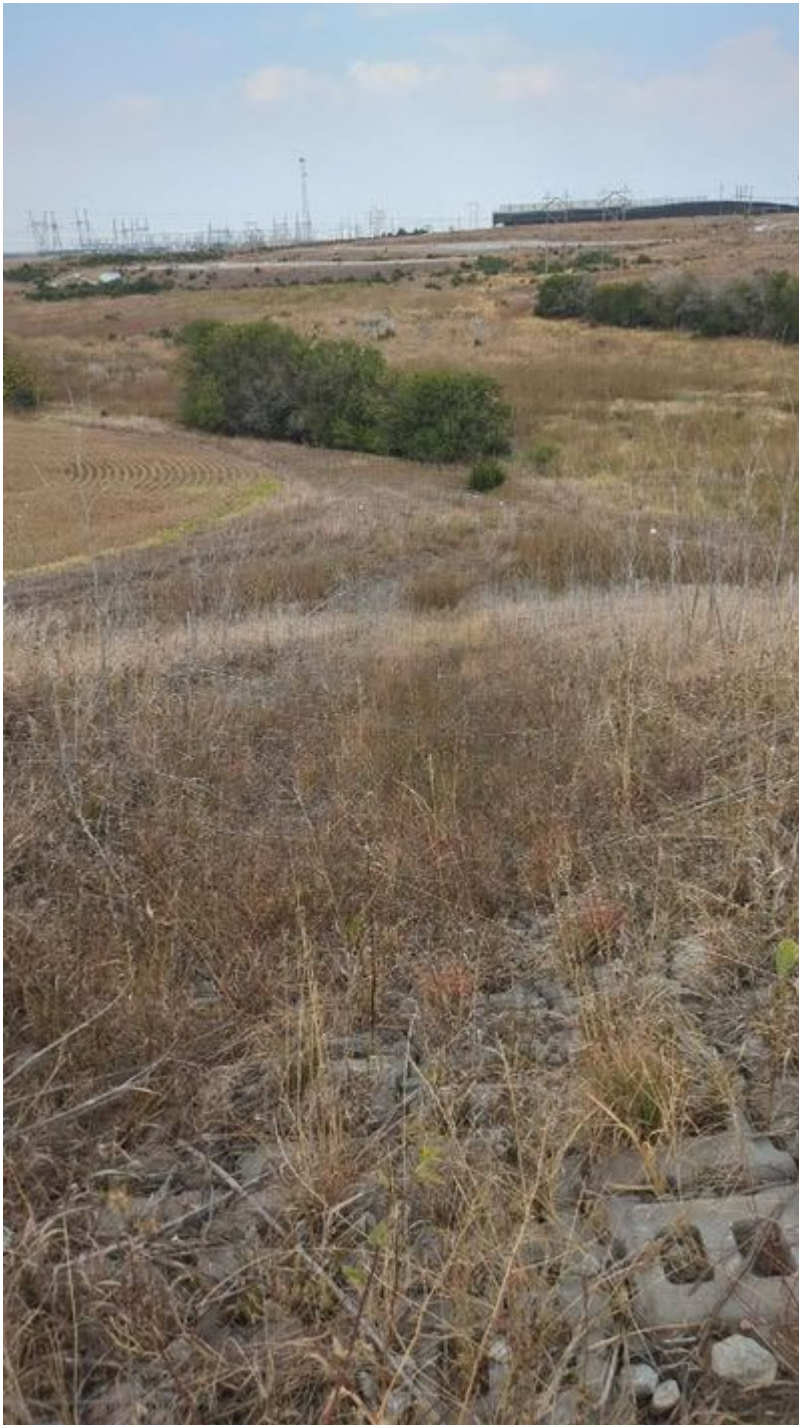
Photo Location: 11

Photo Caption: Northeast downchute.

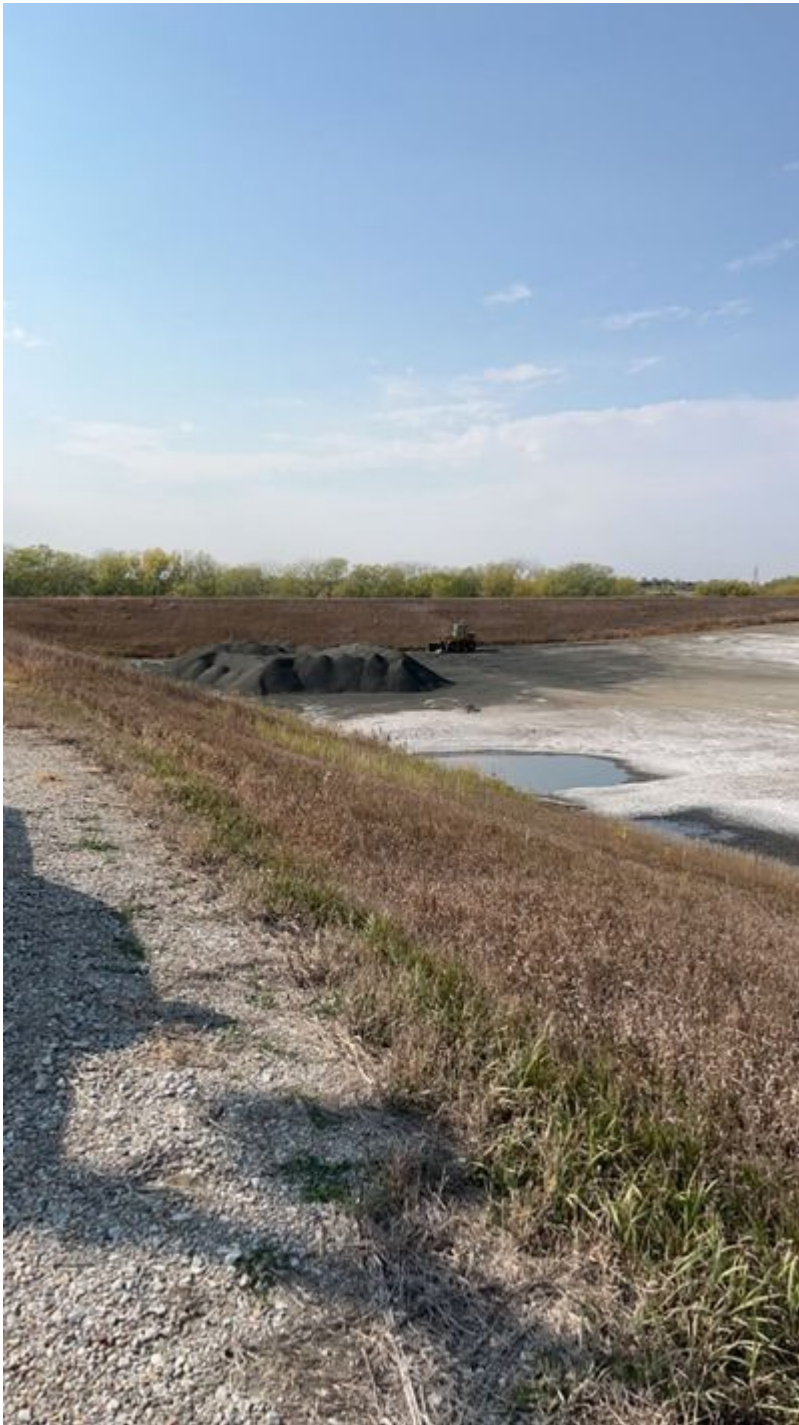
Photo Location: 12

Photo Caption: Active ash deposition area.

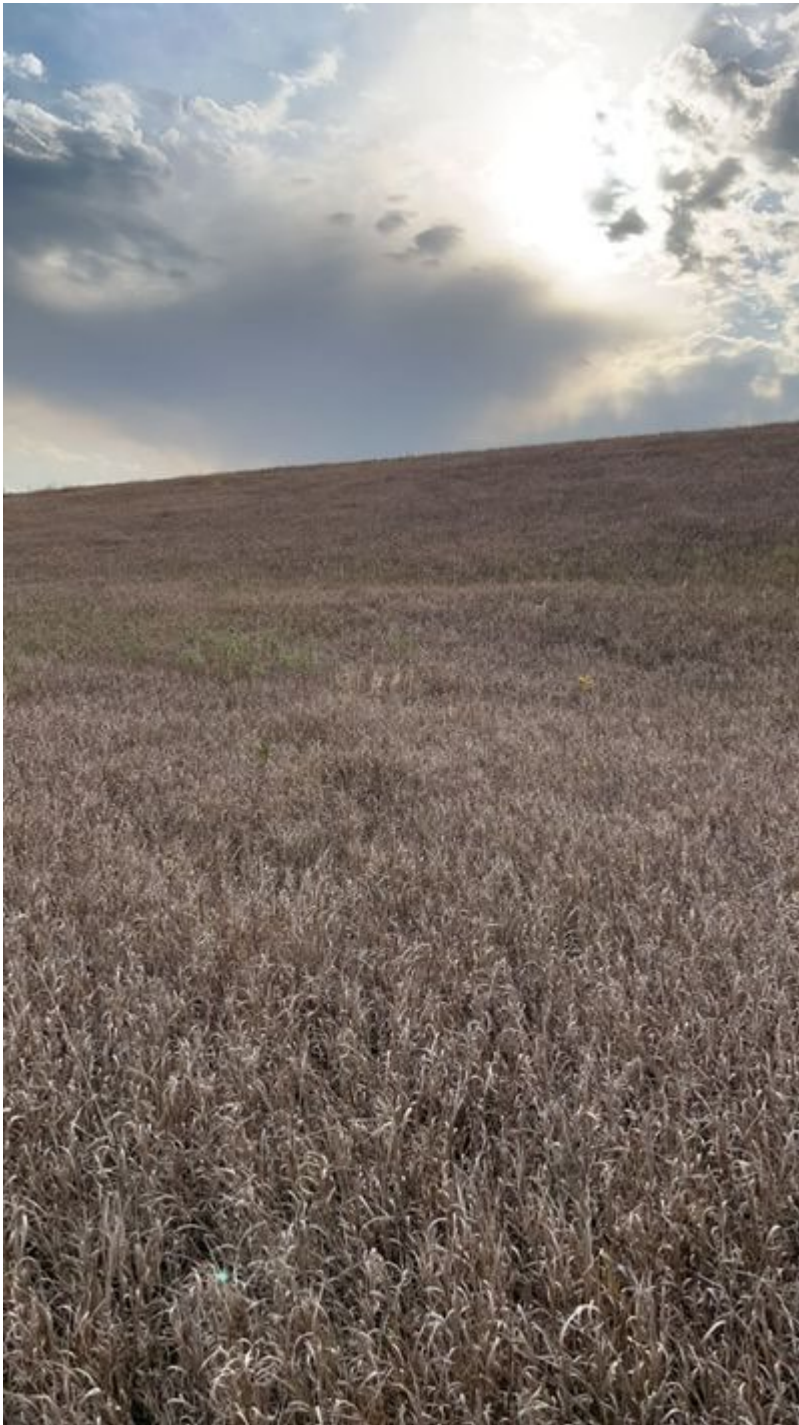
Photo Location: 13

Photo Caption: East exterior slope.
