2025 Professional Engineer Inspection Report

Gerald Gentleman Station Ash Disposal Facility

Nebraska Public Power District

GLA21457062.3513-002-RPT-0

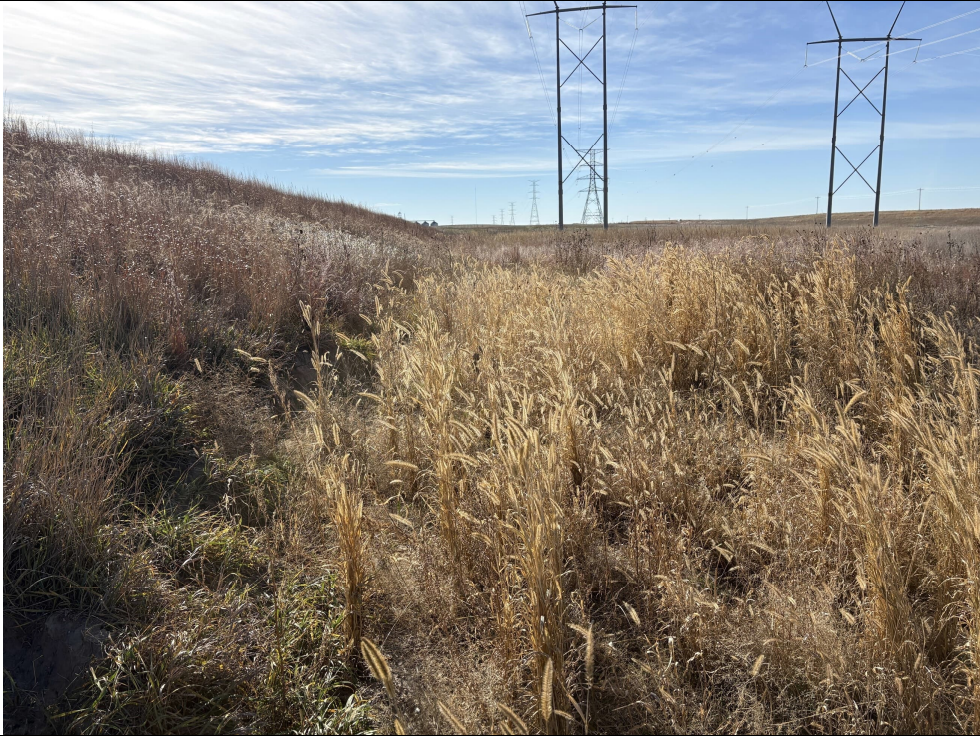
- Minor erosion was observed on the west slope of Ash Landfill No. 3 and south slopes of Ash Landfill No. 3 and Ash Landfill No. 4.
- Locations of ash deposition and ponded water indicated that the facility is being operated according to design.
- Maintenance activities, including pump maintenance, removal of small saplings, and erosion repairs were ongoing throughout the year.
- The area with erosion on the west slope of Ash Landfill No. 3 was repaired the week of June 25, 2025.

Photograph 1
Erosion repairs west of Ash Landfill No. 3

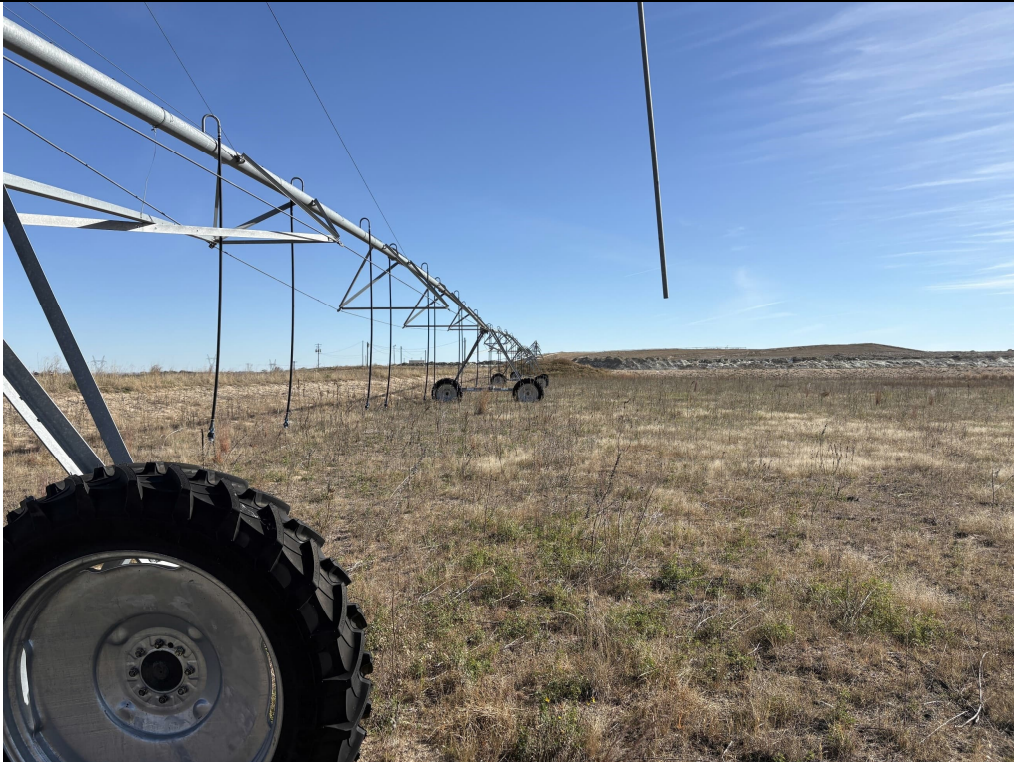
Photograph 2
West (inactive) cell of Ash Landfill No. 3

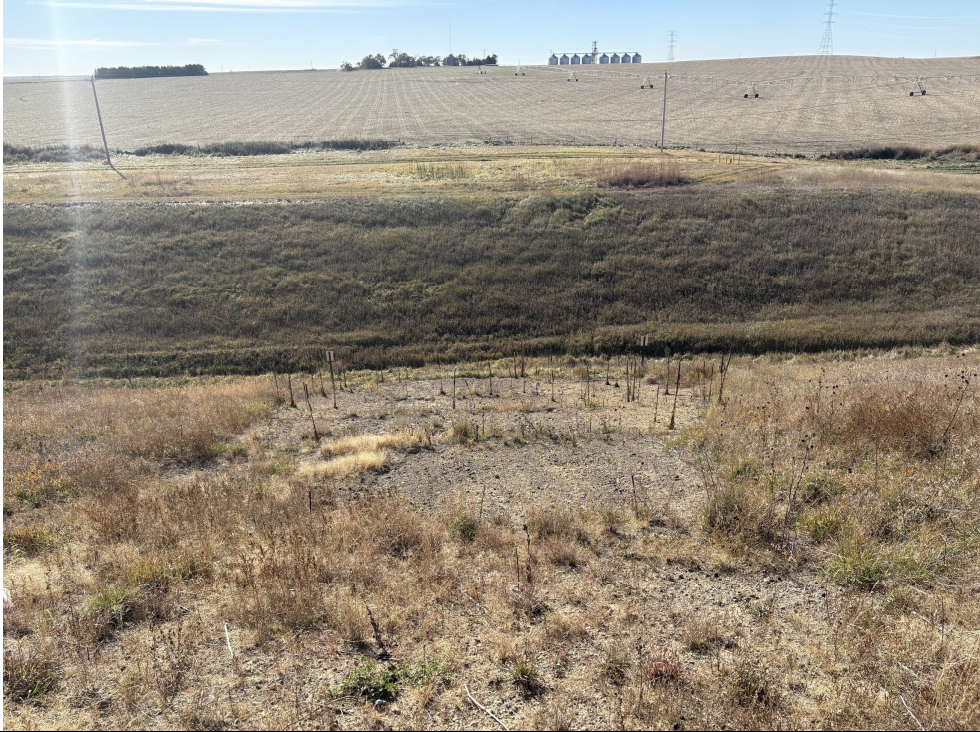
Erosion was observed on the outer embankment slopes on the west and south sides of Ash Landfill No. 3 and the south side of Ash Landfill No. 4. Erosion of the exterior slopes should be monitored, and NPPD should continue to perform routine maintenance on the slopes. NPPD performed significant maintenance on the area on the west side of Ash Landfill No. 3 in June of 2025. This area should be monitored as vegetation is reestablished. NPPD should also address the area on the south exterior slopes of Ash Landfill No. 3 and south side of Ash Landfill No. 4 that have experienced erosion so that vegetation can be established to minimize future erosion.

Photograph 3
Area with thin vegetation on south of Ash Landfill No. 3

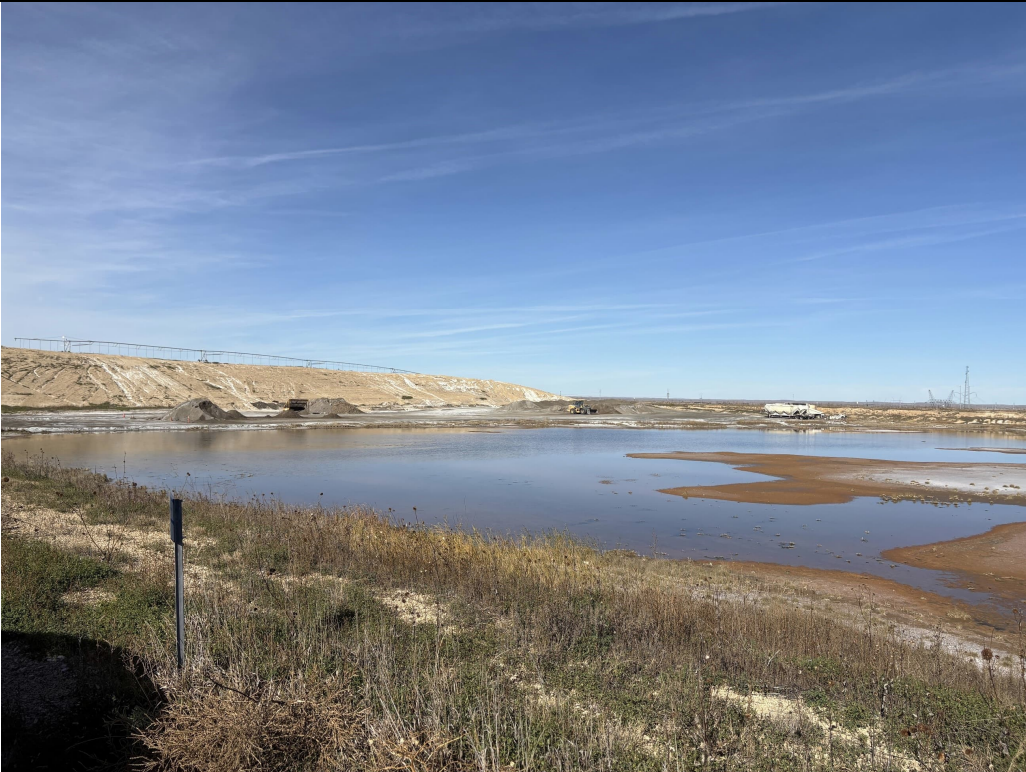
Photograph 4
Contact water evaporation pond

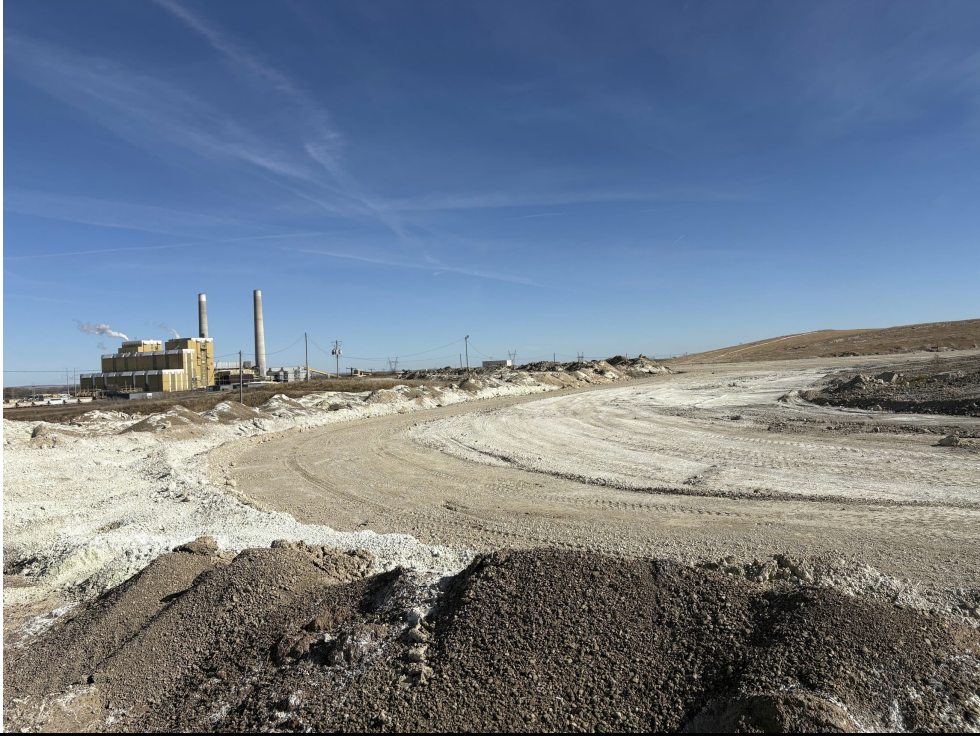
Photograph 5
Active deposition area of Ash Landfill No. 3.

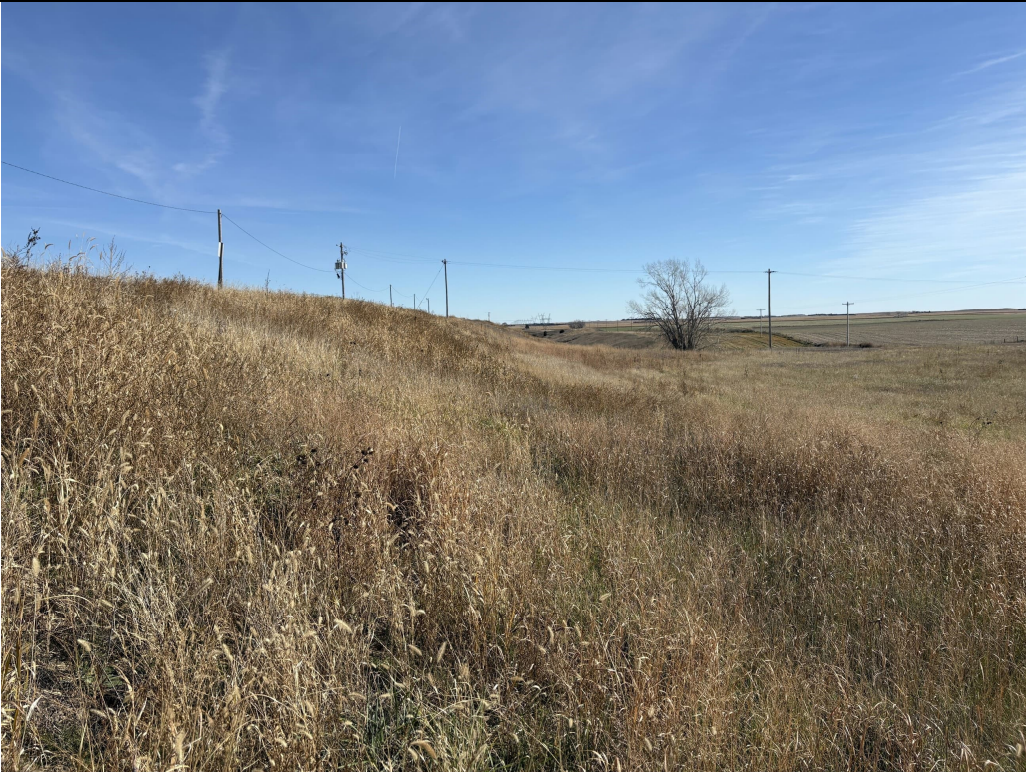
Photograph 6
North slope of Ash Landfill No 3 and closed Bottom Ash Landfill

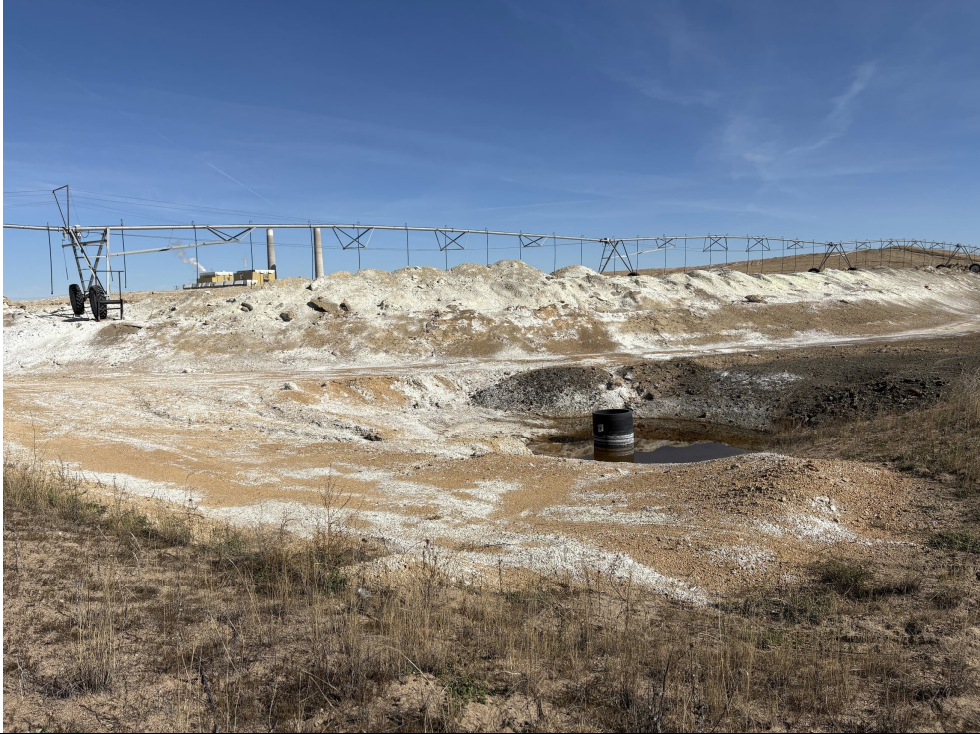
Photograph 7
Sump area in east cell of Ash Landfill No. 3

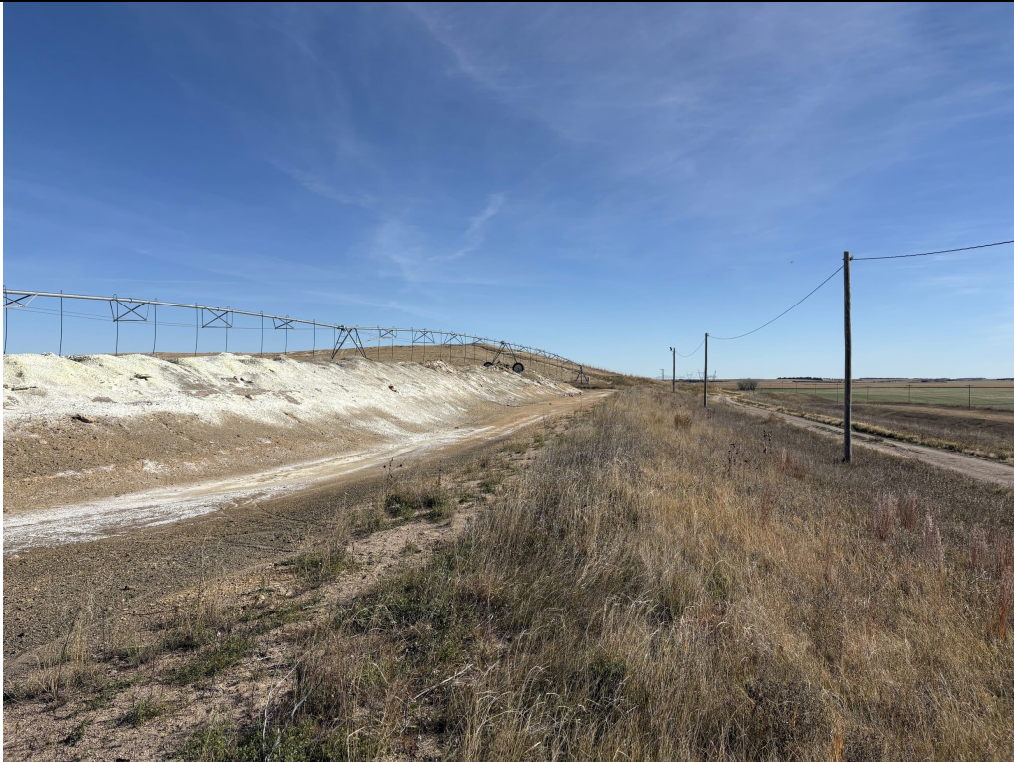
Photograph 8
Ash contact water containment berm south side of Ash Landfill No. 3

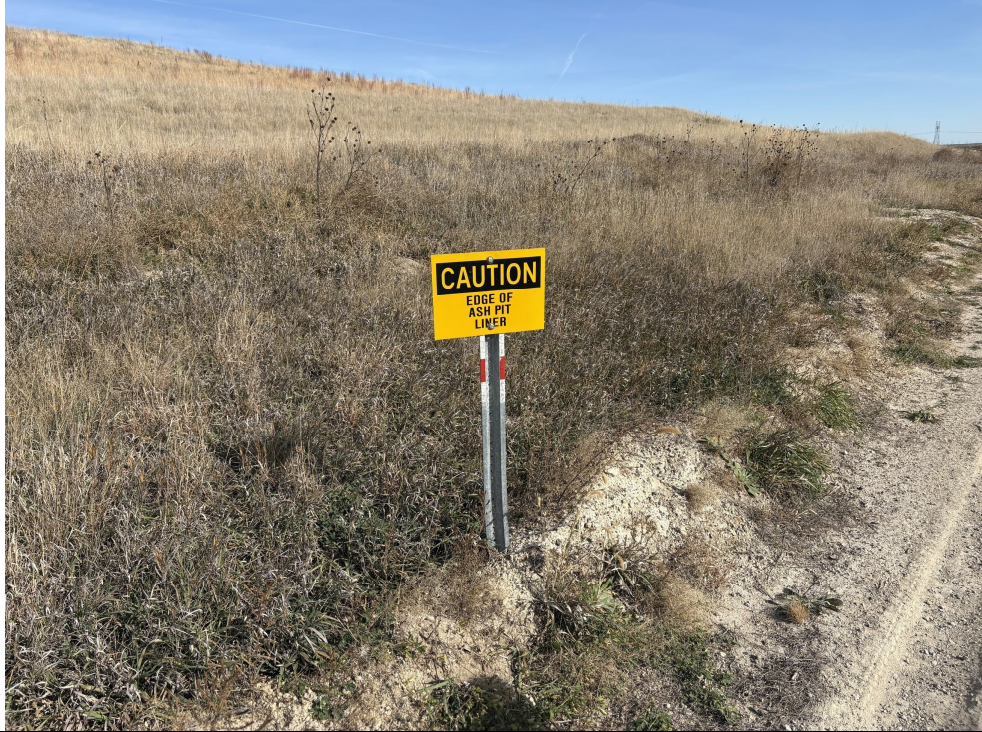
Photograph 9
Edge of liner marker on Ash Landfill No. 4

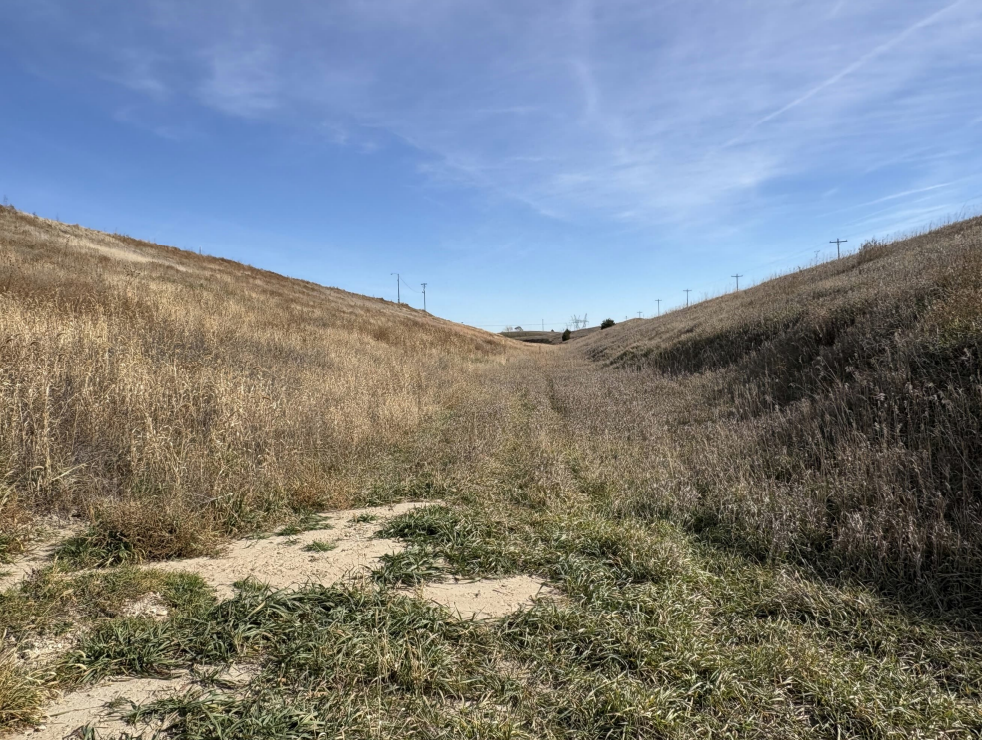
The terrace channels and down chute channel on the final cover appear to be functioning as designed.

Photograph 10
South exterior slope and drainage channel at Ash Landfill No. 4

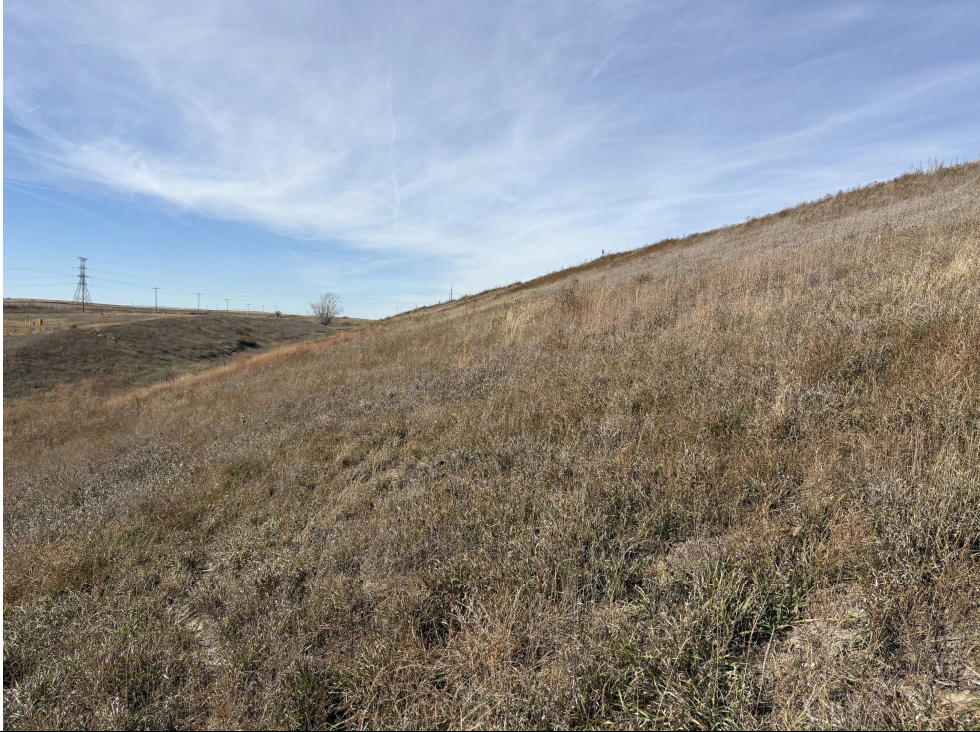
Photograph 11
South exterior slope at Ash Landfill No. 4

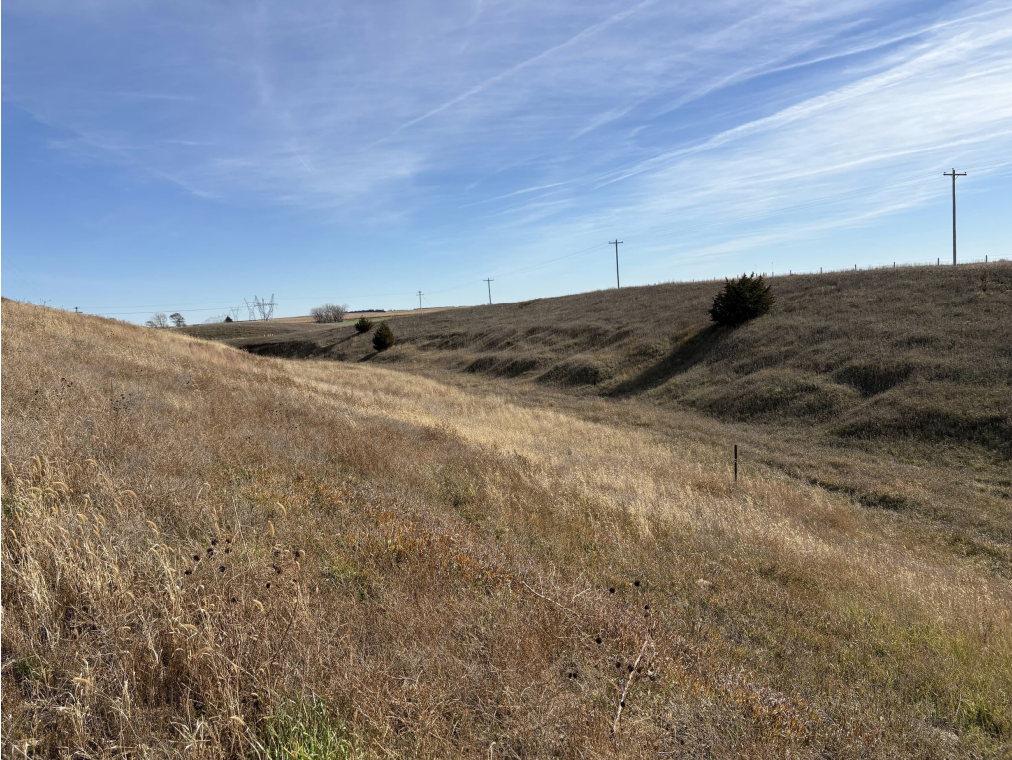
Photograph 12
Southeast corner exterior slope at Ash Landfill No. 4

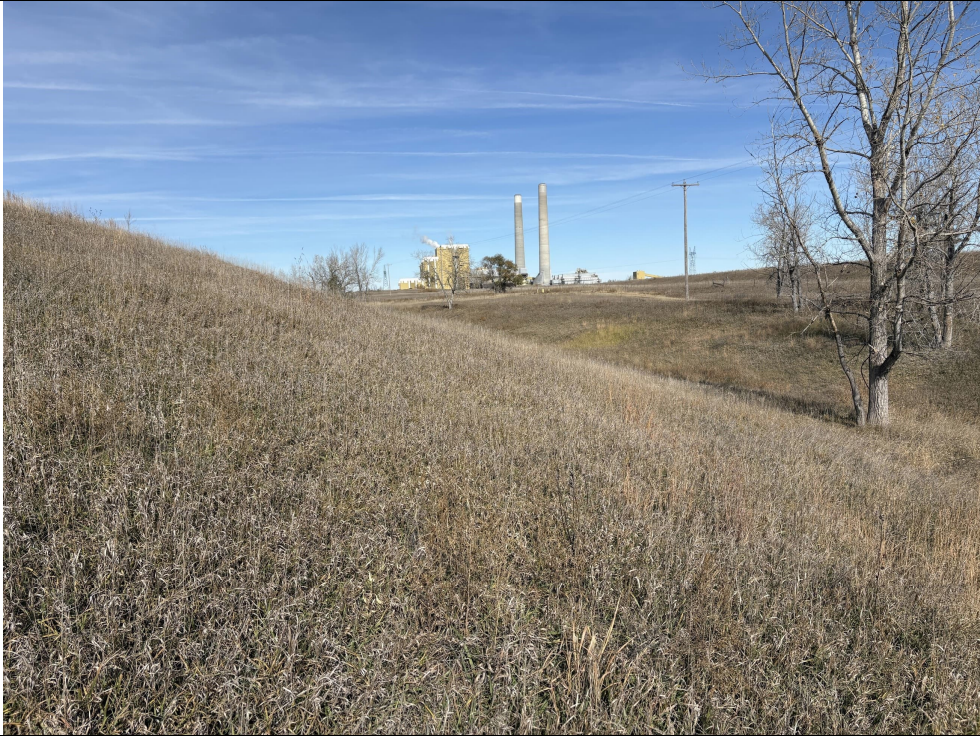
Photograph 13
East exterior slope at Ash Landfill No. 4

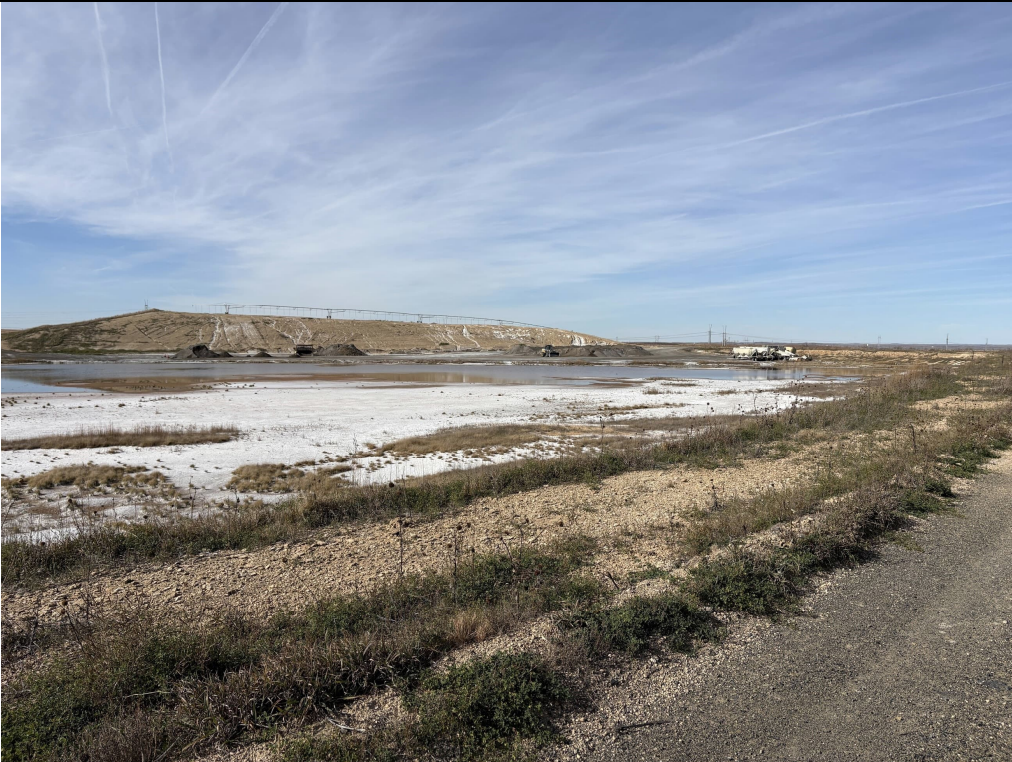
Photograph 14
Contact water evaporation pond and bottom ash handling area

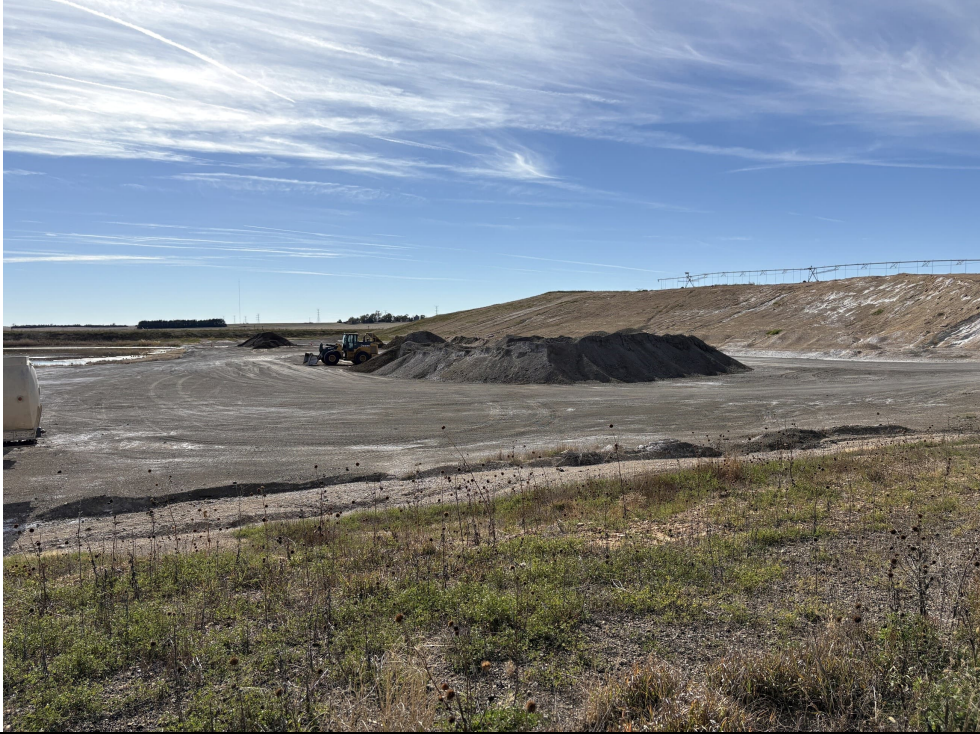
Photograph 15
Bottom ash handling area

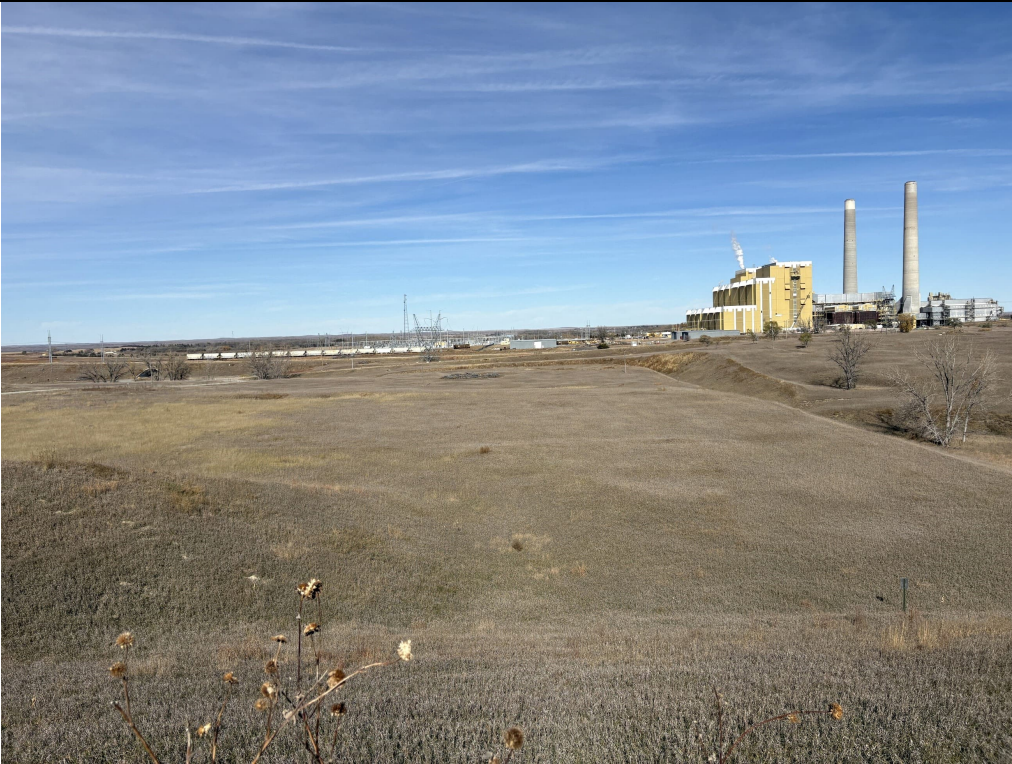
Photograph 16
North exterior slope of Ash Landfill No. 4
