2025 Professional Engineer Inspection Report

Sheldon Station Ash Landfill No. 4

Nebraska Public Power District

GLA21457062.3557-002-RPT-0

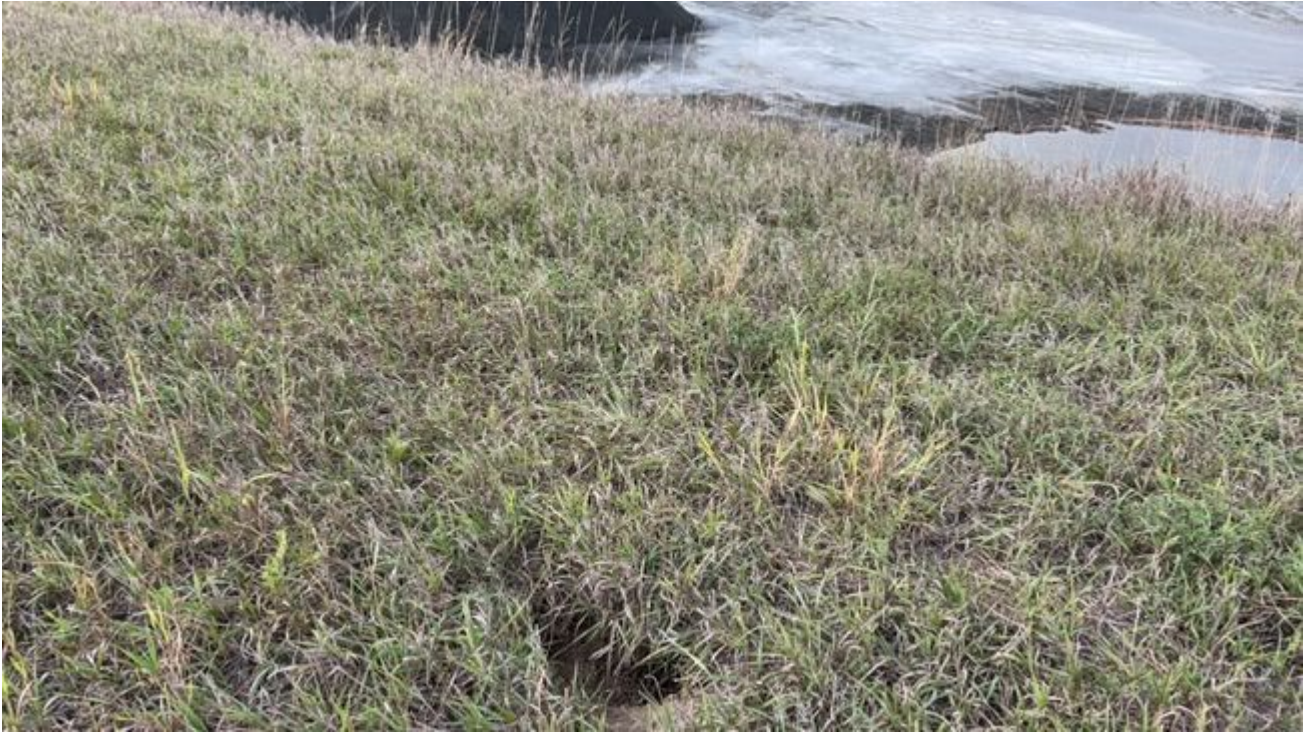
Minor animal burrows were observed during the October 9, 2025, site inspection. No mitigating action is necessary at this time, but burrows should continue to be monitored. Any significant increase in the level of small animal activity, or any sign of large animal burrowing, will be remedied by trapping and removal to an off-site location.

Site Notes:
Critter hole

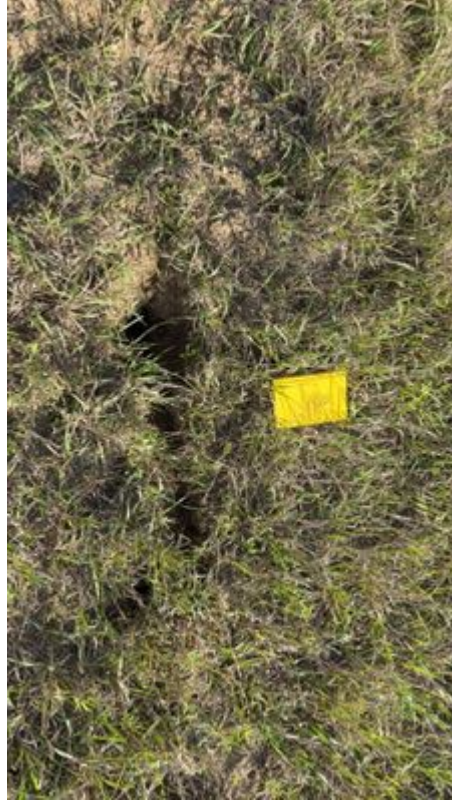
Surficial cracks have been observed in the perimeter road around the crest of the facility embankment during previous annual inspections. The cracking was observed to be significantly improved during the site inspection on October 9, 2025. 2025 has been wetter than recent years, and the additional precipitation appears to have helped the surficial cracking observed around the perimeter embankment. Cracks were previously observed along significant stretches of the embankment crest, both along the interior and exterior, especially on the south, east, and west sides of the facility. During the 2025 site inspection, the cracking was limited to the south embankment crest. The cracks were confined to about a 20-foot area, generally parallel with the crest. No signs of bulking or slope movement were observed along the surface or toe of interior or exterior slopes. NPPD should continue to closely monitor the cracking and report to WSP immediately if the cracks change in size or if additional cracks appear or displacement is observed.

Site Notes:
Crack at south embankment crest

The 2025 annual inspection for Ash Landfill No. 4 at Sheldon Station was performed on October 9, 2025. The inspection met the requirements for CCR landfills under 40 CFR Part 257.84. The inspection found no indication of major structural deficiencies. NPPD should continue to monitor the cracking in the perimeter and notify WSP of any changes.

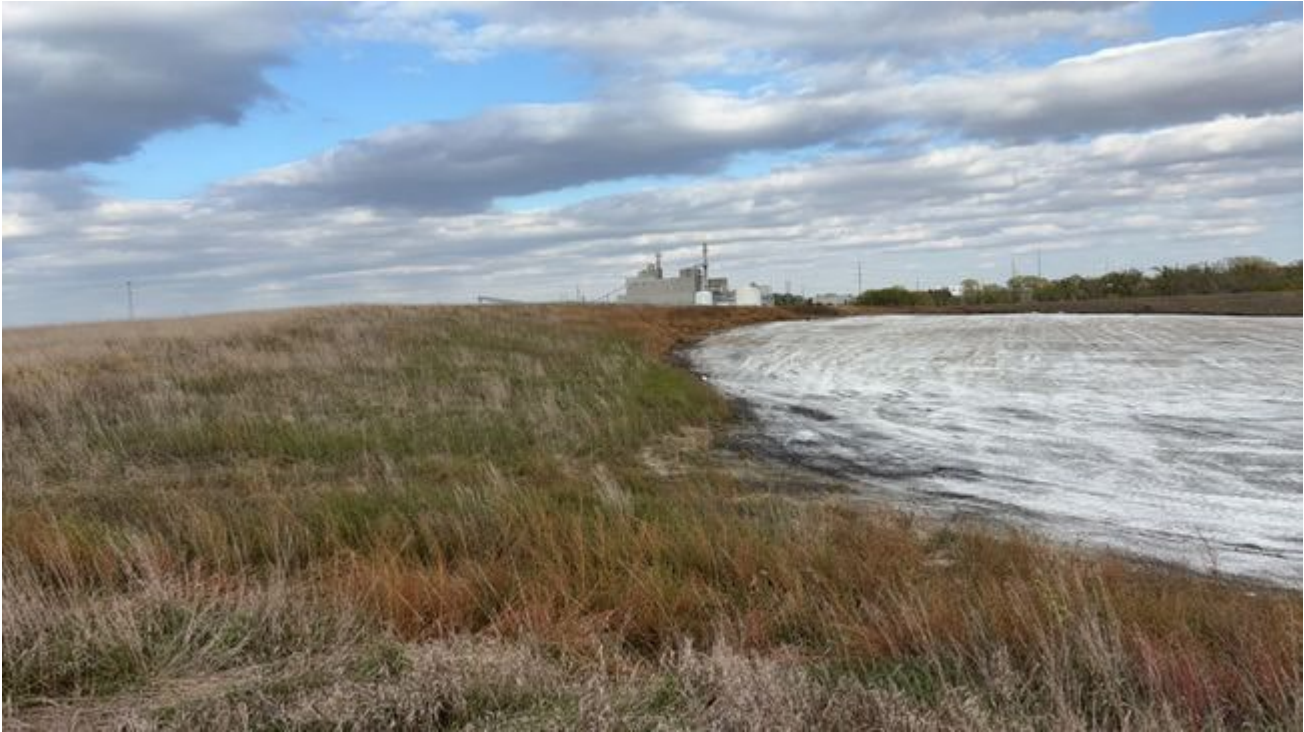
Site Notes:
Minor burrow
