2021 Annual Inspection Report

Sheldon Station Ash Landfill No. 4

Nebraska Public Power District

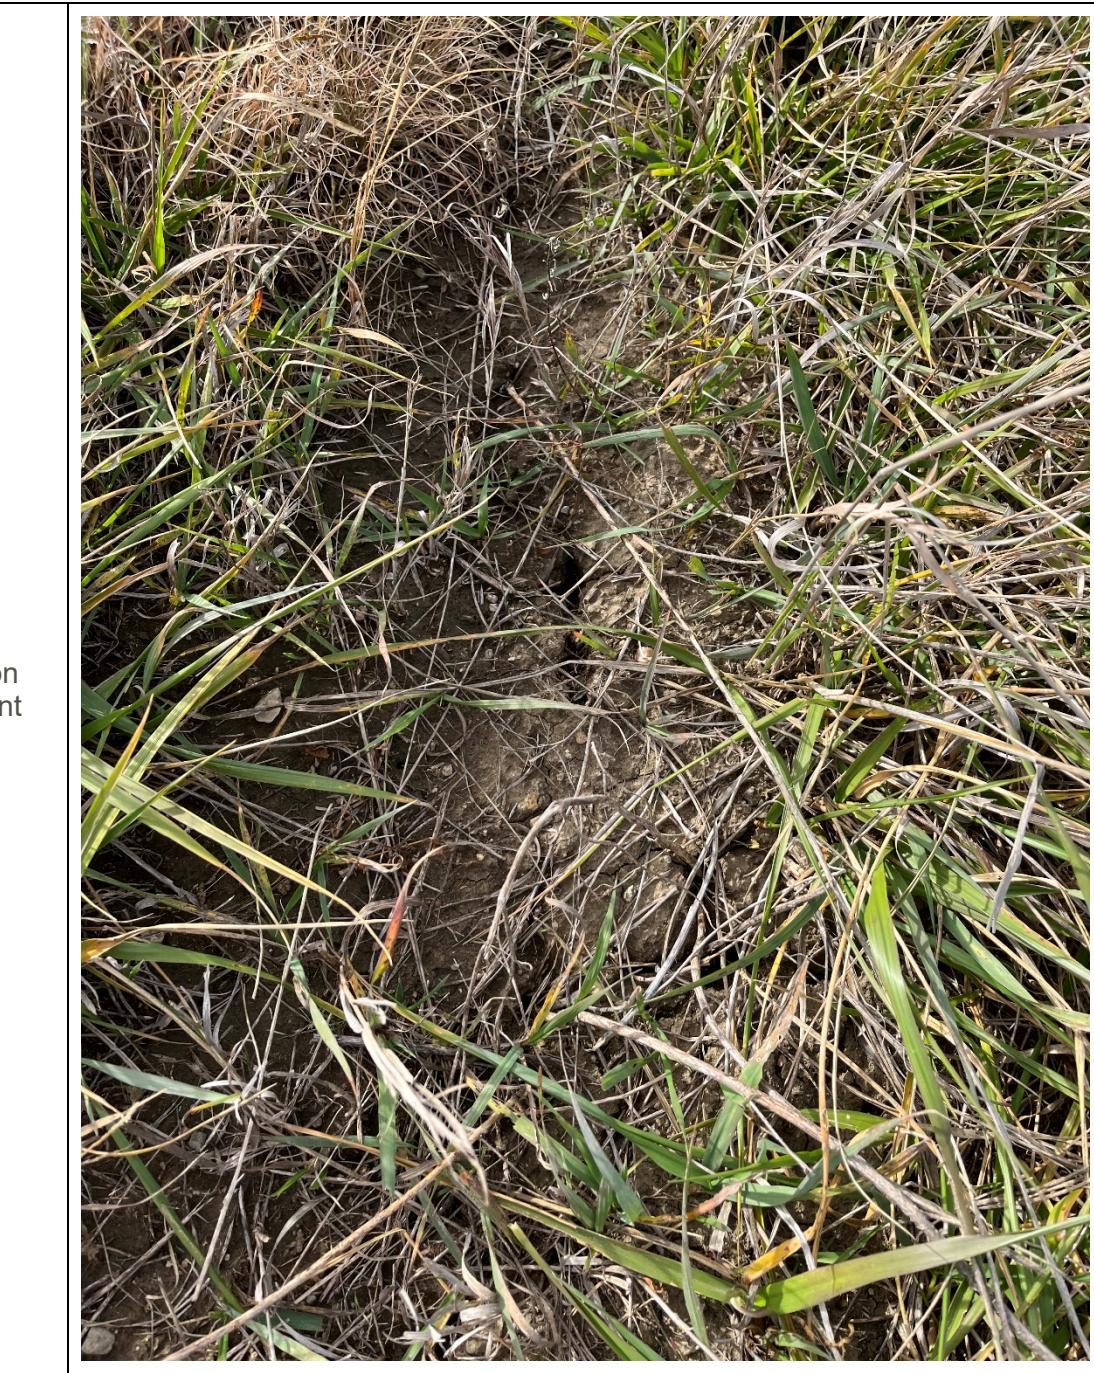
РНОТО 1

Surficial cracks were observed in the perimeter road around the crest of the facility embankment during the annual inspection. Cracks were observed in four locations on the south end of the embankment crest and one location on the east embankment crest. The cracks were as large as approximately one inch wide and more than six inches deep in several locations. The crack near the southwest corner of the embankment crest was approximately seven feet long. The other cracks observed were four feet long or less. The cracking and accompanying displacement are likely due to warm and dry conditions desiccating the surface soils. NPPD should fill the cracks with soil and continue to closely monitor the cracking and report to Golder immediately if the cracks reappear or change in size, or if additional cracks appear or displacement is observed.

Crack observed on south embankment crest

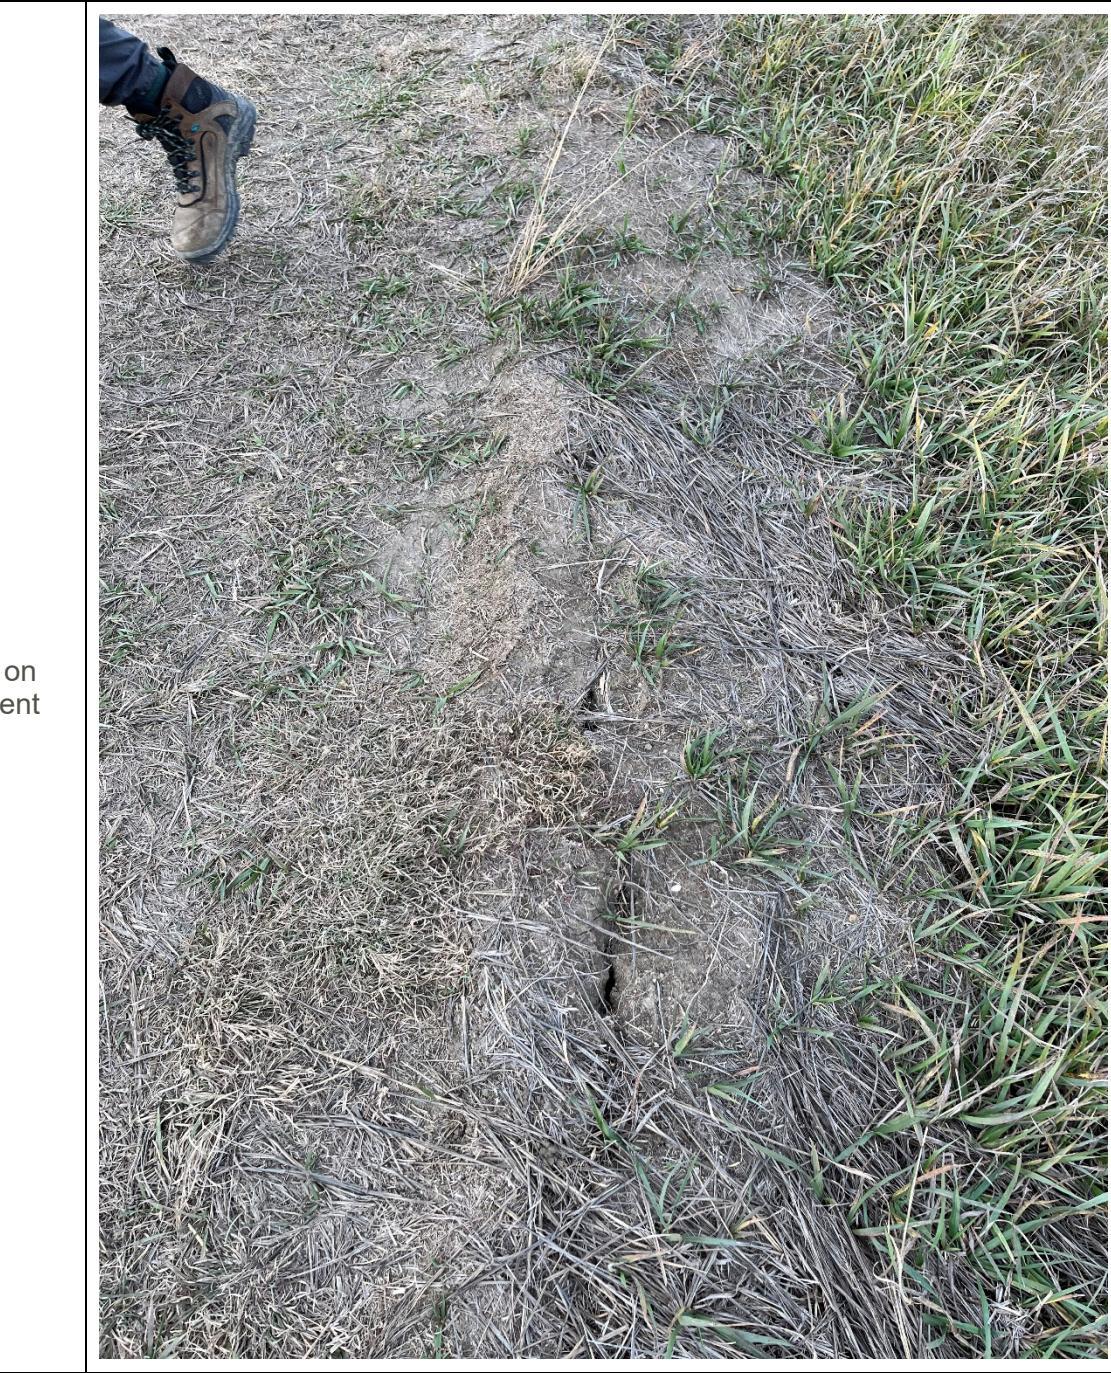
PHOTO 2

Crack observed on south embankment crest

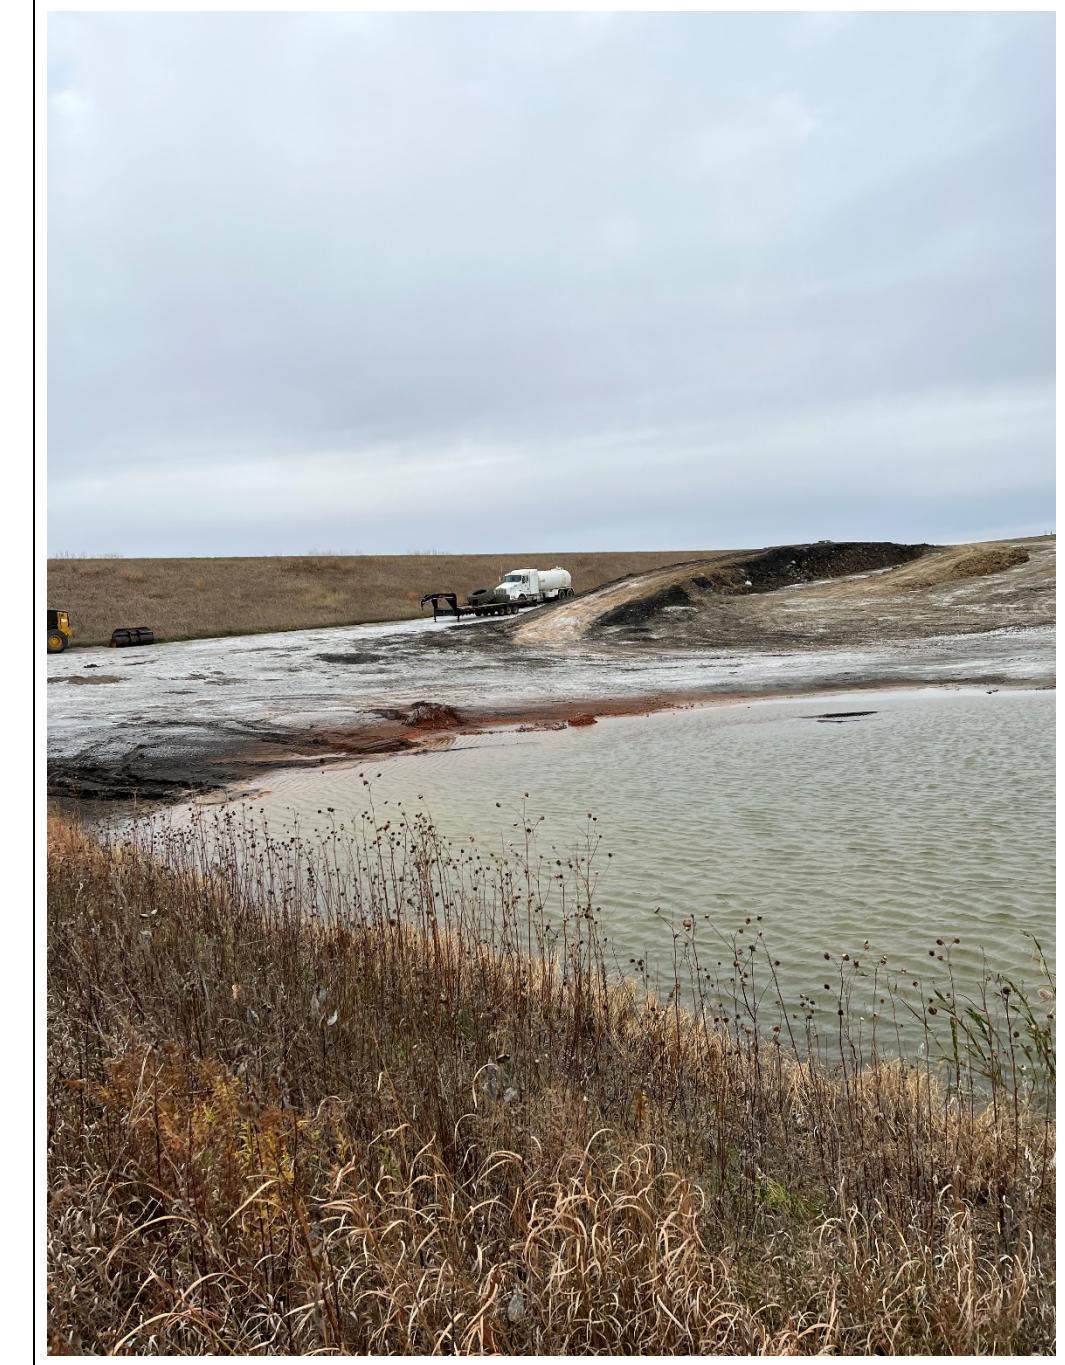
РНОТО 3

Contact water pond on south side of ash disposal facility

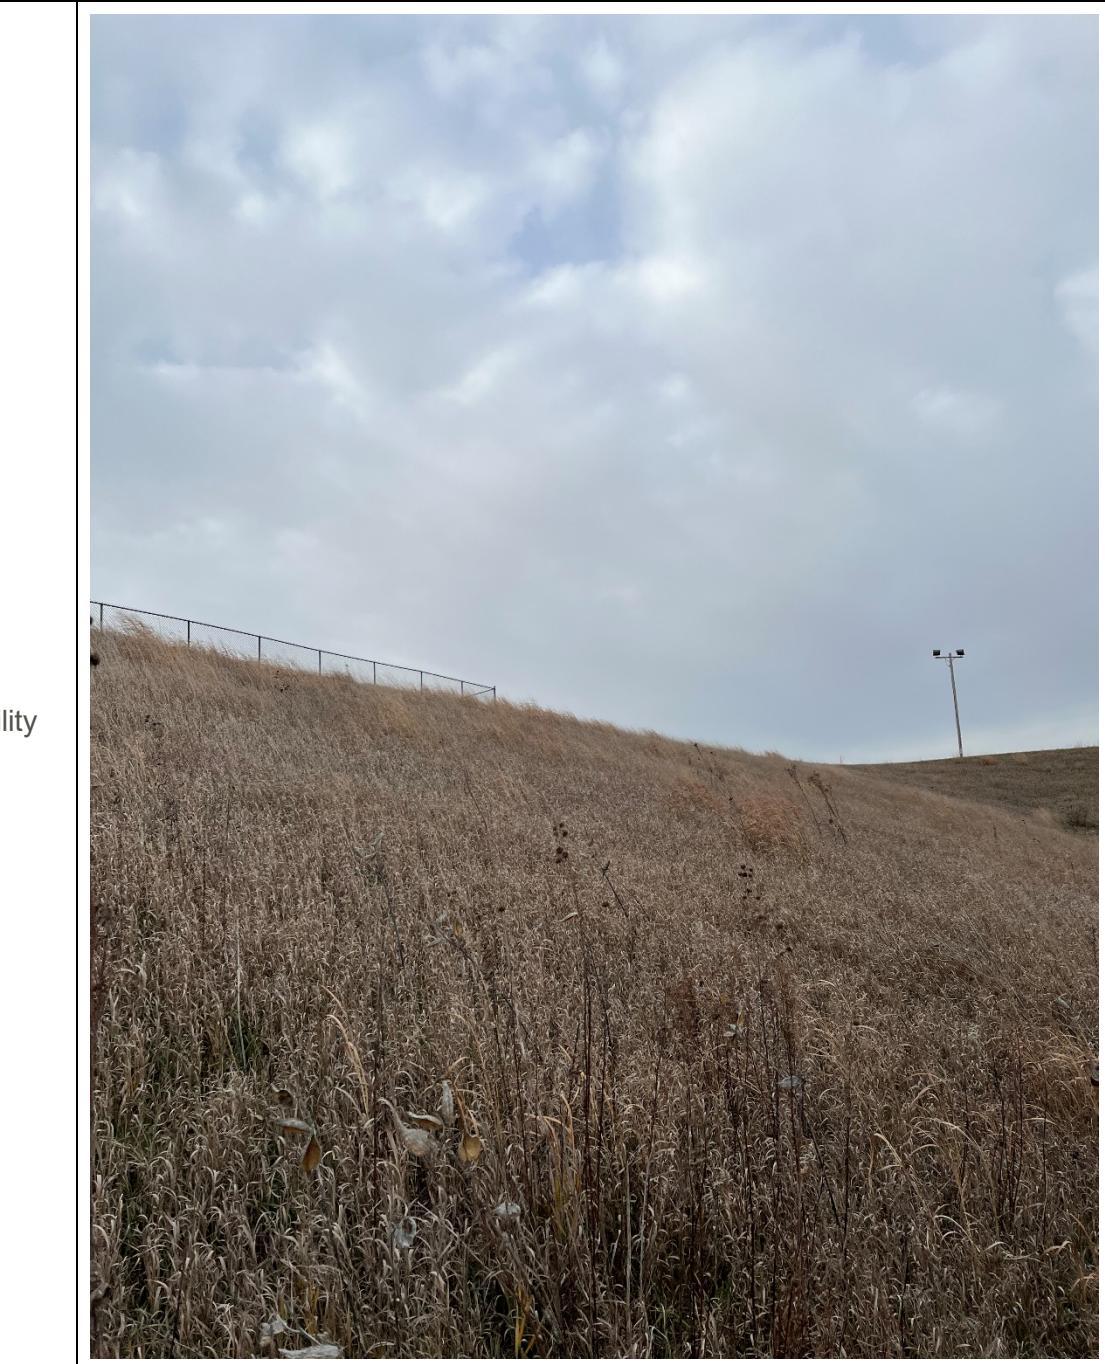
PHOTO 4

Interior slope on south side of facility

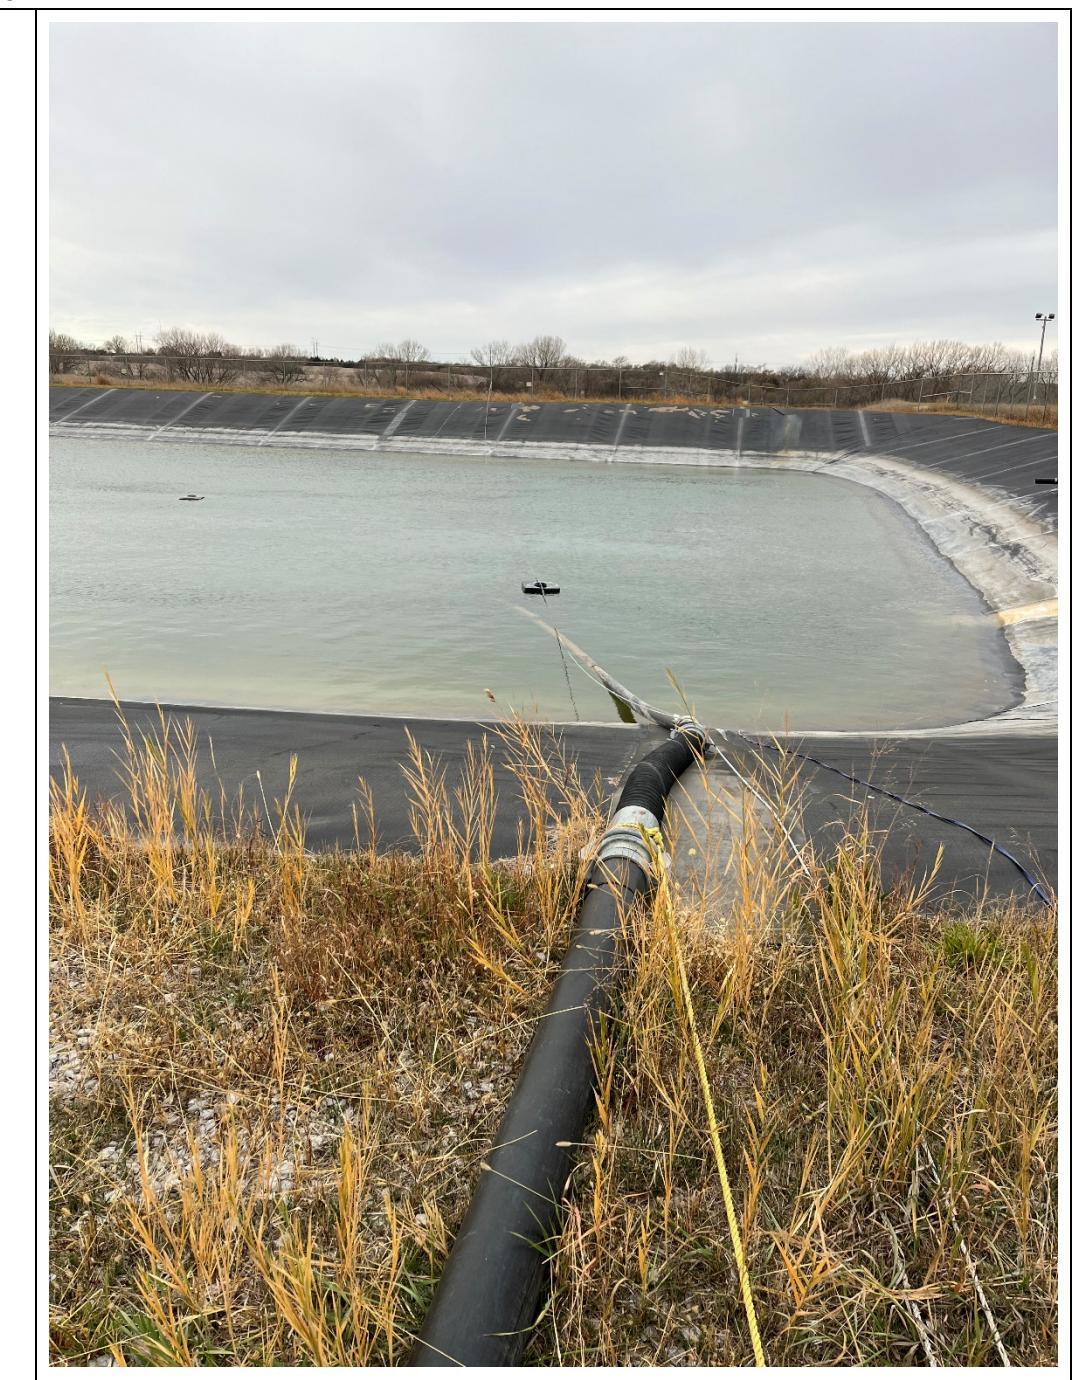
PHOTO 5

Leachate evaporation pond

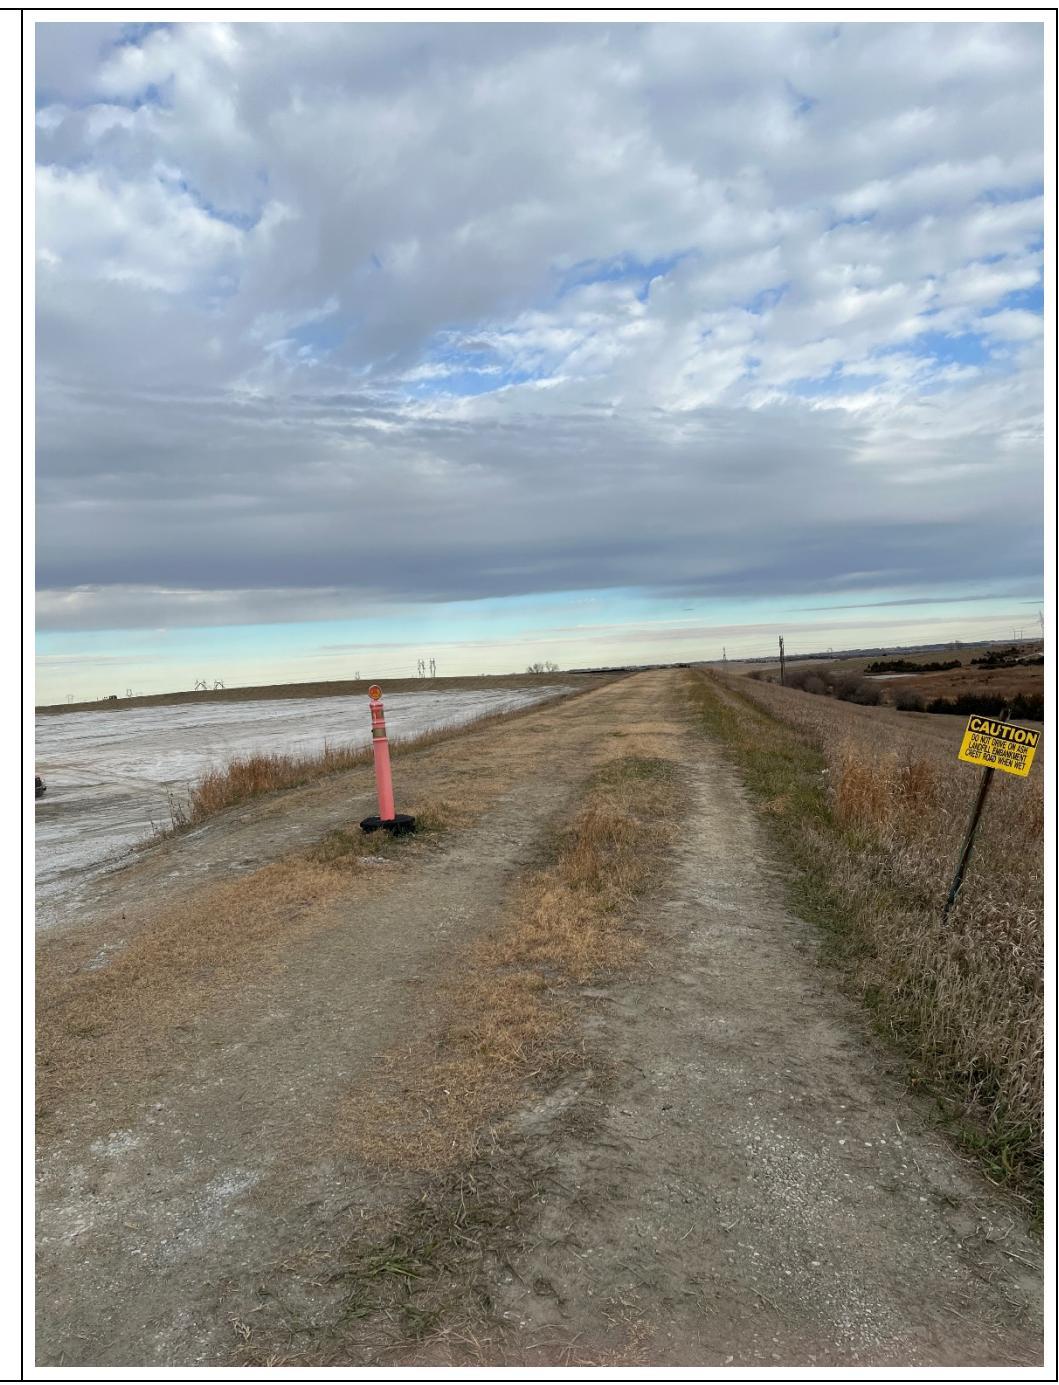
PHOTO 7

Perimeter road (southeast corner of facility)

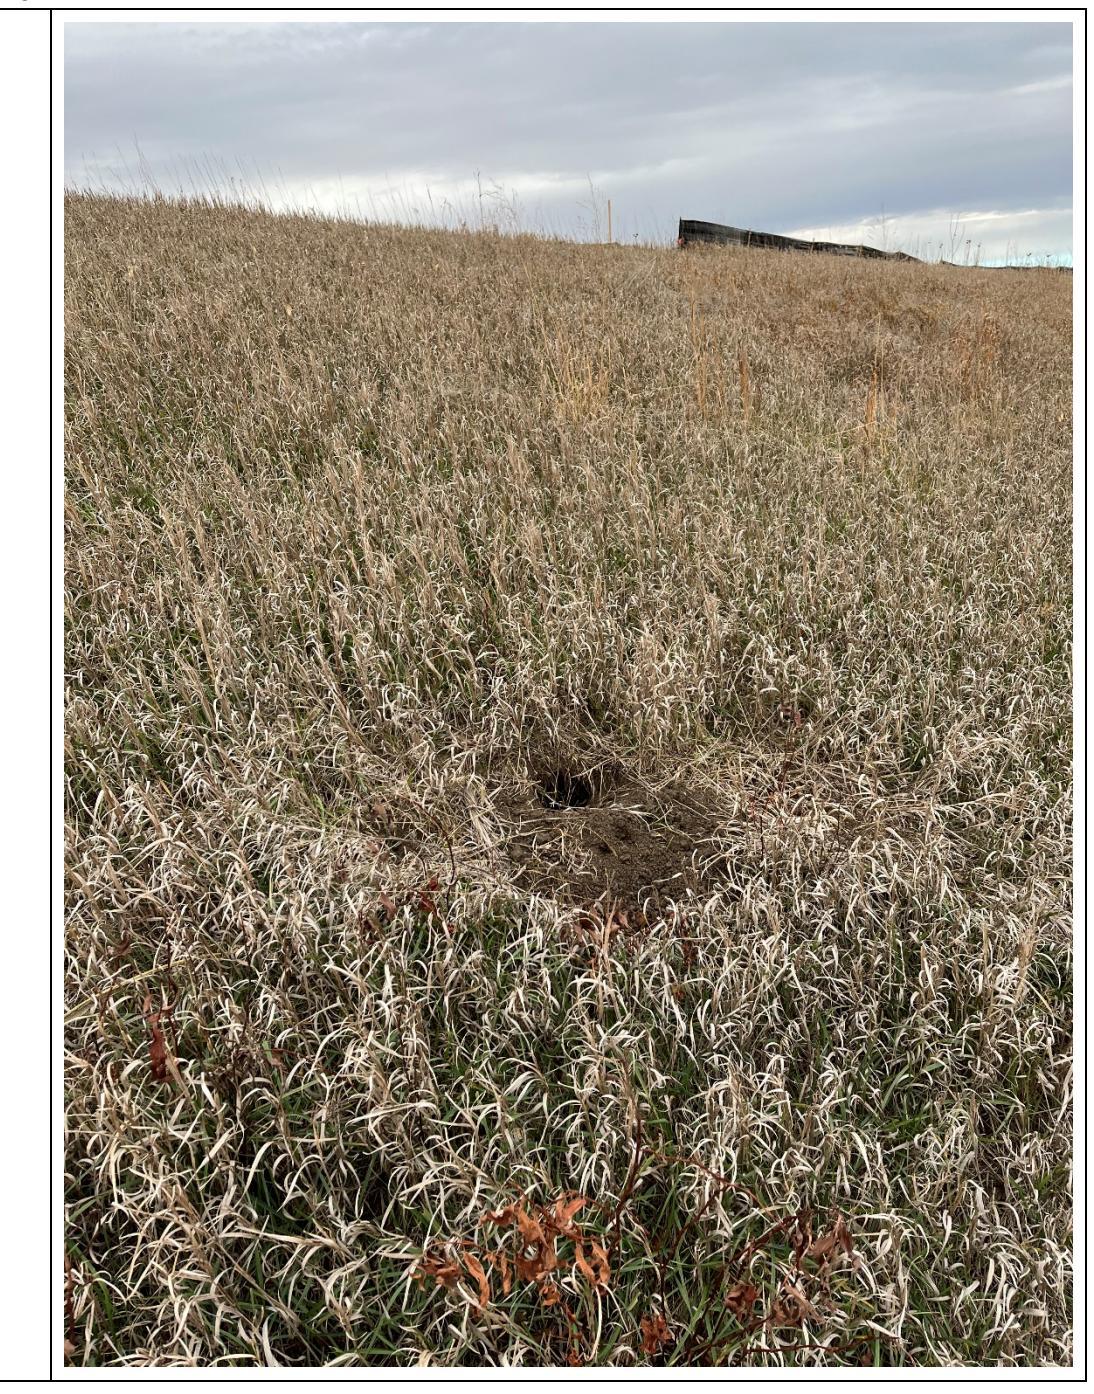
РНОТО 8

Isolated signs of historical (inactive) large animal burrowing have been previously observed around the ash disposal facility. Efforts by NPPD and USDA to trap and relocate large burrowing animals appear to have been successful, as only one small burrow on the east exterior slope of the landfill was observed during the inspection. Regardless, the embankments will continue to be inspected weekly, and signs of burrowing animals will be closely watched by plant personnel. Any increase in the level of small animal activity, or any sign of large animal burrowing, will be remedied by trapping and removal to an off-site location.

Signs of animal activity on east exterior slope

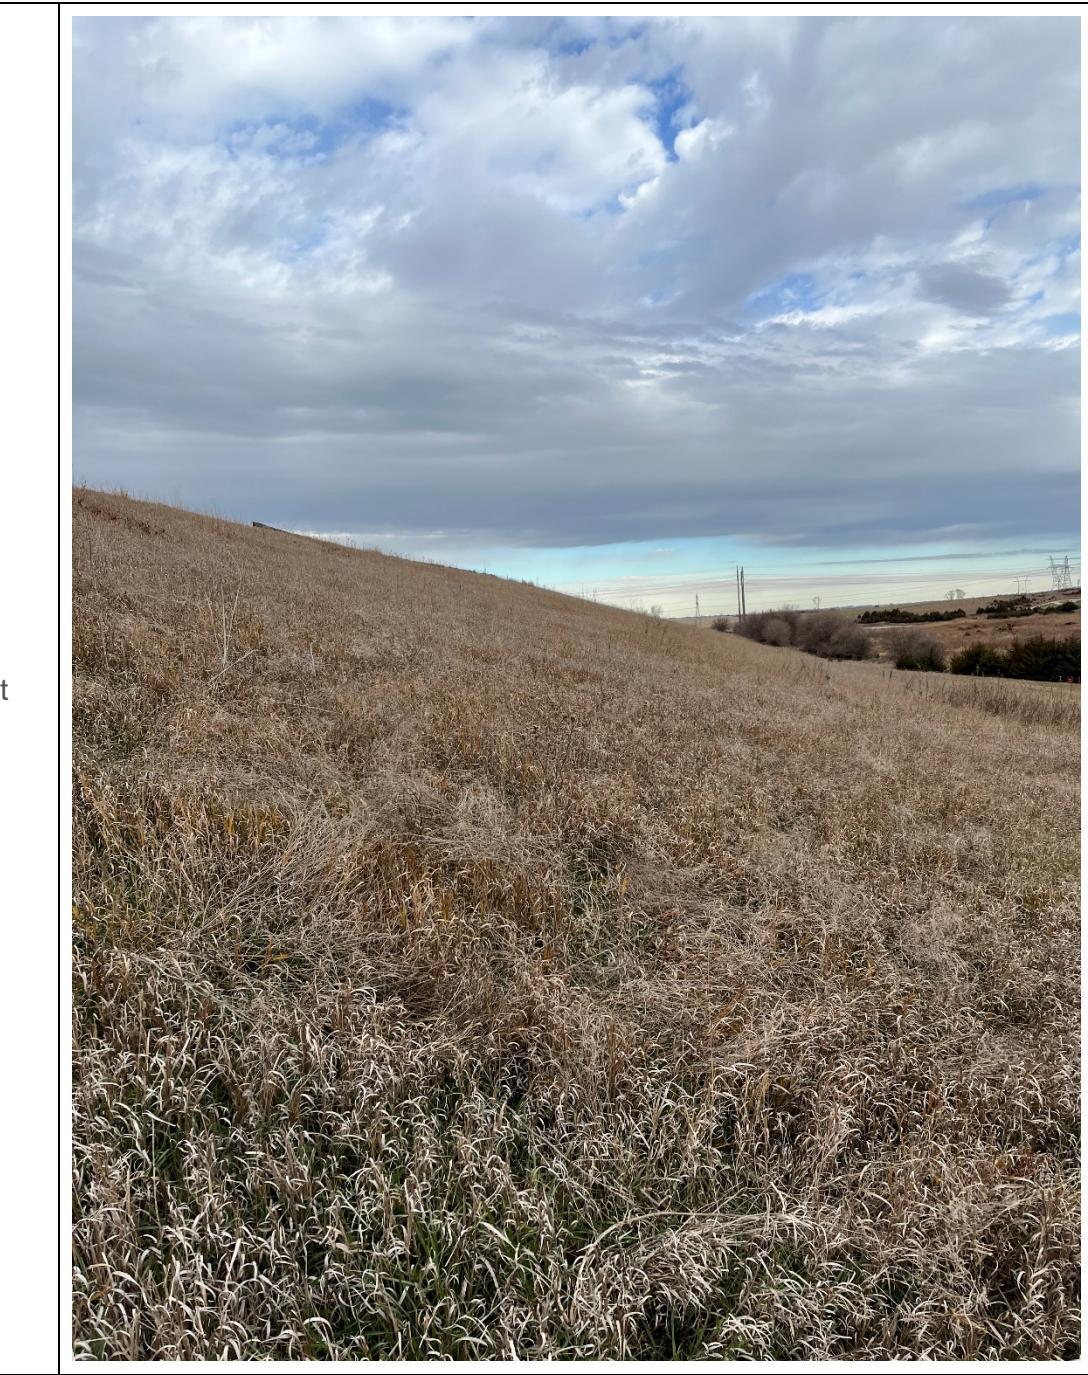
РНОТО 9

Vegetation on east exterior slope

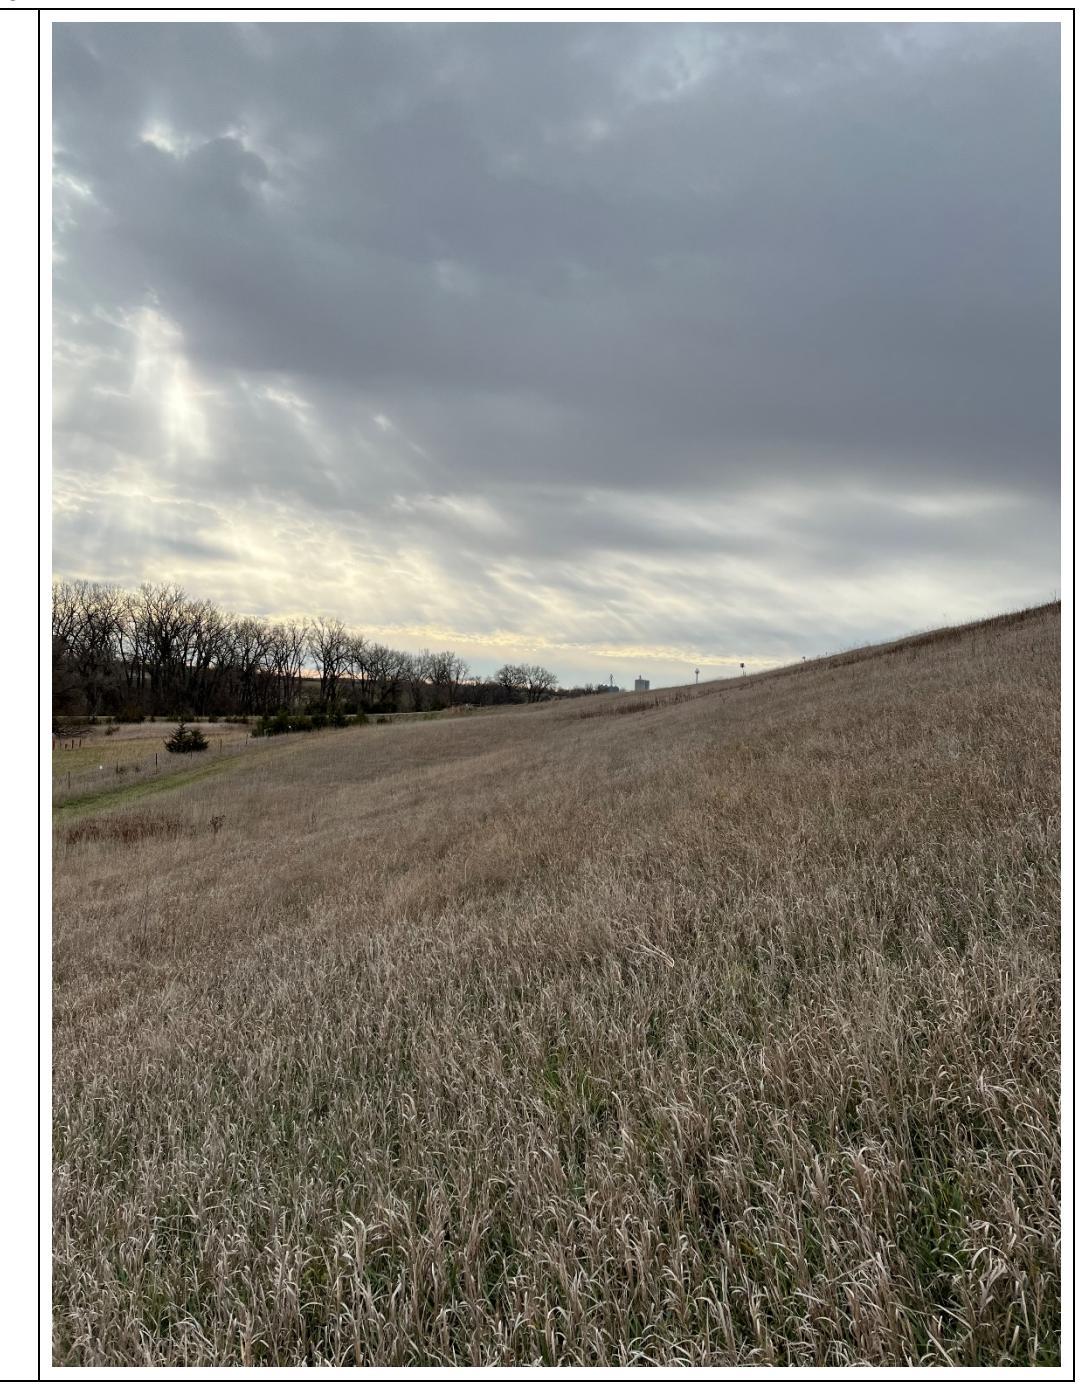
РНОТО 10

Exterior slope on west side of ash disposal facility

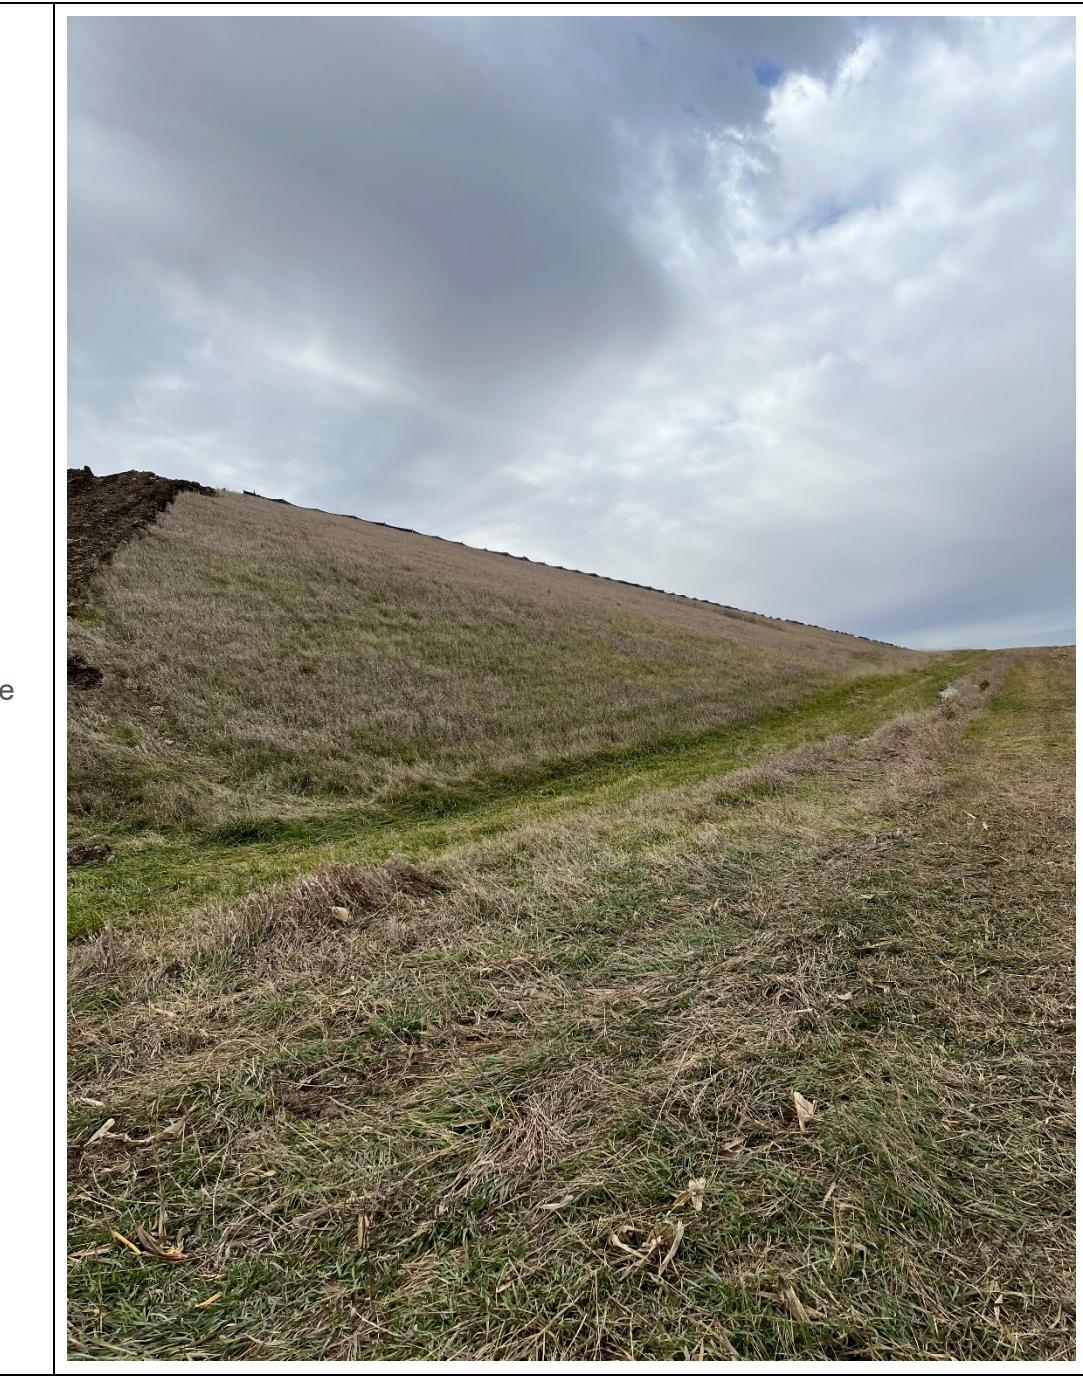
РНОТО 11

North exterior slope of ash landfill

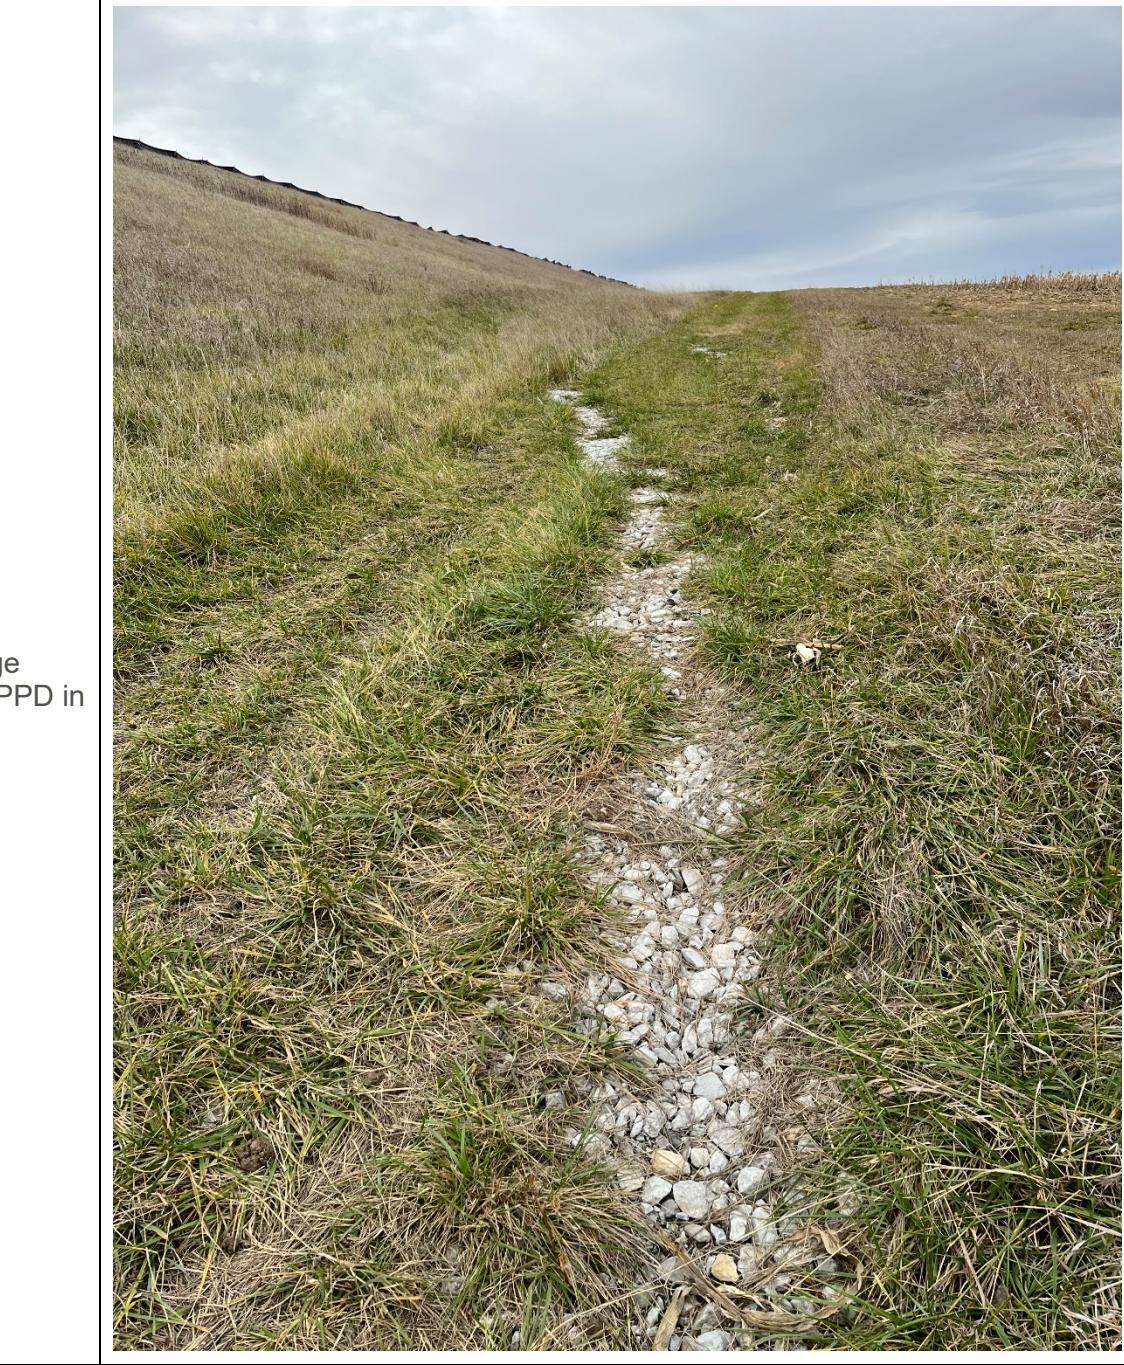
PHOTO 12

In reviewing the weekly inspection reports, NPPD noted that during the spring thaw apparent seepage was observed from the exterior perimeter road in the northeast corner of the facility. The water was suspected to be surface water infiltration and frost melt following the high-permeability surface gravel and daylighting in this area (and not indicative of seepage from ash disposal facility). No signs of seepage were observed during the annual inspection on November 16 to 17, 2021. Vegetation in this area was indistinguishable from the surrounding areas and no signs of instability were observed. NPPD should continue to monitor this area during weekly inspections and notify Golder if any changes are observed.

Area of seepage observed by NPPD in March 2020
