2020 Annual Inspection Report

Gerald Gentleman Station Ash Disposal Facility

Nebraska Public Power District

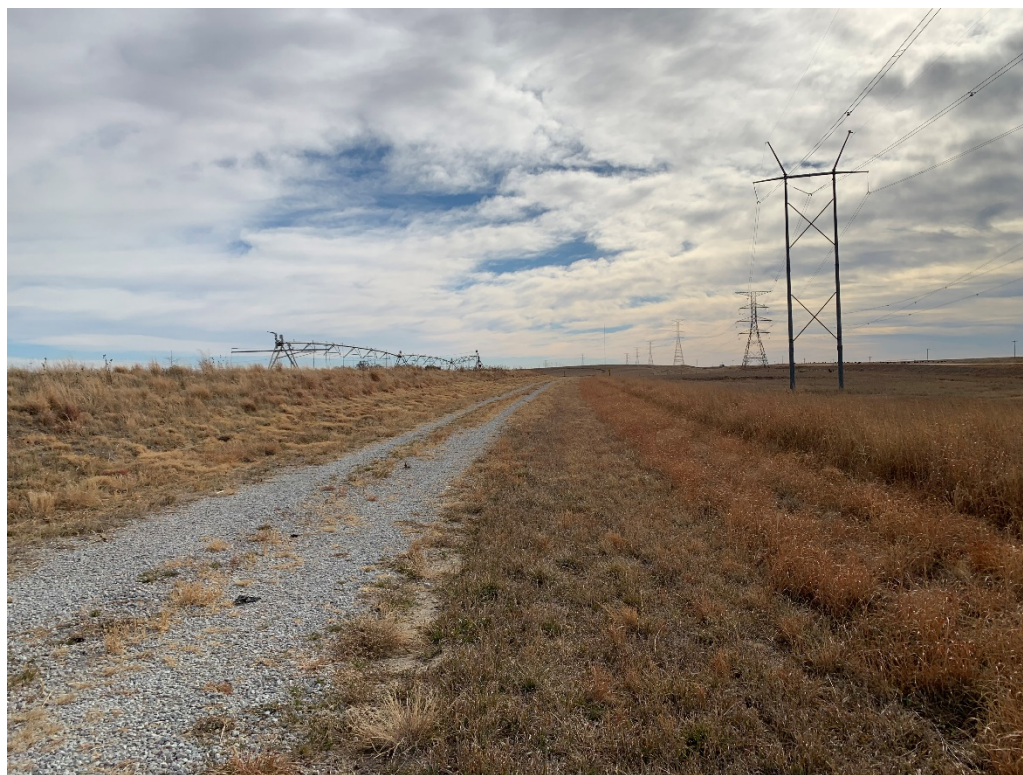
Ash Disposal Facility Annual Inspection, Gerald Gentleman Station**PHOTO 5**

Area of historical erosion needing revegetation

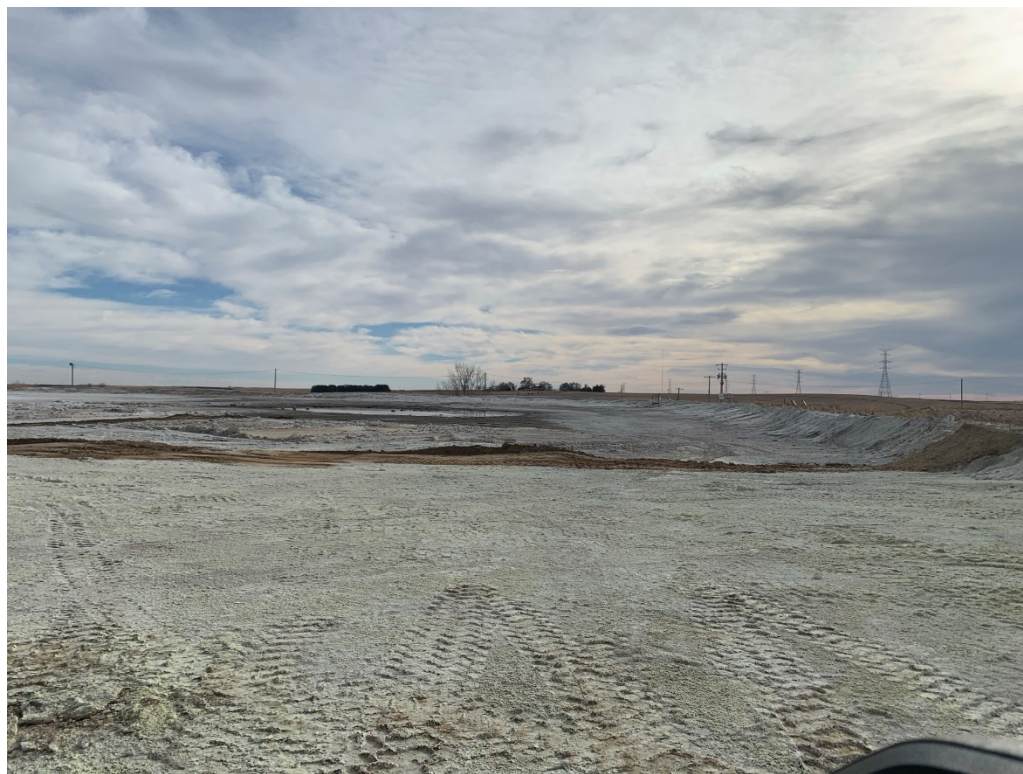
**PHOTO 12**

Contact water pond
on east end of Ash
Landfill No. 4.

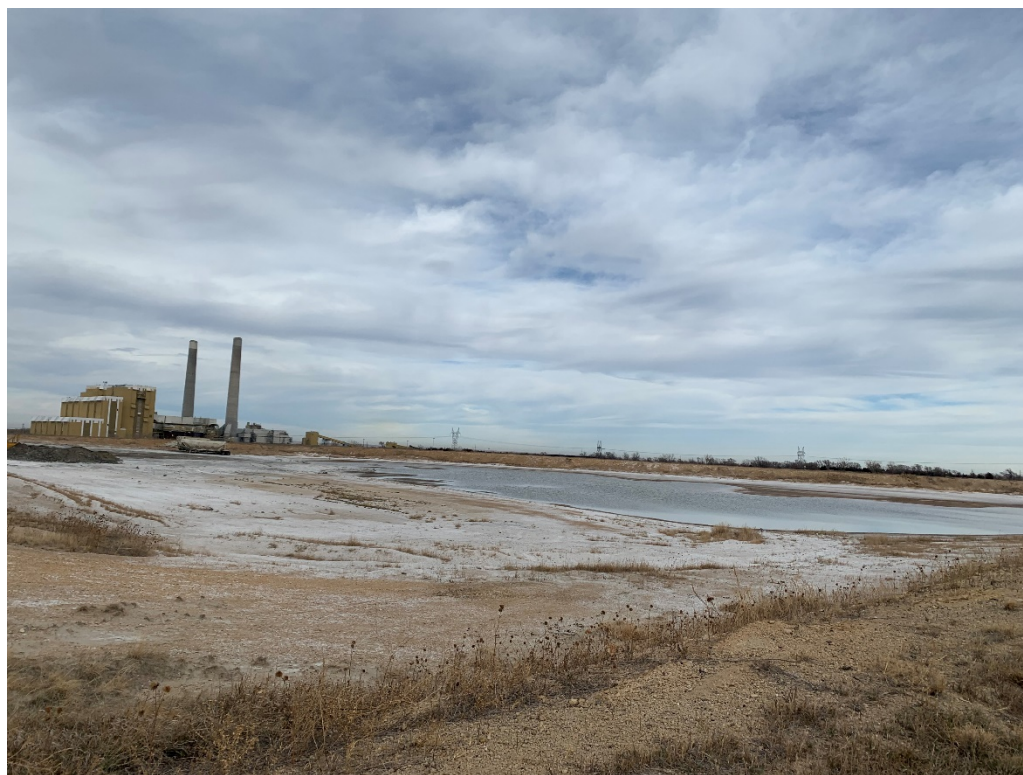
Ash Disposal Facility Annual Inspection, Gerald Gentleman Station**PHOTO 13**

Access ramp to active deposition area on Ash Landfill No. 4.

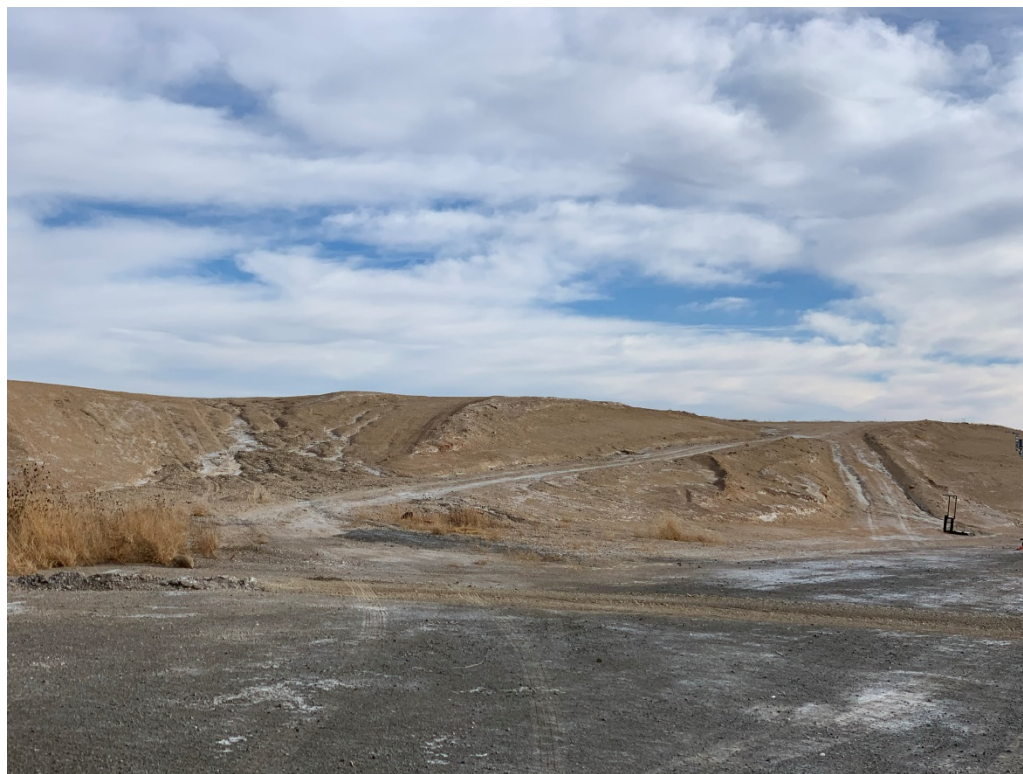
**PHOTO 14**

Edge of liner signage on south side of Ash Landfill No. 4.
