2025 Professional Engineer Inspection Report

Sheldon Station Ash Landfill No. 4

Nebraska Public Power District

GLA21457062.3557-002-RPT-0

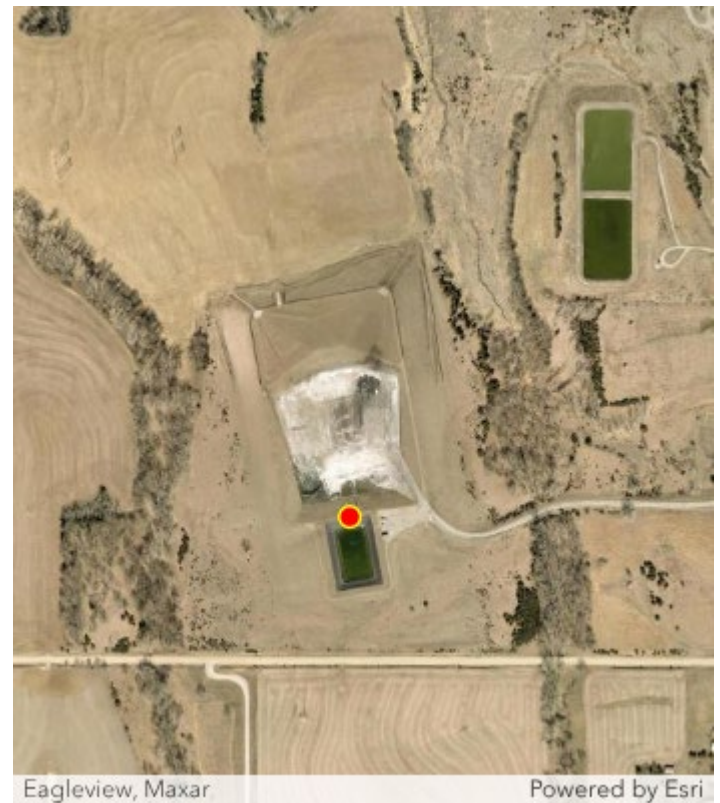
Minor animal burrows were observed during the October 9, 2025, site inspection. No mitigating action is necessary at this time, but burrows should continue to be monitored. Any significant increase in the level of small animal activity, or any sign of large animal burrowing, will be remedied by trapping and removal to an off-site location.

Site Notes:
Critter hole

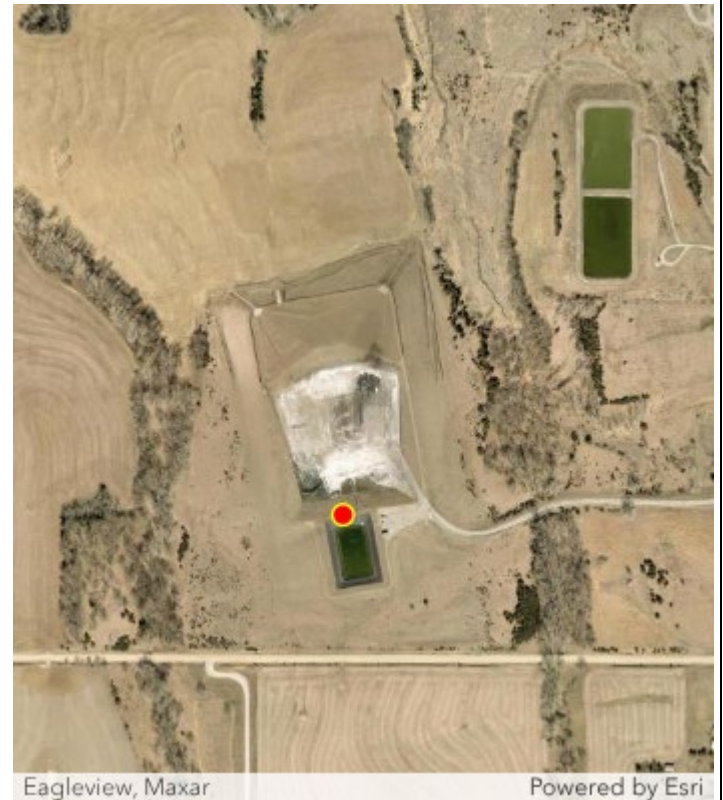
Surficial cracks have been observed in the perimeter road around the crest of the facility embankment during previous annual inspections. The cracking was observed to be significantly improved during the site inspection on October 9, 2025. 2025 has been wetter than recent years, and the additional precipitation appears to have helped the surficial cracking observed around the perimeter embankment. Cracks were previously observed along significant stretches of the embankment crest, both along the interior and exterior, especially on the south, east, and west sides of the facility. During the 2025 site inspection, the cracking was limited to the south embankment crest. The cracks were confined to about a 20-foot area, generally parallel with the crest. No signs of bulking or slope movement were observed along the surface or toe of interior or exterior slopes. NPPD should continue to closely monitor the cracking and report to WSP immediately if the cracks change in size or if additional cracks appear or displacement is observed.

Site Notes:
Crack at south embankment crest

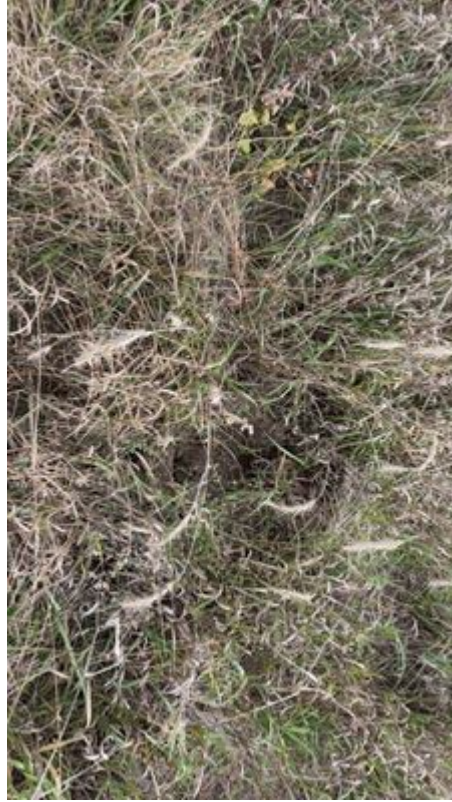
Site Notes:
Minor burrow
