2021 Annual Inspection Report

Gerald Gentleman Station Ash Disposal Facility

Nebraska Public Power District

20149028-R-0

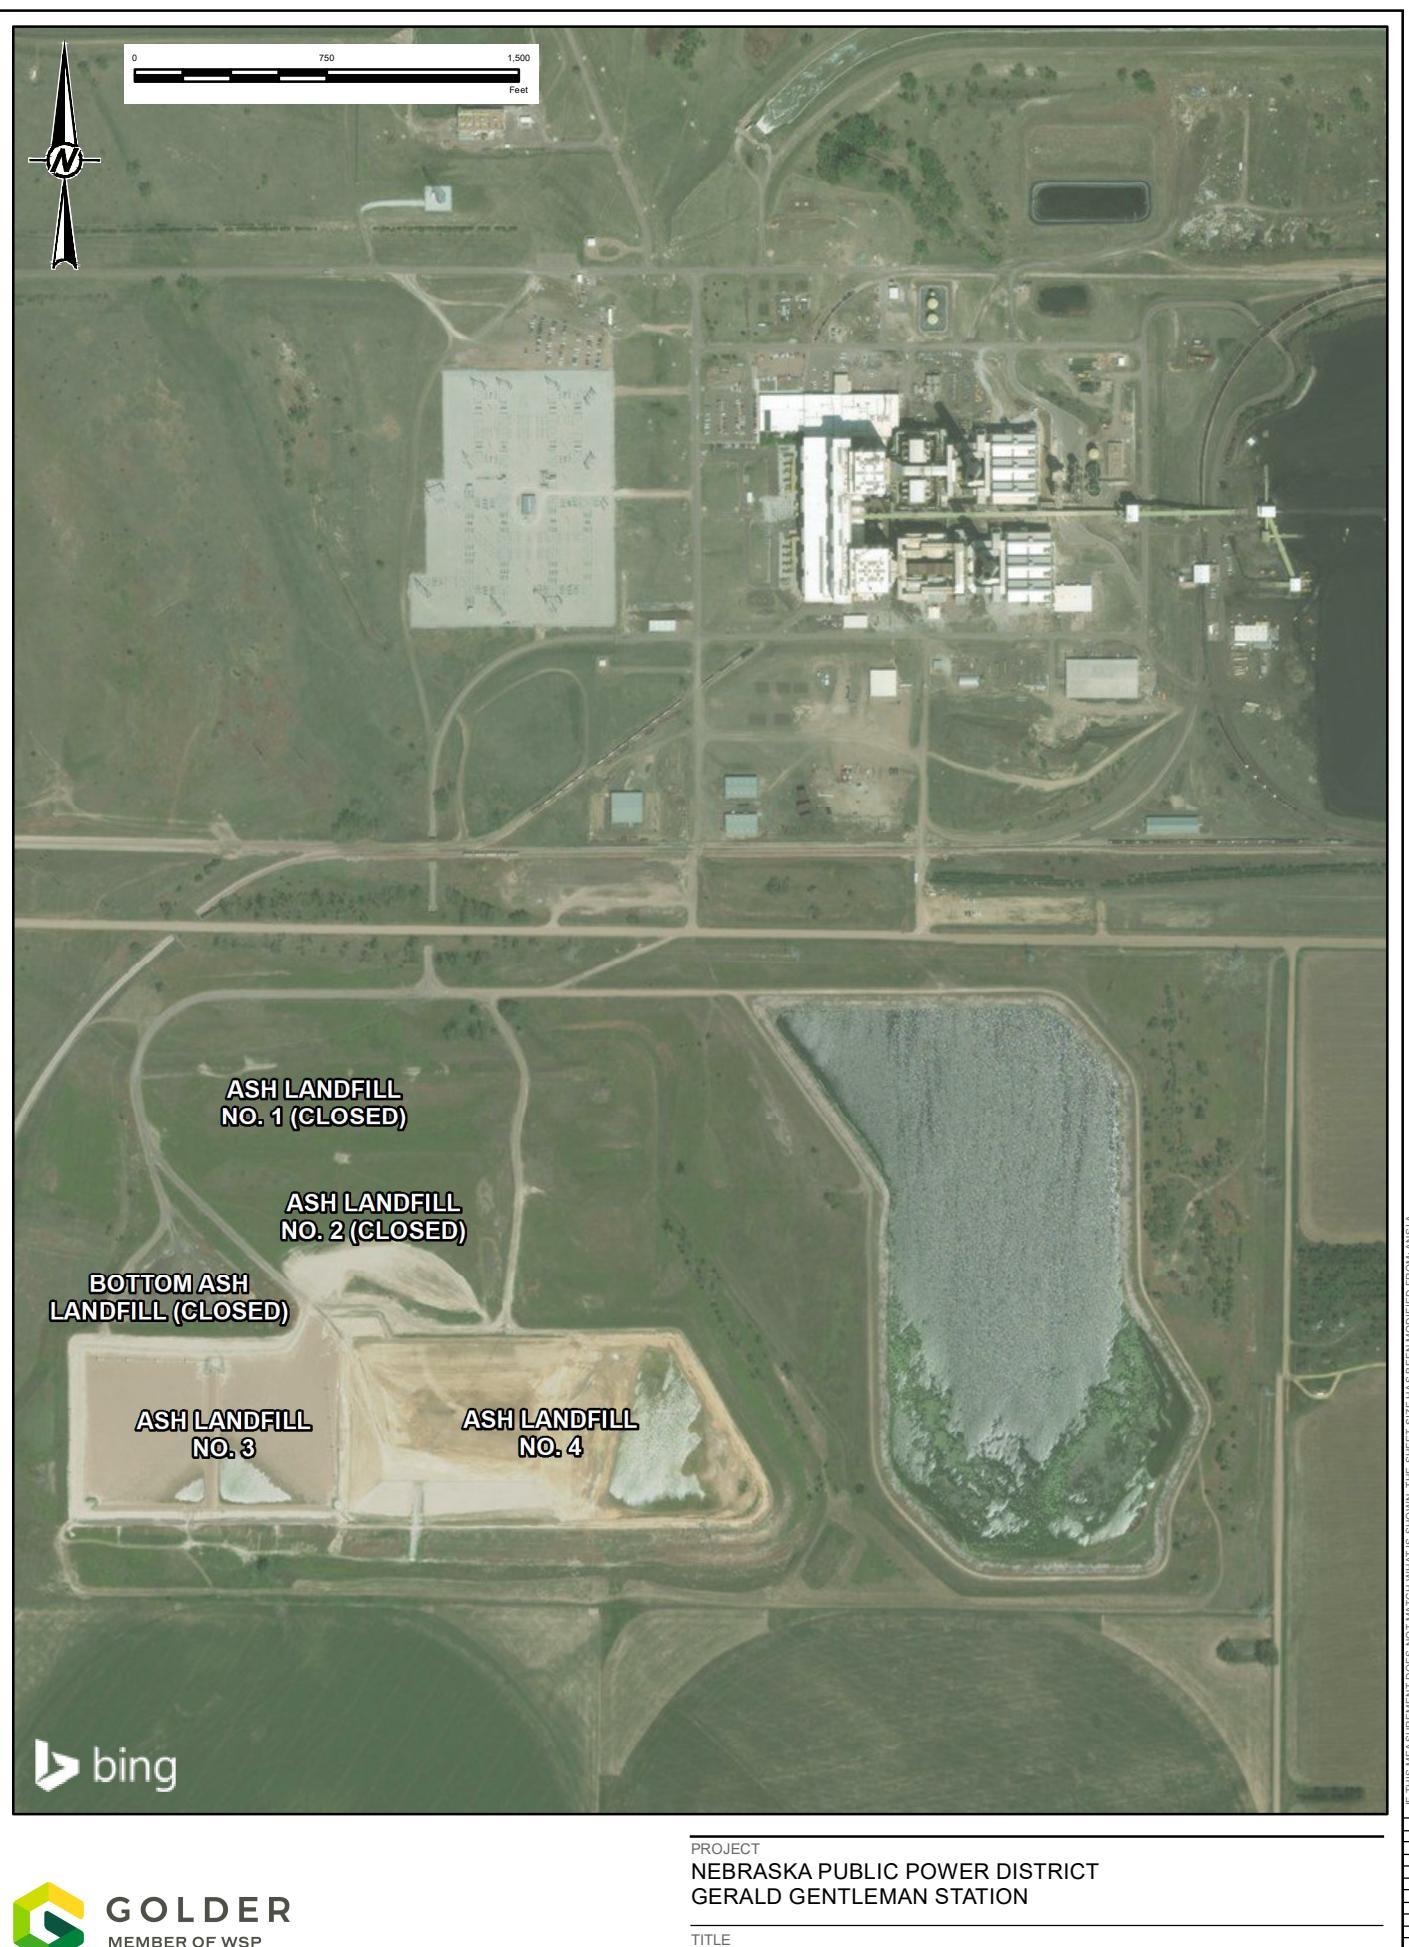
FIGURE 1

Site Layout

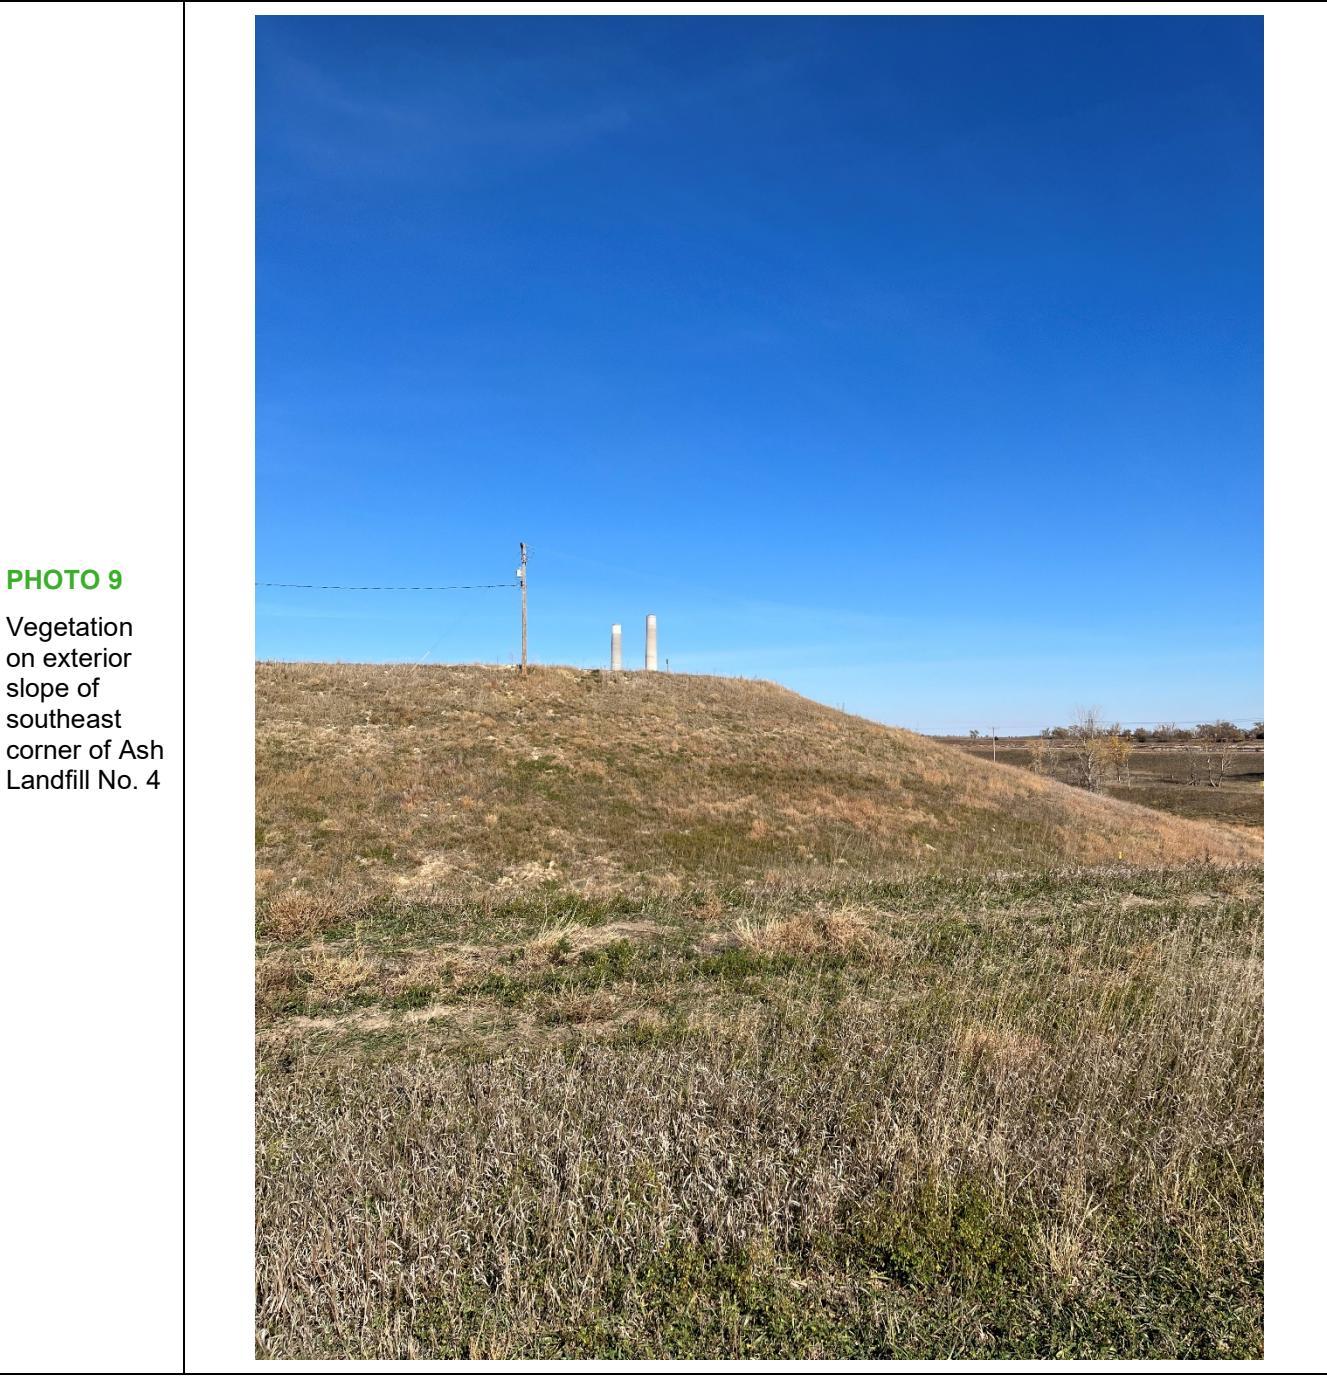
Vegetation on exterior slope of southeast corner of Ash Landfill No. 4

Vegetative growth on the exterior slopes and final cover placed in 2015 appears to have been stressed by the warm and dry weather over the past couple of years. NPPD may consider irrigation of the exterior slopes if the vegetation doesn't rebound in 2022 to maintain vegetation capable of protecting the slopes from erosion.
