Transmission Line

2304B Storm Damage

NPPD Board of Directors Emergency Virtual (Teams) Meeting July 2, 2025

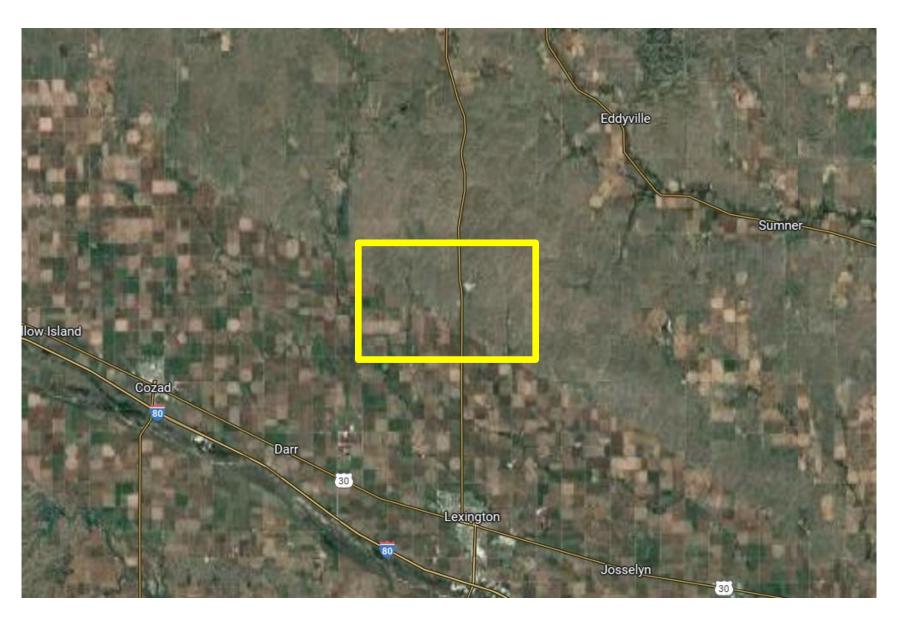
Line Description and Location

- Line 2304B Crooked Creek to North Platte
- Approximately 59.72 miles
- 409 Structures in total line
- Much of this line was rebuilt following the 1994 wind event

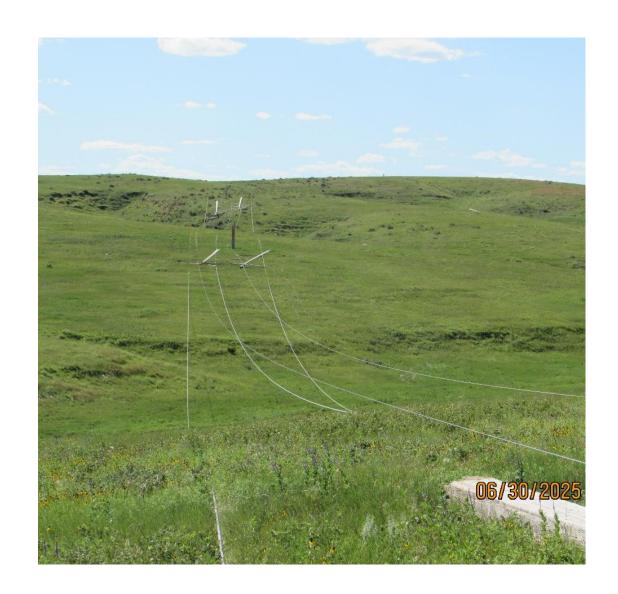
Damage Quantity

- 7.6 miles of line damaged
- 49 structures unrepairable
 - Structure 229 just outside Crooked Creek Substation westward to structure 277
- Conductor is 954 ACSR/SD Type 7
- One Shield wire is 3/8 EHS
- The other Shield wire is 547 OPGW

- Total estimated clean-up and reconstruction project cost is \$6.7 million.
- Majority of materials will be from inventory.
- Expect construction labor contract cost in excess of \$1.5 million.
- Clean-up and reconstruction can begin as soon as approval is obtained.
- Goal is in-service date of 8/31/2025 or earlier.
